BRIDGE INSPECTION REPORT

Routine Inspection

BRIDGE NO.:
23C0092

STRUCTURE NAME:
PUTAH CREEK

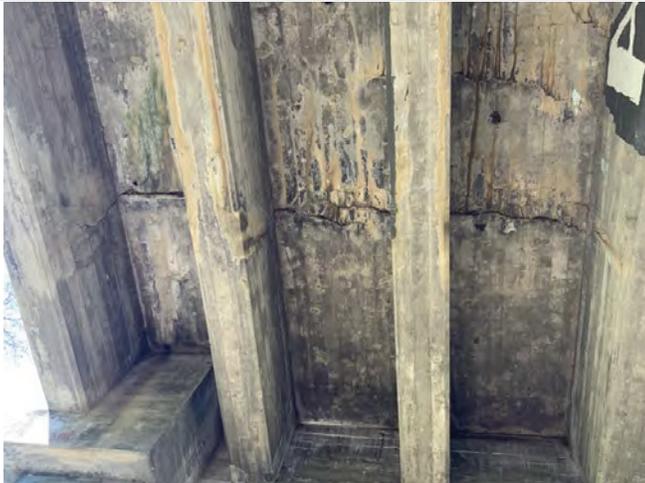
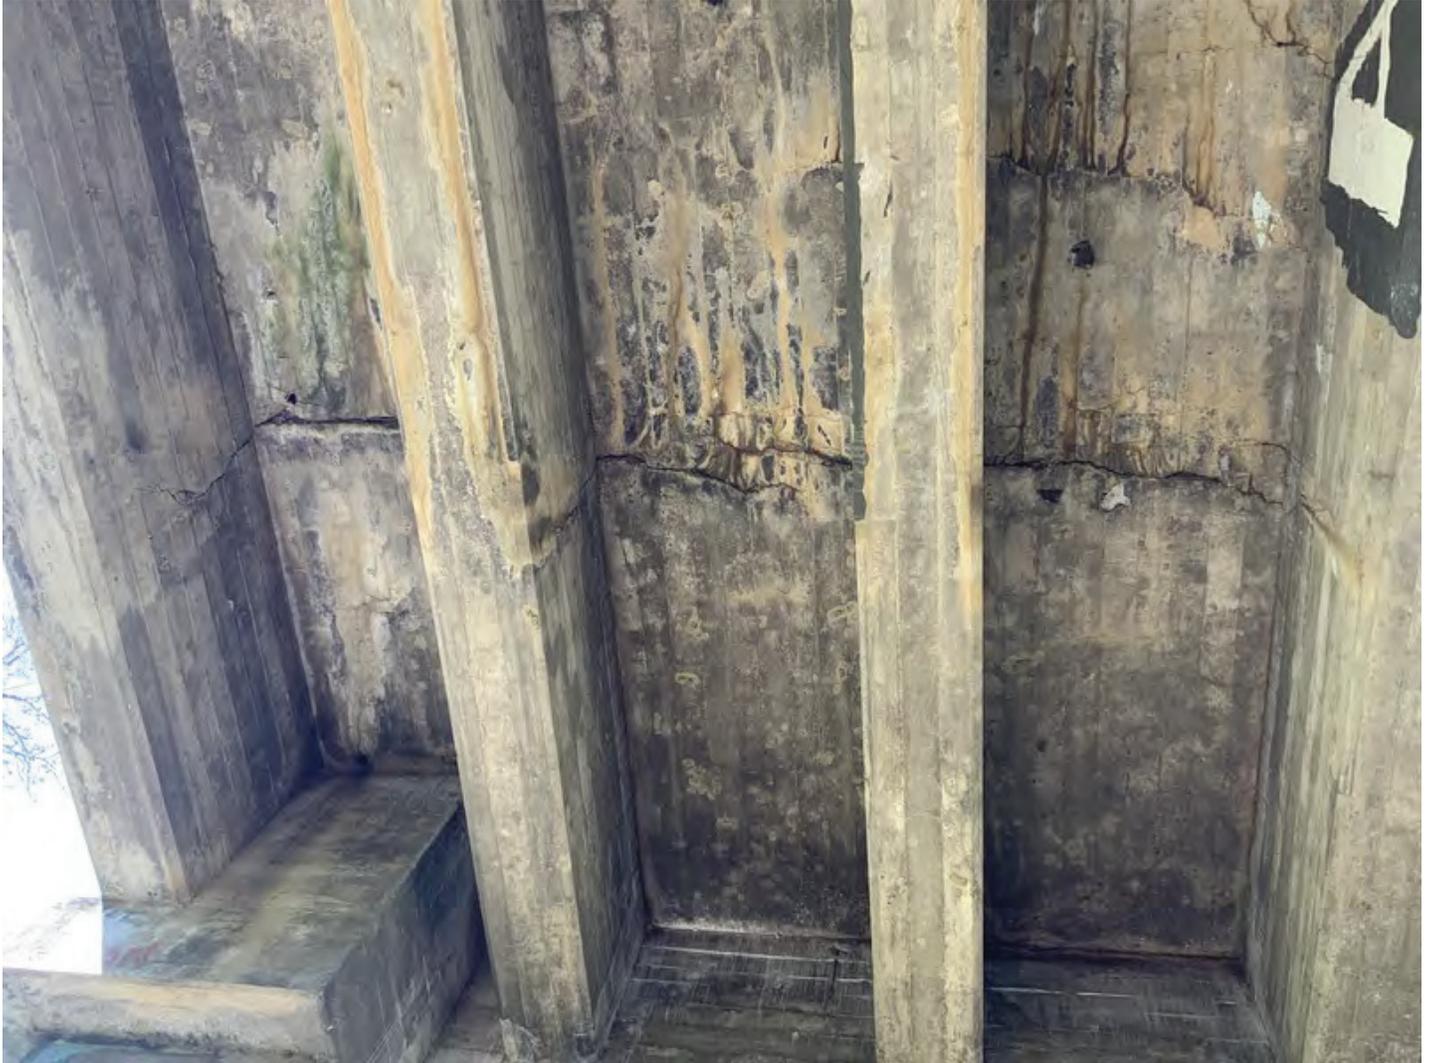
Photo 8

There are two transverse deck cracks in Span 1 near Bent 2 and 2 transverse deck cracks in Span 4 near Bent 4. These cracks penetrate the full depth of the deck, are reflective in the soffit and have associated spalling. Refer to Photos 8 and 9.

Transverse crack with spalling in the soffit of Span 1.

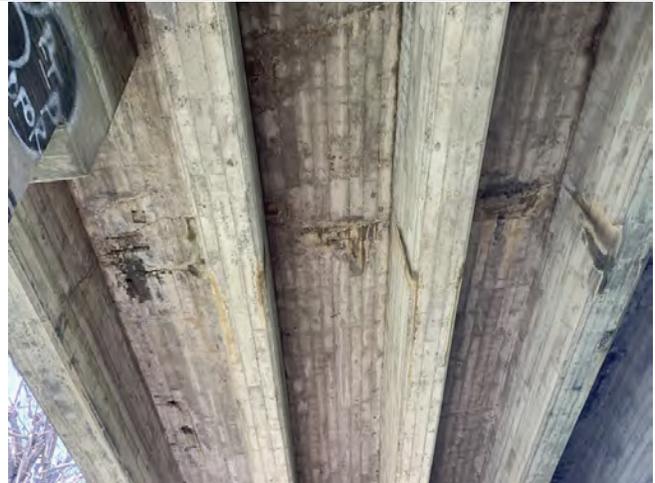
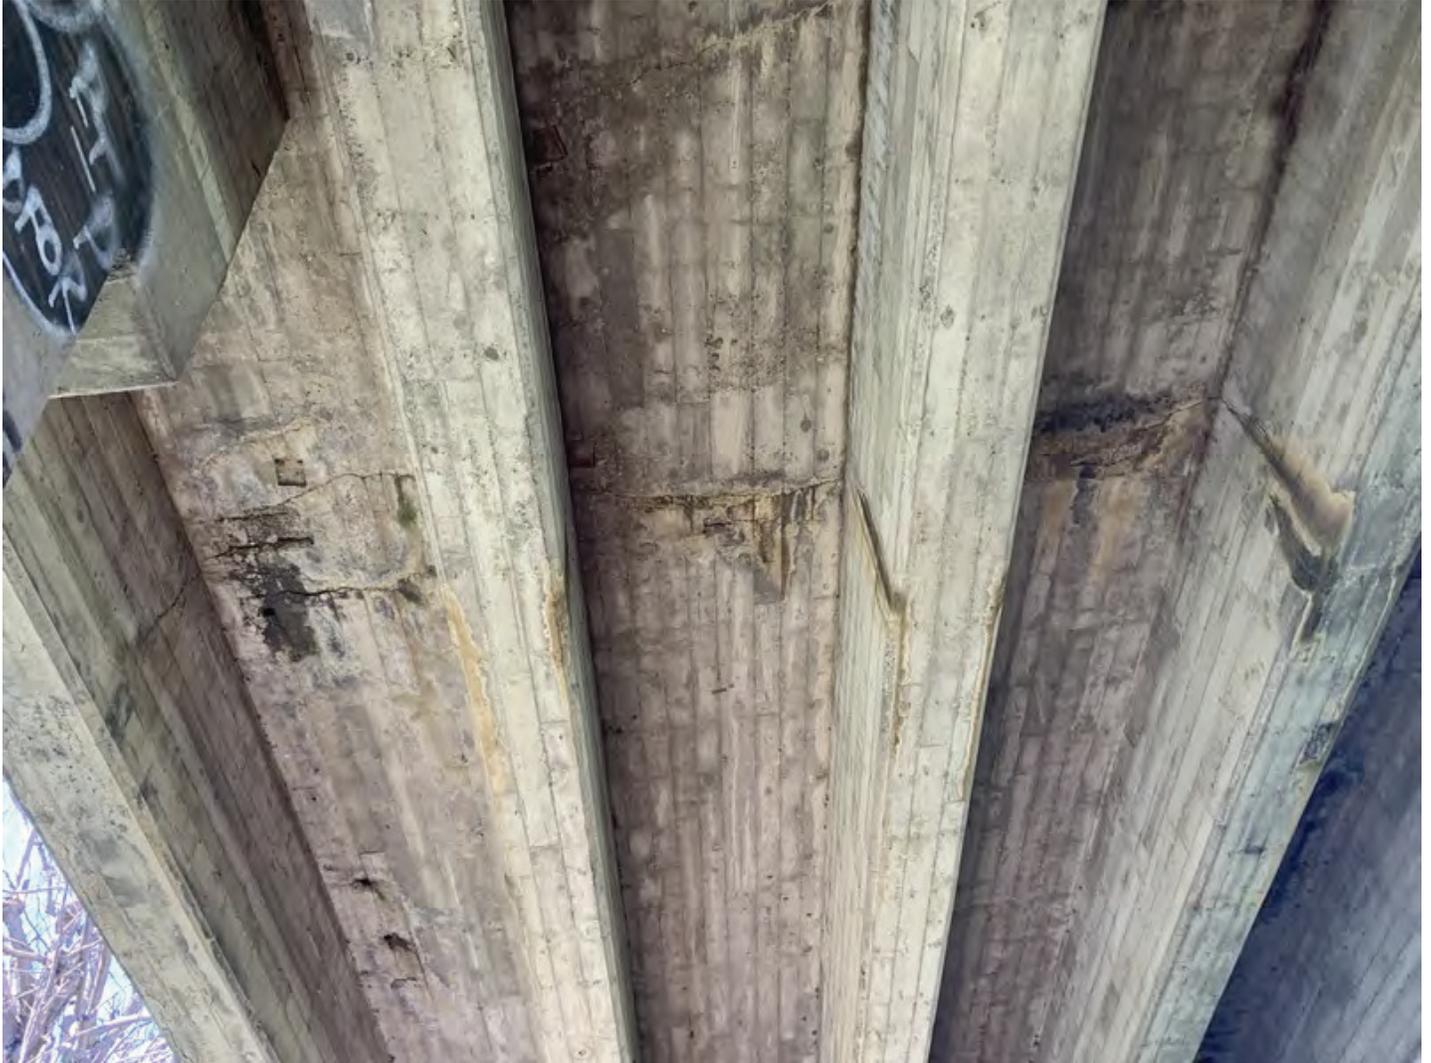
Photo 9

There are numerous shallow soffit spalls on the structure in all spans. The spalls are typically between one to two feet in length and approximately one foot wide with exposed corroding rebar. Spalls present randomly throughout the soffit but heaviest along the transverse cracks in Spans 1 and 4. Refer to Photos 9, 12 and 22.

Transverse crack with spalling in the soffit of Span 4.

A work recommendation to remove loose concrete around the spalls, clean the exposed rebar and apply a corrosion inhibitor to the exposed rebar was created.

Remove loose concrete, clean the exposed rebar and apply a corrosion inhibitor to all spalls throughout the soffit of the deck.

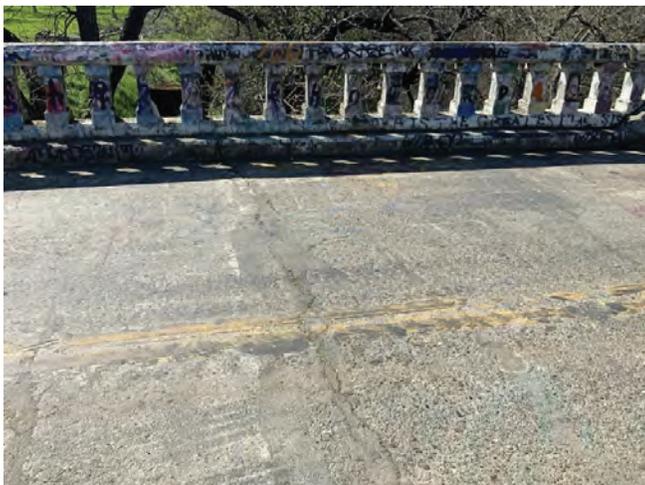
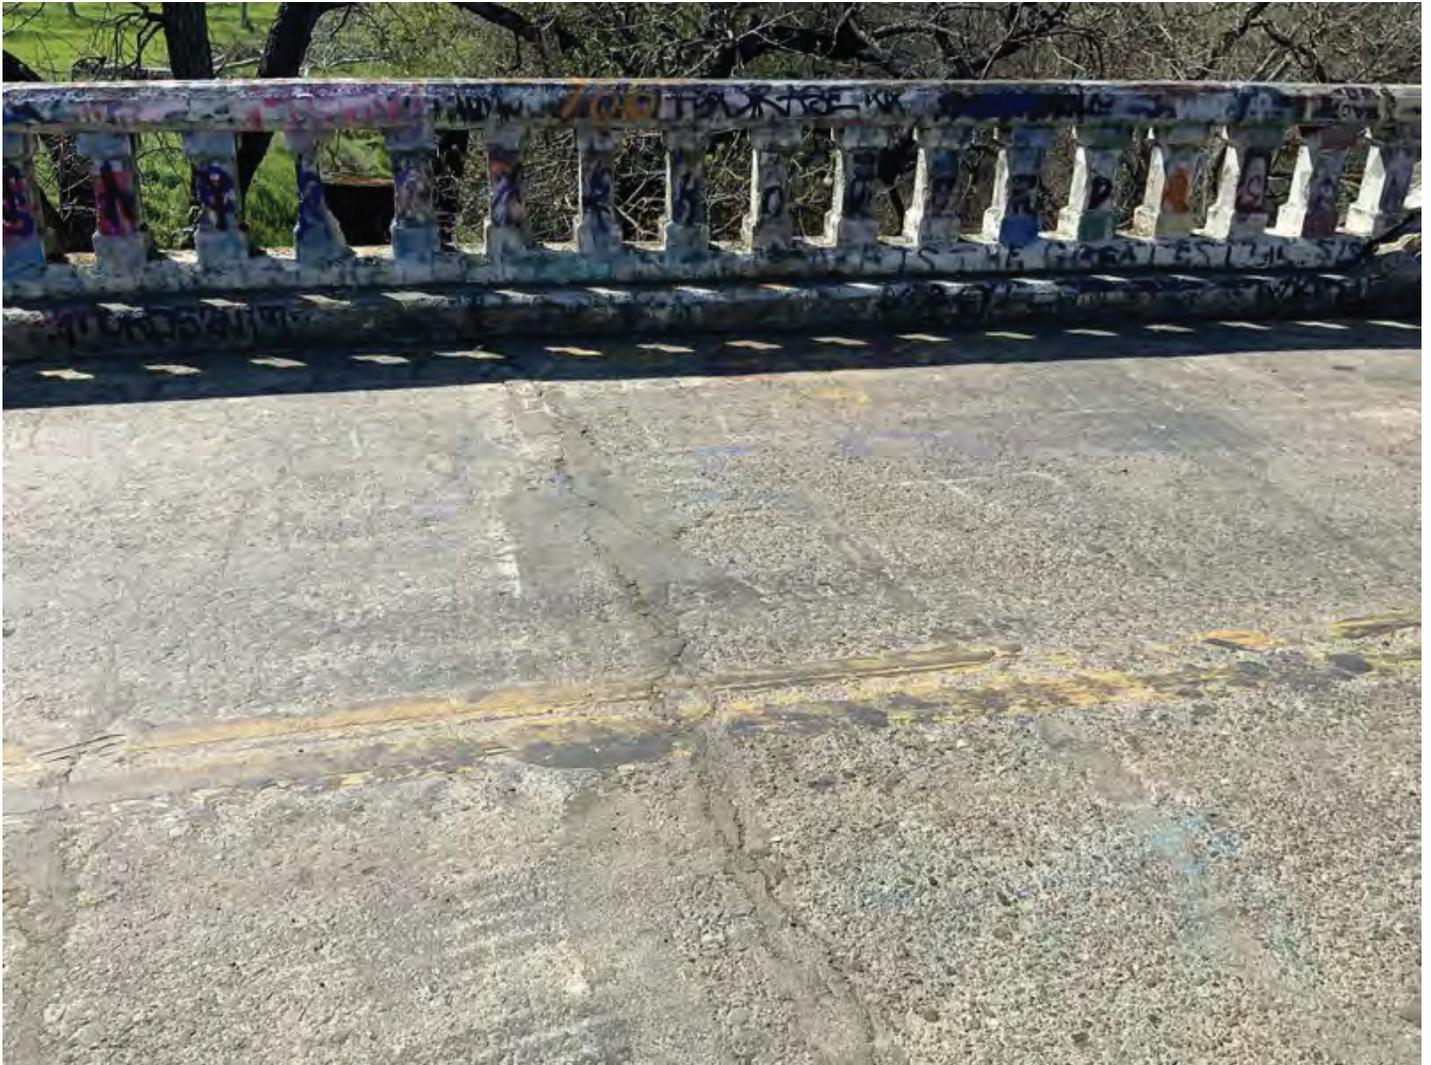
Photo 10

The cracks have been treated with methacrylate as shown in Photo 10. Prior to being treated, the were noted to be 0.4 to 0.6 inch wide and will therefore remain in Condition State 3.

Sealed transverse deck crack in Span 1.

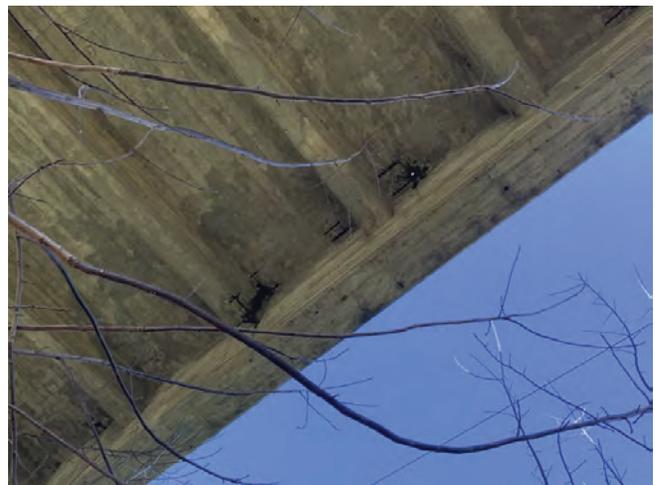
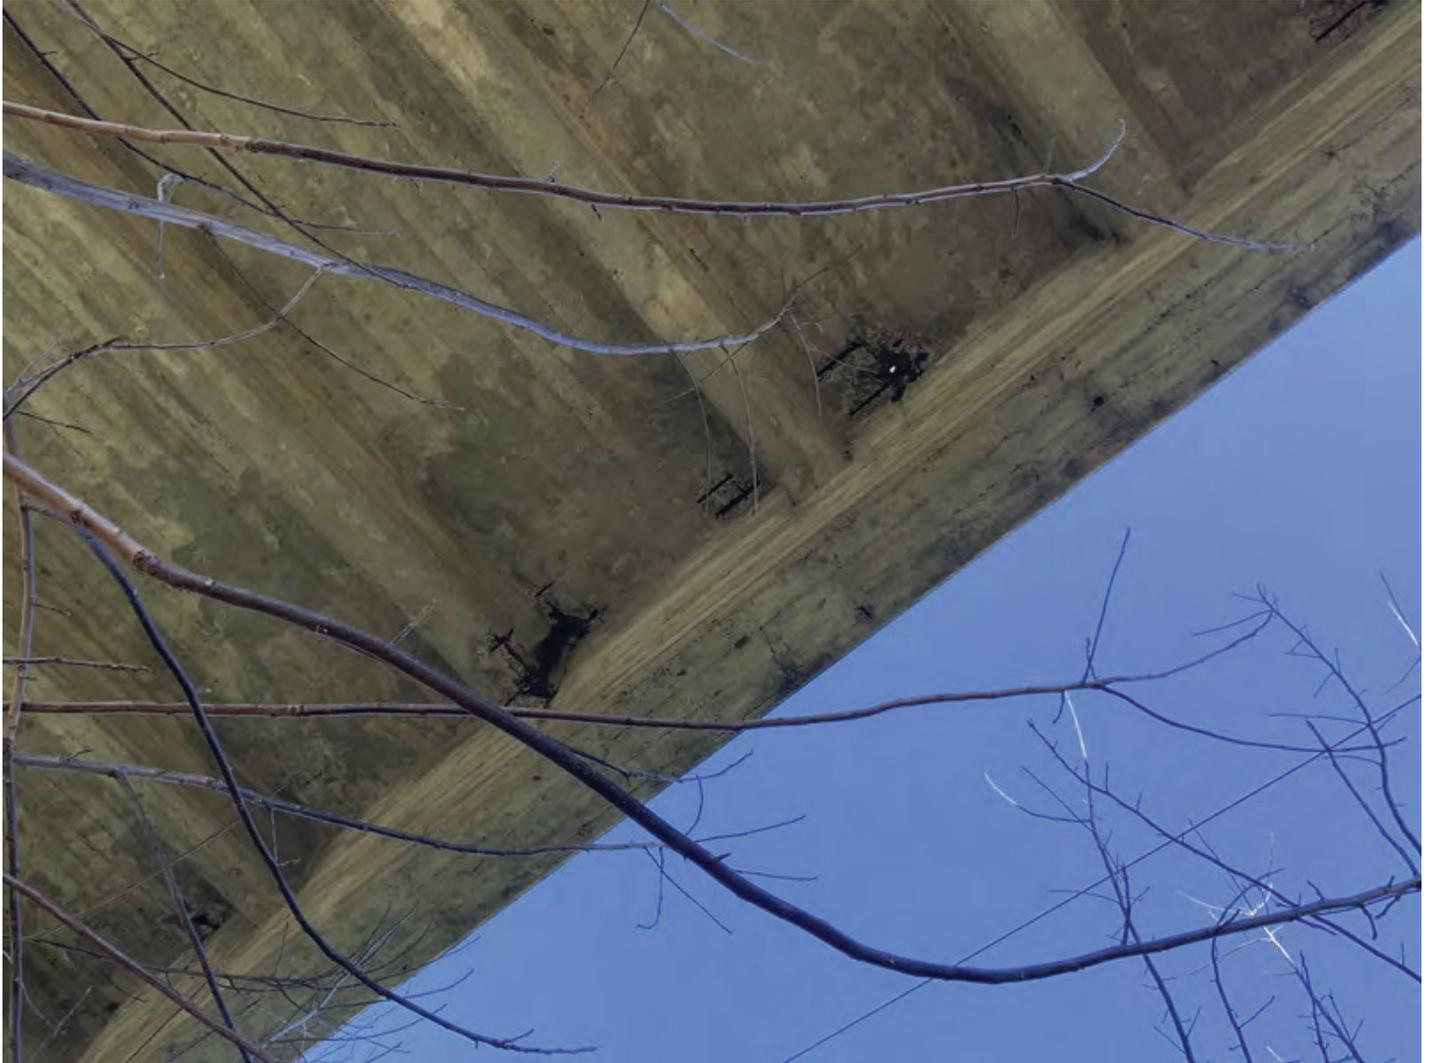
Photo 22

Spalls with exposed rebar in the soffit.

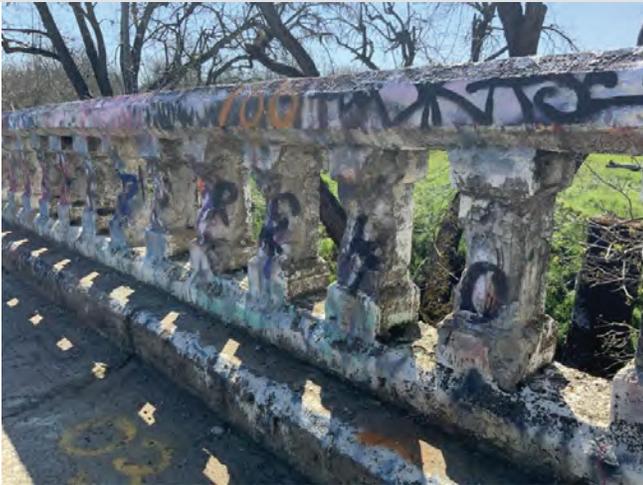
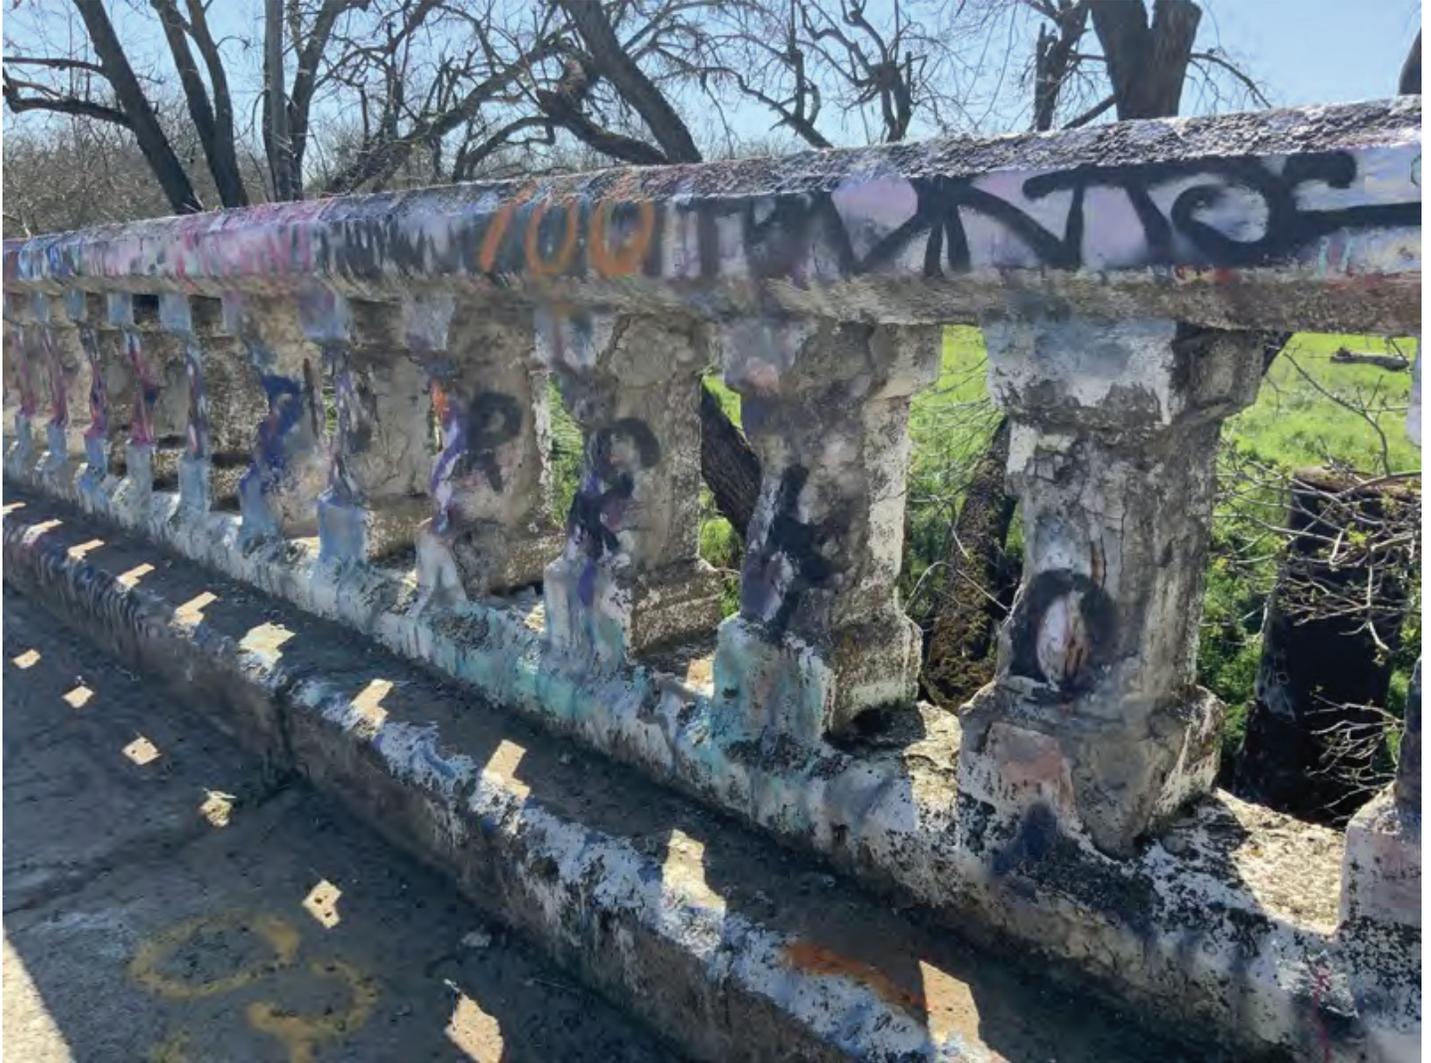
There are numerous random spalls and incipient spall on both bridge rails. Many of the spalls have been patched; however, the patches are beginning to fail. Refer to Photo 11.

Photo 11
Failed patches in the left bridge rail.

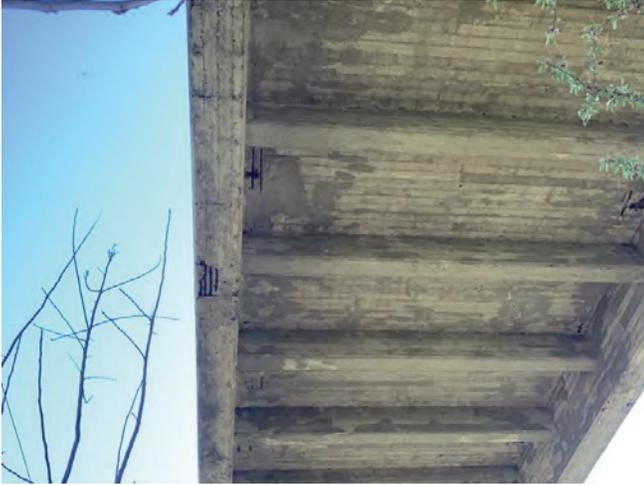
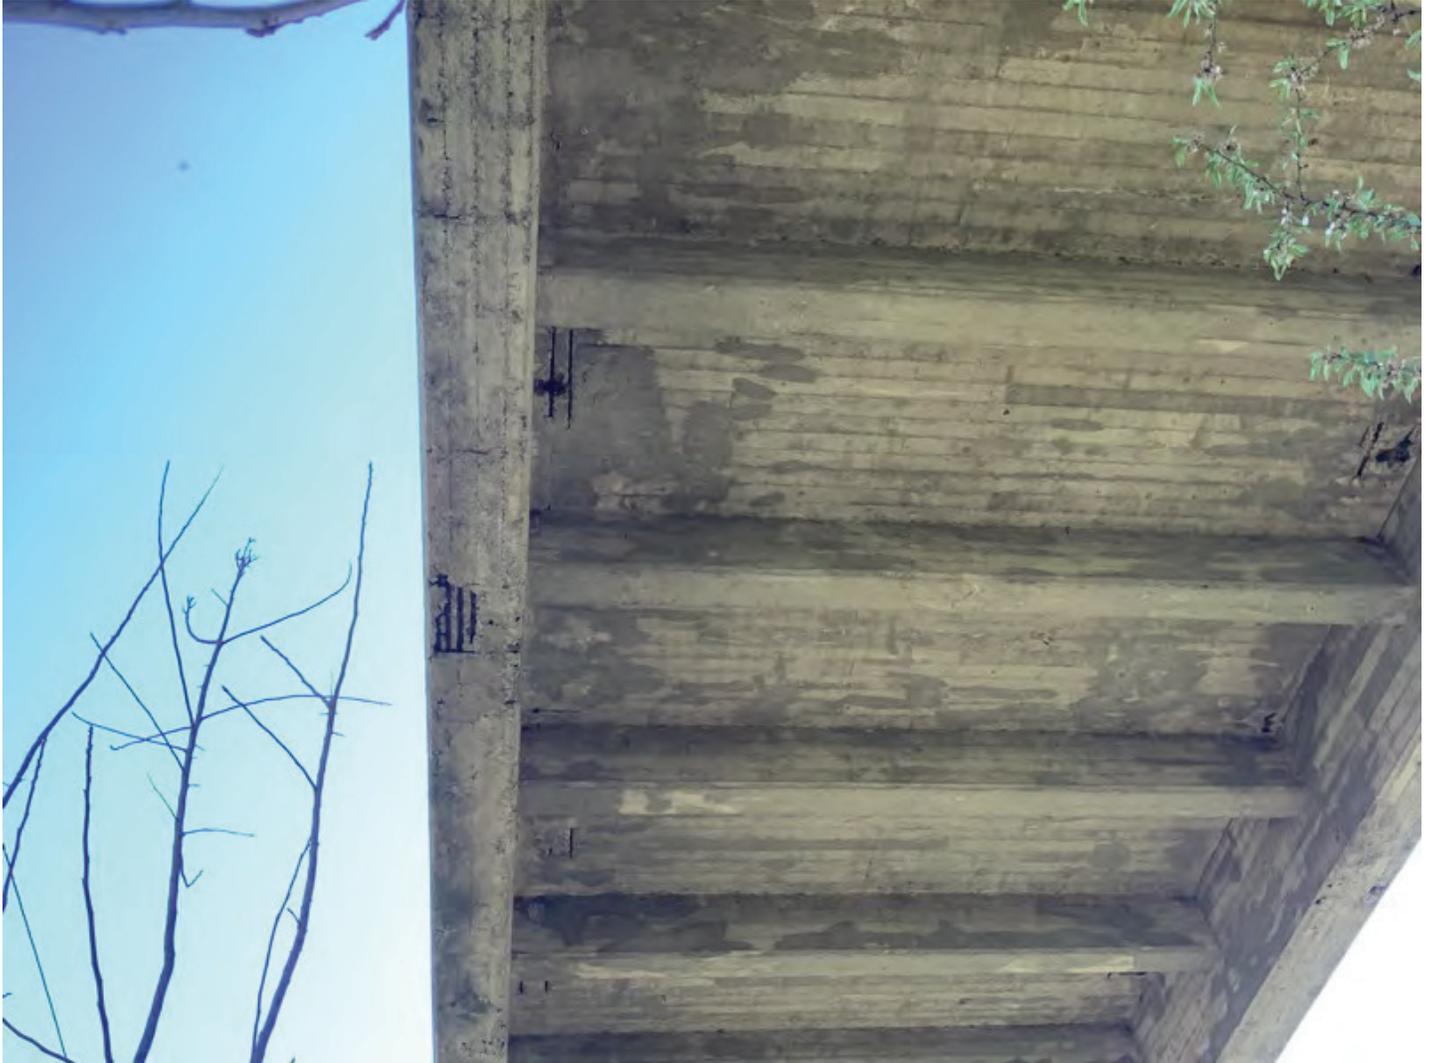
There are spalls with exposed rebar randomly throughout both girders. The spalls are typically 1 to 2 square feet in area. Approximately 15% of the girders have spalls or delaminations, less than 5% are Condition State 3 spalls. Refer to Photo 12.

Photo 12
Spalls with exposed rebar in the bottom of the girders.

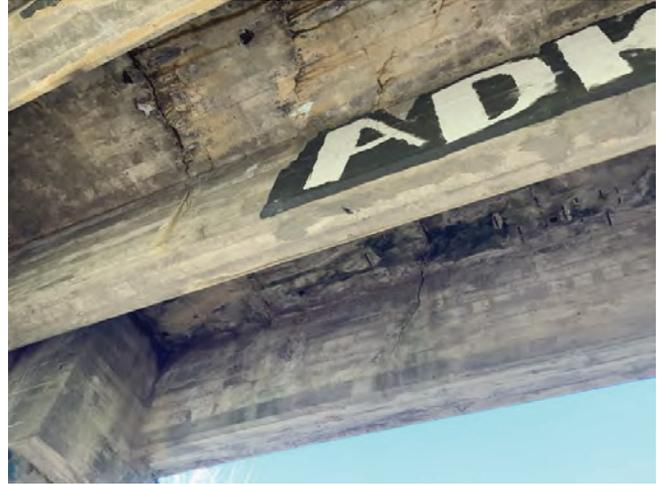
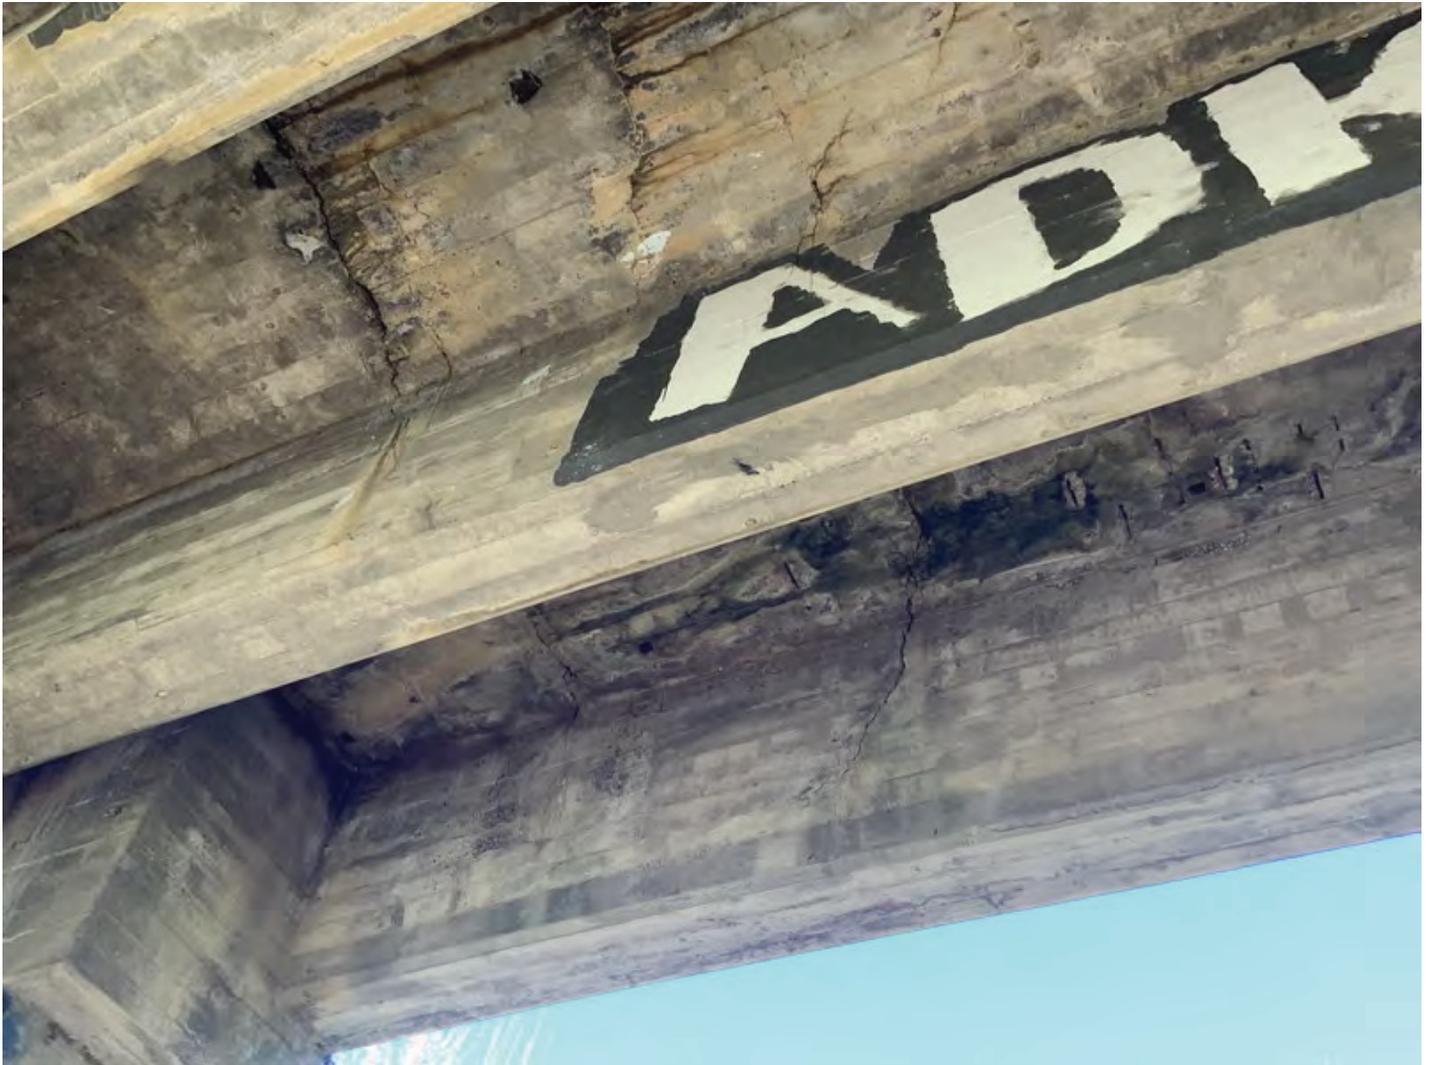
There are vertical cracks in all four girders in Spans 1 and 4. These cracks are greater than 0.05 inch wide, extent 3/4 the depth of the girders and open to the top of the girder. The cracks are up to 0.5 inch wide where they surface in the deck. Refer to Photos 13 through 16.

These cracks are located approximately 8 to 10 feet from the bents and coincide with transverse cracks in the deck. The cracks do not indicate stress in the tension area, but more likely settlement at the abutments.

These cracks have been previously noted and no significant progress was noted when compared to Photos 4, 5, 11 and 12 from the 10/23/2009 report.

Photo 13
Vertical cracks in the girders in Span 1.

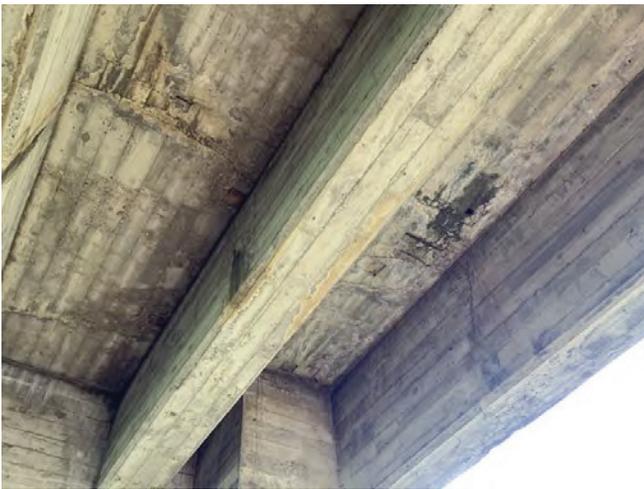
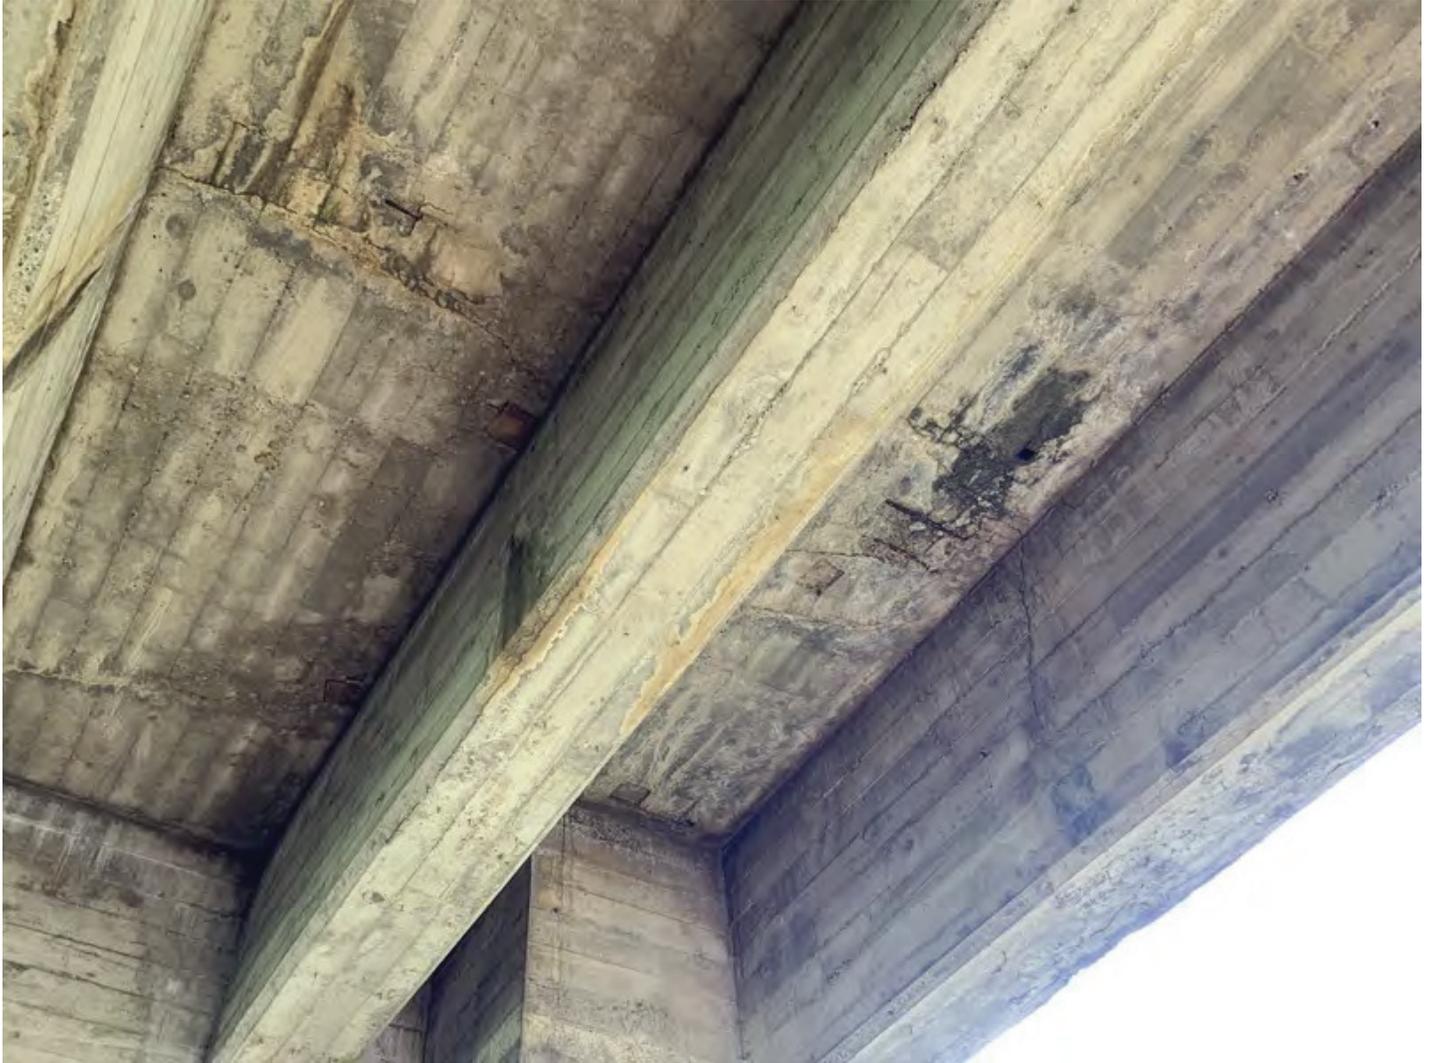
Photo 14
Vertical cracks in the girders in Span 4.

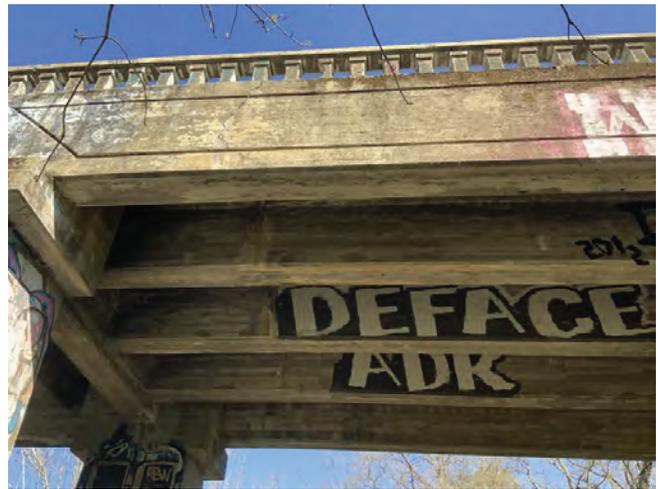
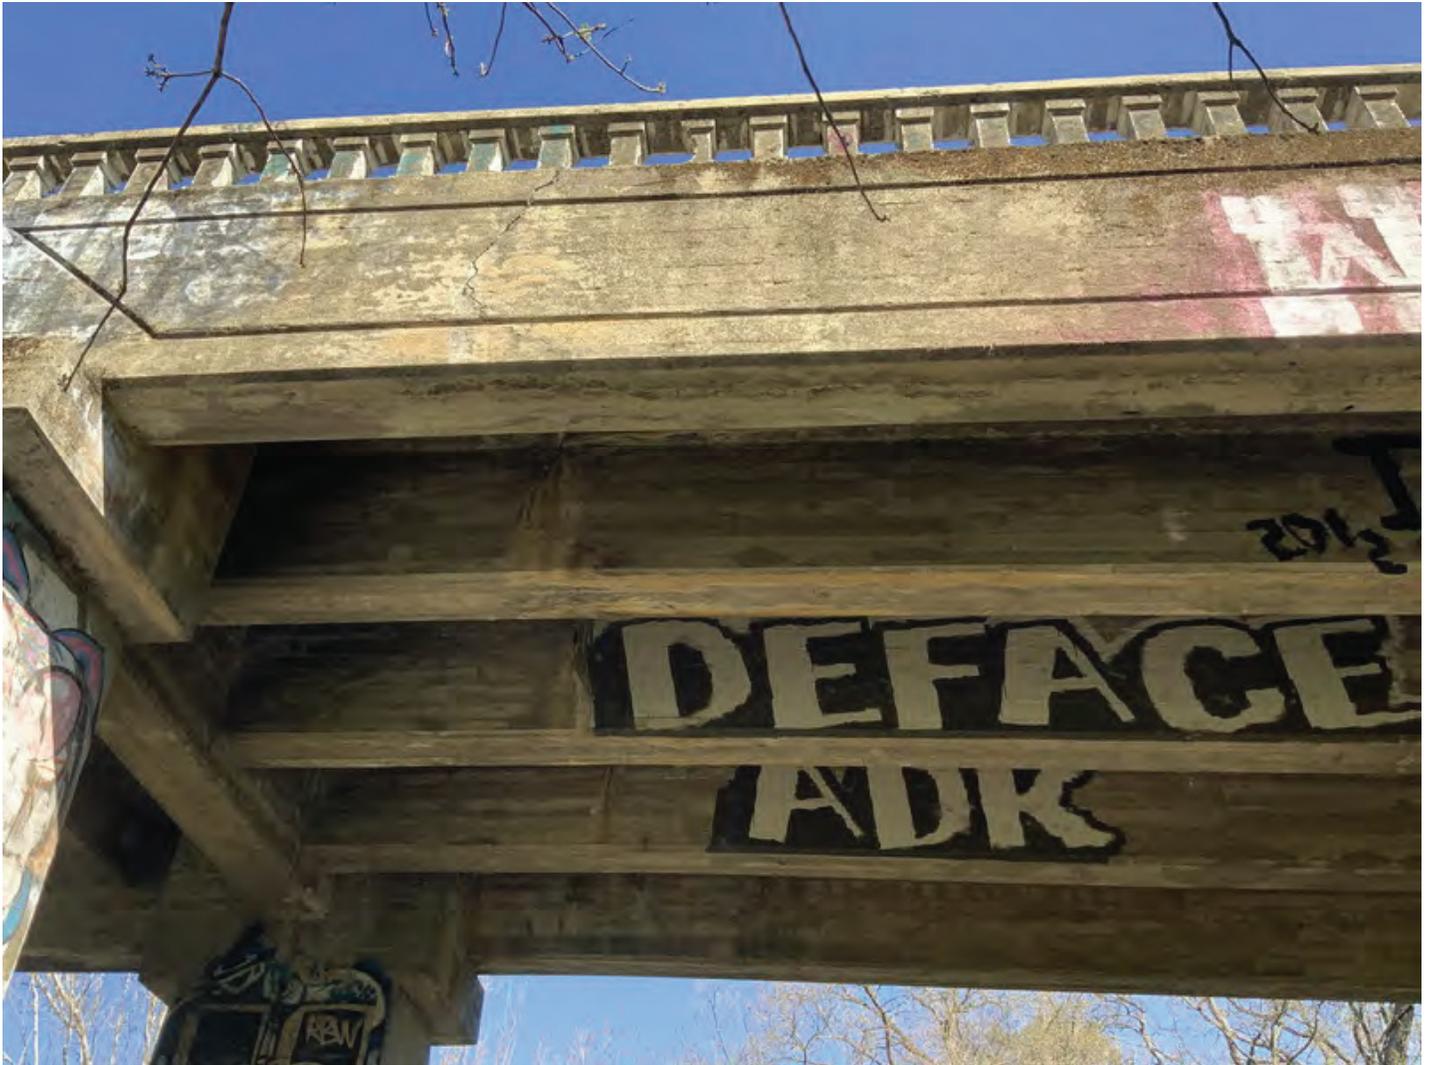
Photo 15
Vertical cracks in the girders in Span 1.

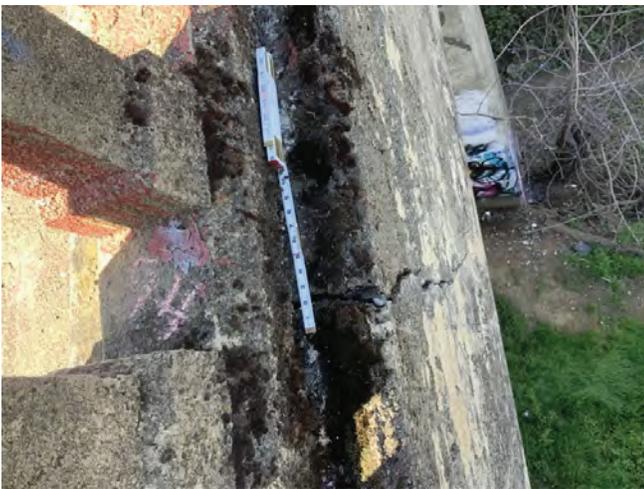
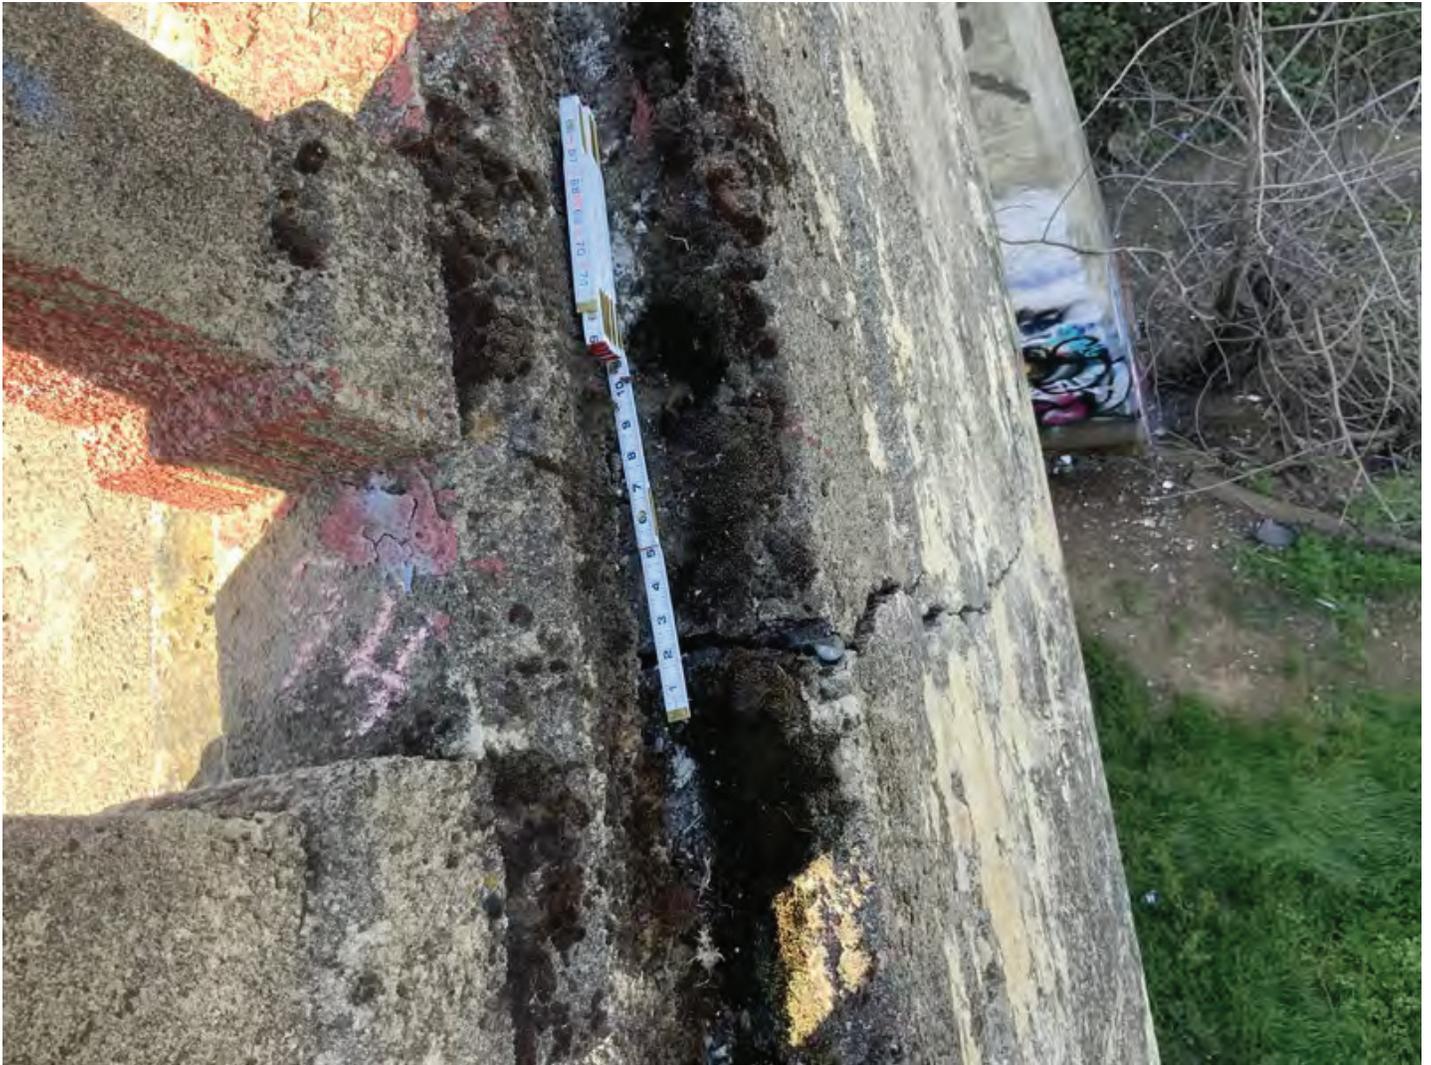
Photo 16
Vertical crack in Girder 4 in Span 1 opening to the top.

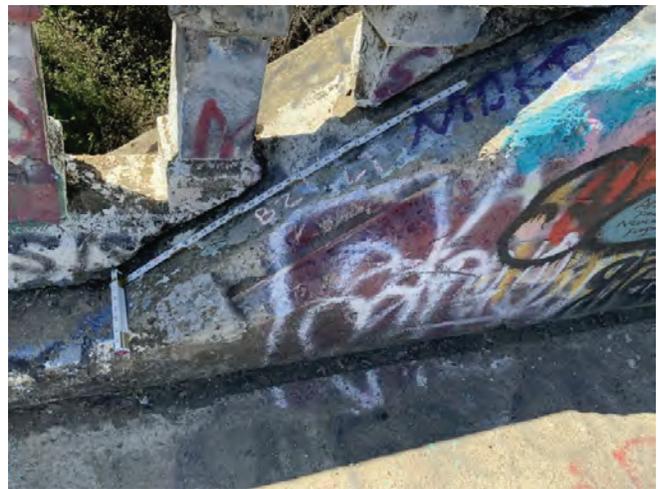
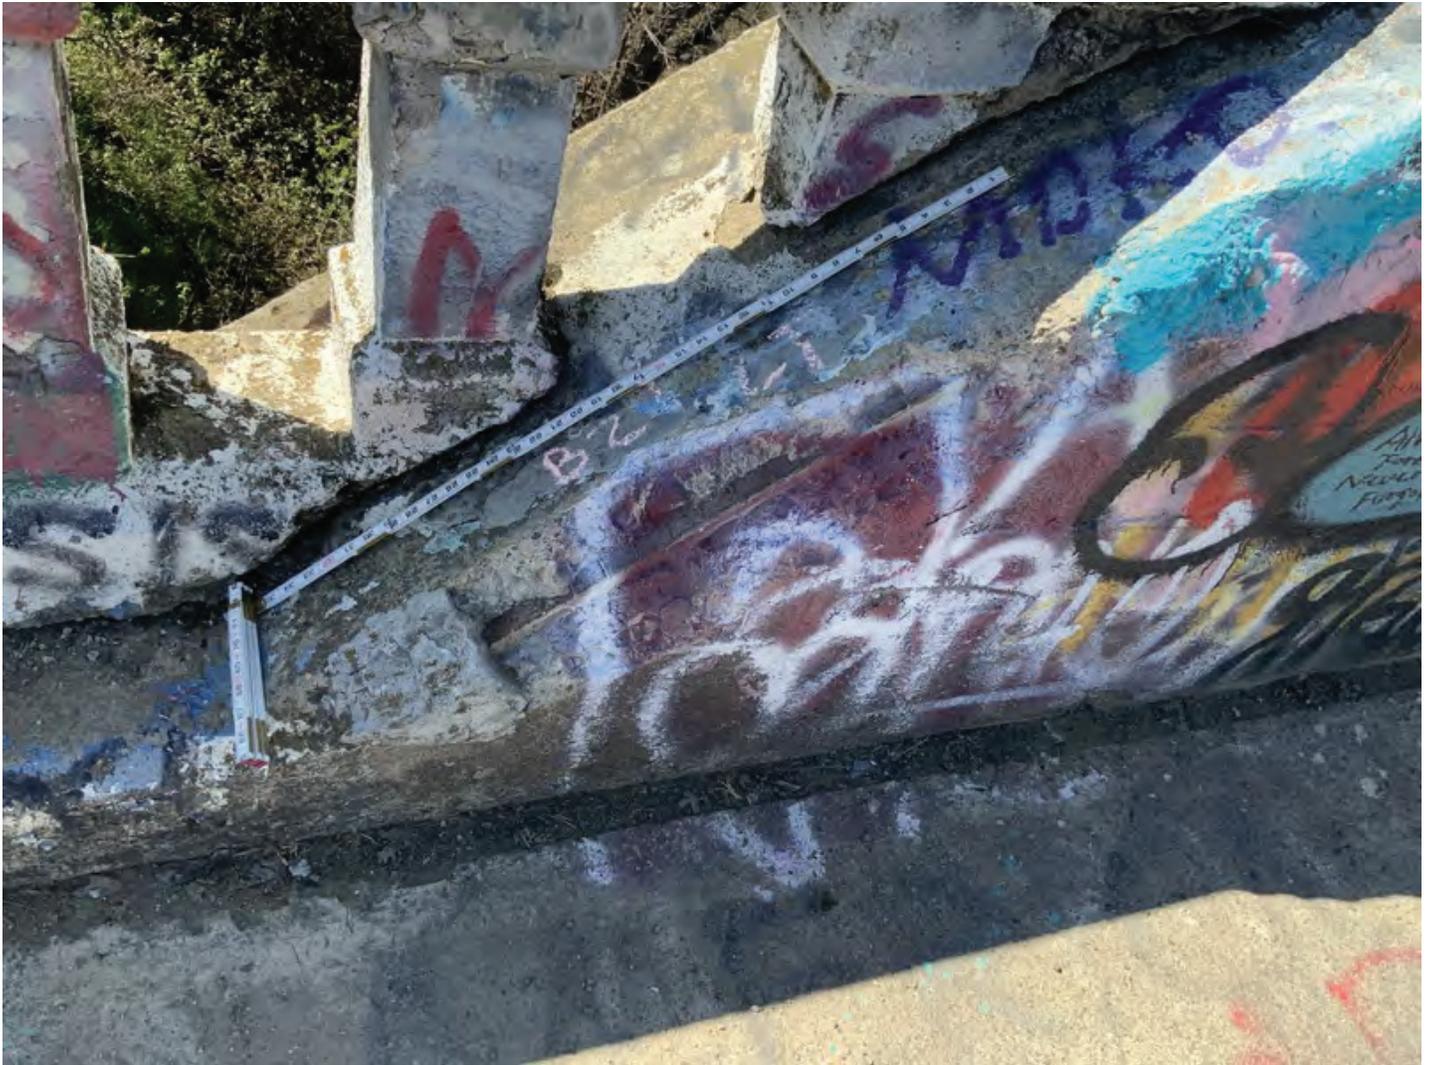
Spalls with exposed rebar are present through the arch. Refer to Photos 17 through 19. The largest spall is located at the base of the left arch at Bent 2 and is approximately 22 inches by 6 inches by 3 inches deep with an exposed square main reinforcing bar. See Photo 17. The majority of the spalls appear to have been previously patched, however the patches have completely failed. No indication of section loss was noted in the exposed bars. Approximately 25% of the arch has spalls or delaminations and approximately 10% are Condition State 3.

Photo 17
Spall in the left arch rib at Bent 2.

There is an existing work recommendation to remove loose concrete in the spall, clean and apply a corrosion inhibitor to all exposed rebar.

Remove loose concrete, clean the exposed rebar and apply a corrosion inhibitor to all spalls throughout the concrete arch.

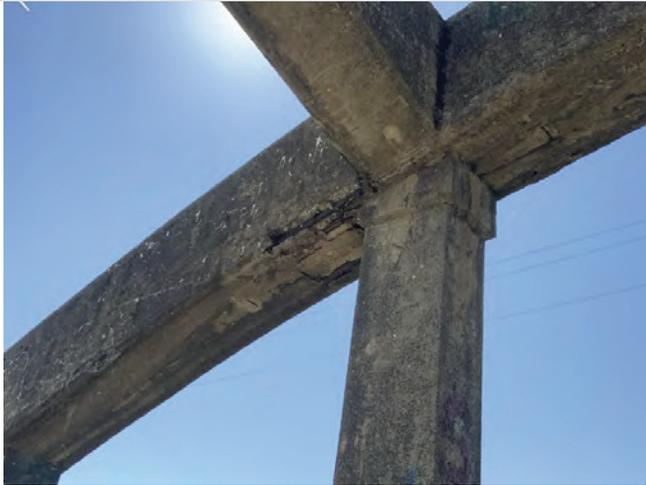
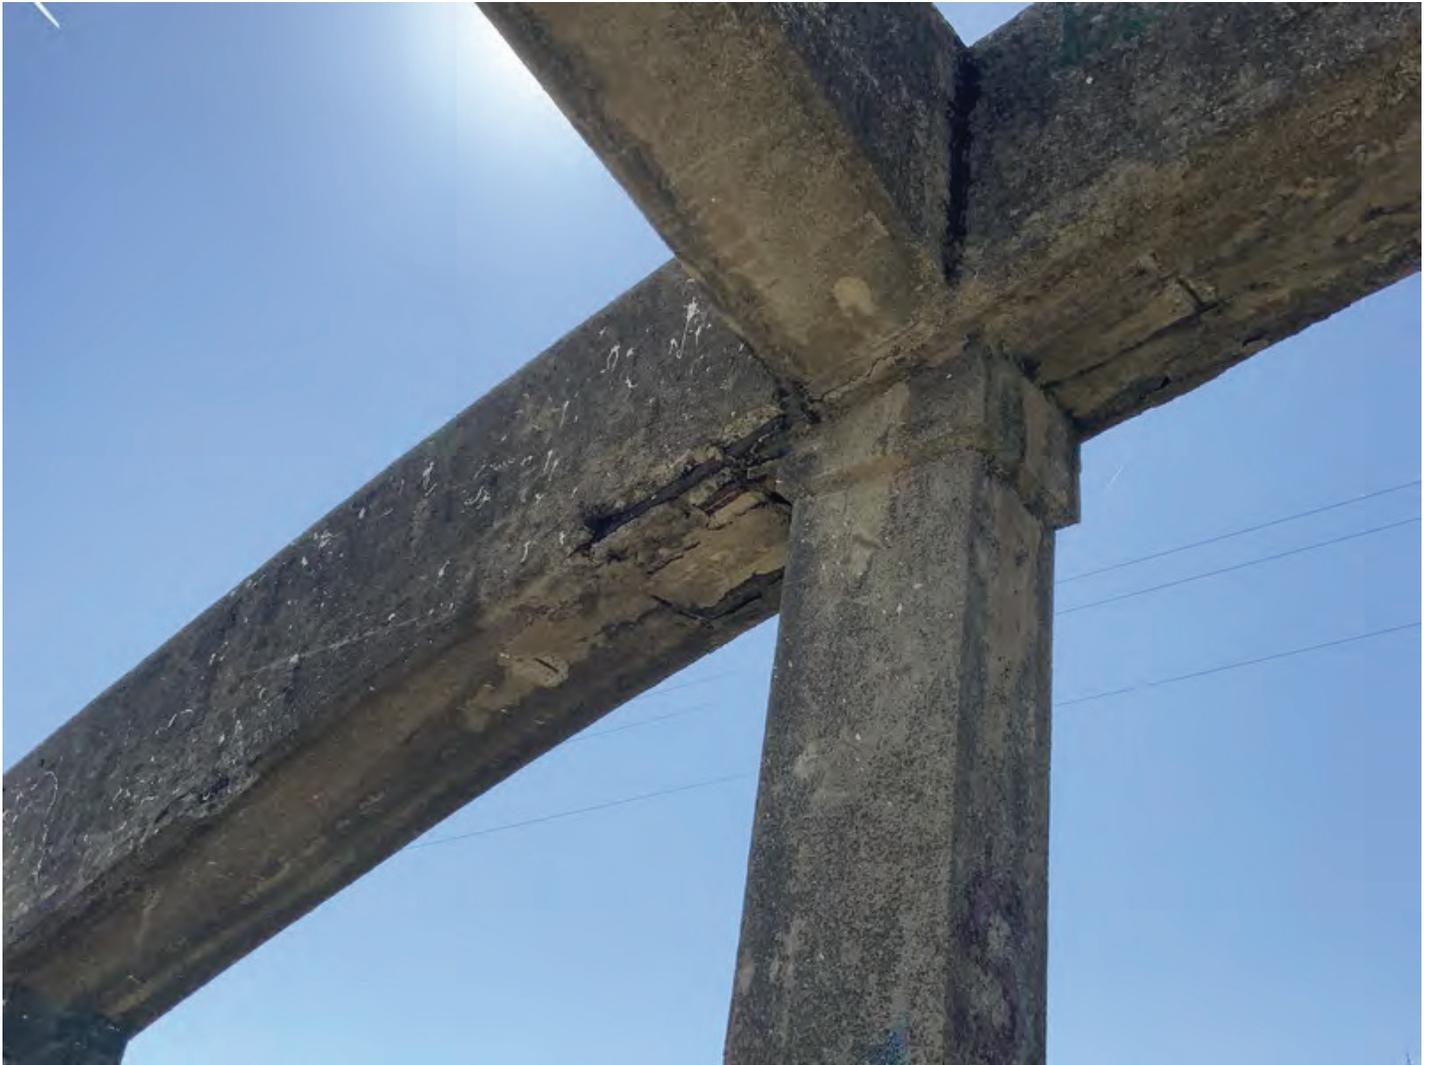
Photo 18
Spall in the left arch rib.
