BRIDGE INSPECTION REPORT

Routine Inspection

BRIDGE NO.:
23C0092

STRUCTURE NAME:
PUTAH CREEK

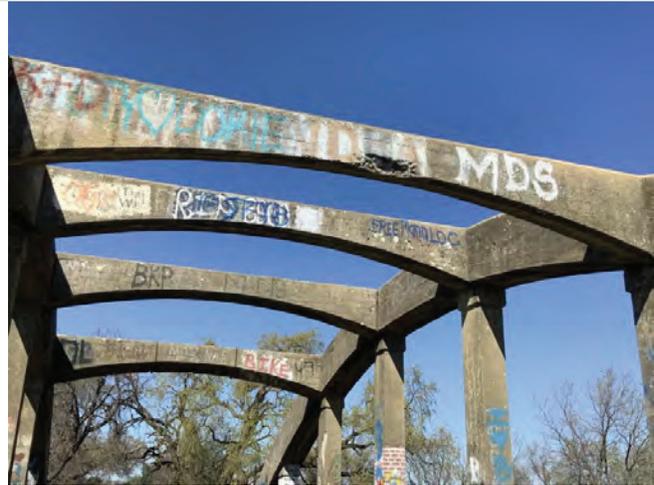
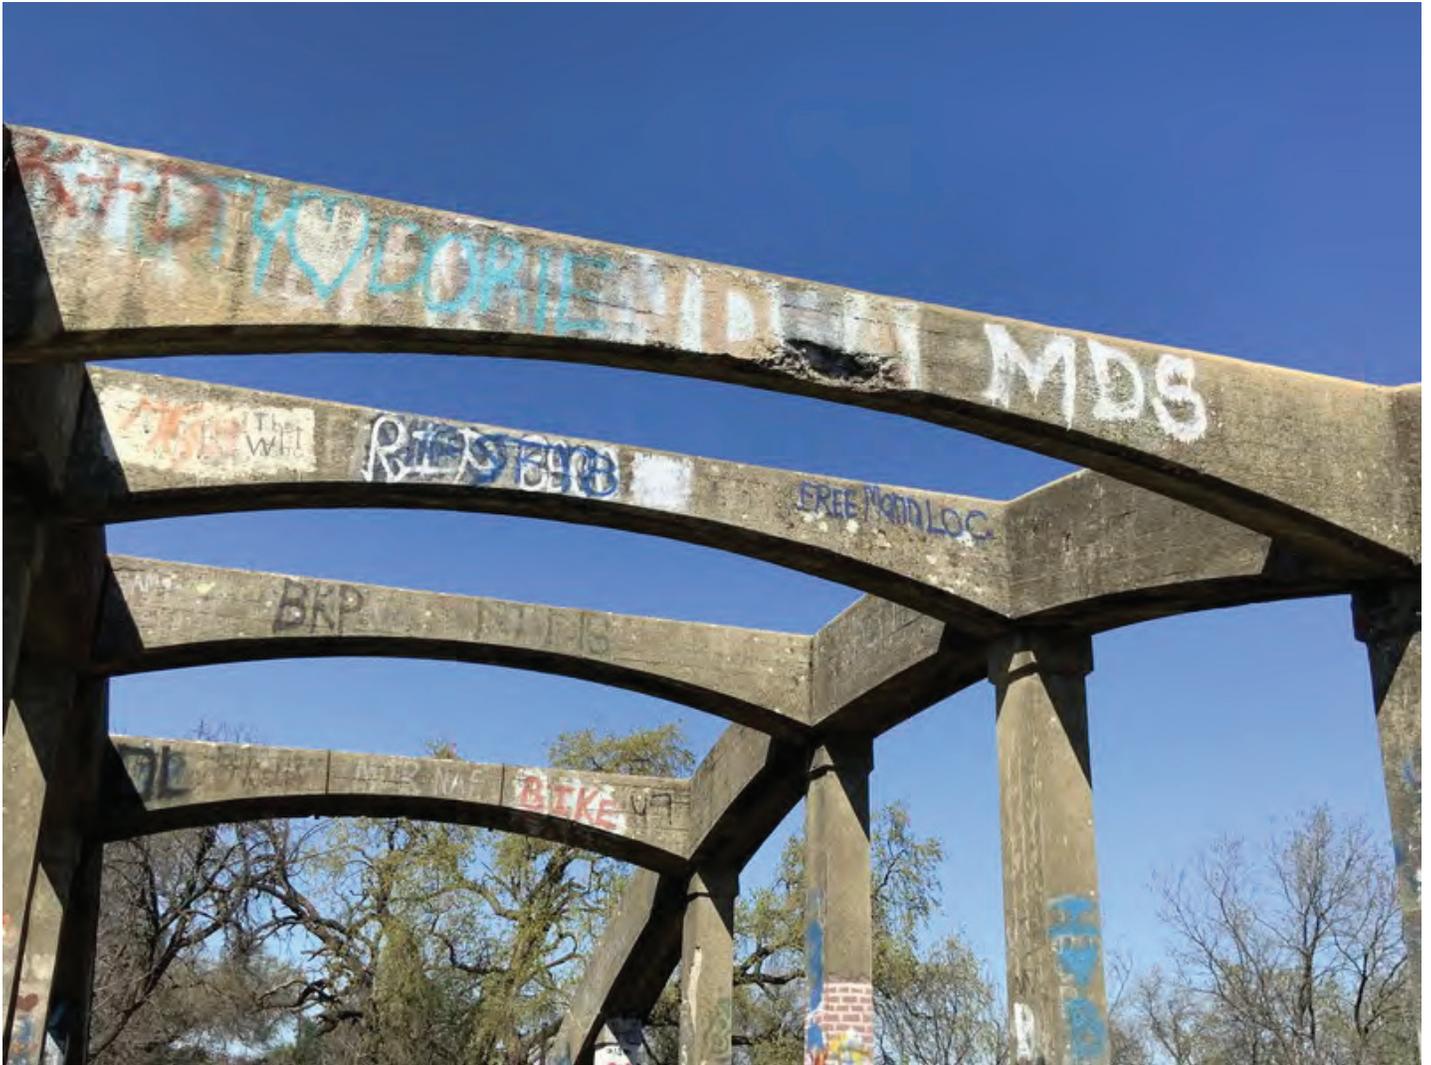
Spalls with exposed rebar are present through the arch. Refer to Photos 17 through 19. The largest spall is located at the base of the left arch at Bent 2 and is approximately 22 inches by 6 inches by 3 inches deep with an exposed square main reinforcing bar. See Photo 17. The majority of the spalls appear to have been previously patched, however the patches have completely failed. No indication of section loss was noted in the exposed bars. Approximately 25% of the arch has spalls or delaminations and approximately 10% are Condition State 3.

Photo 19
Spall in the first arch strut.

There is an existing work recommendation to remove loose concrete in the spall, clean and apply a corrosion inhibitor to all exposed rebar.

Remove loose concrete, clean the exposed rebar and apply a corrosion inhibitor to all spalls throughout the concrete arch.

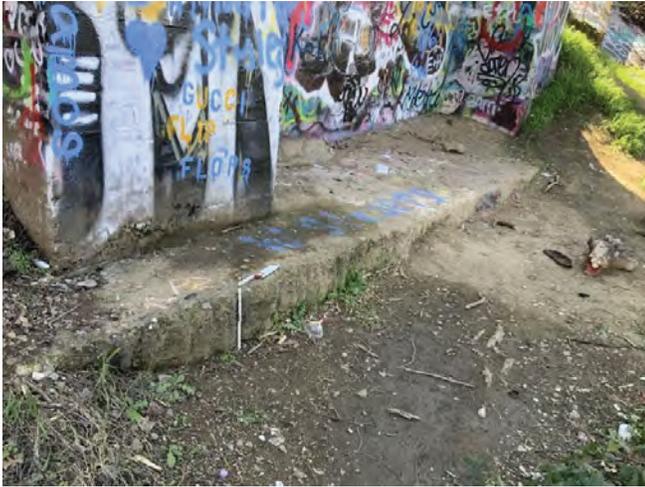
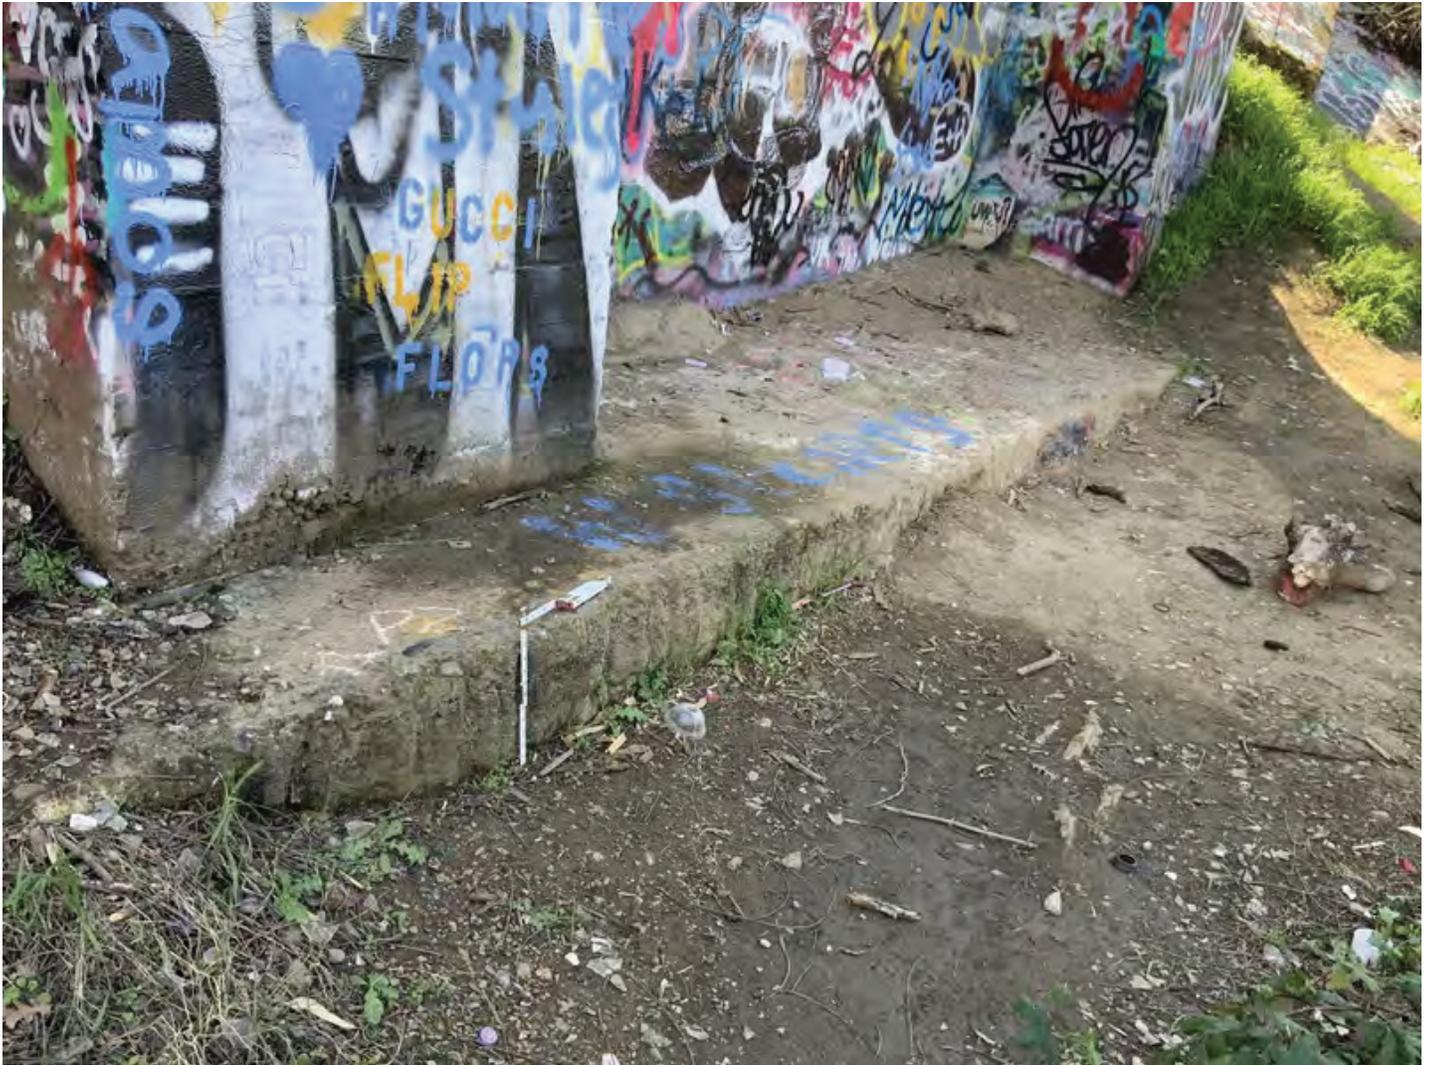
(205) Column-RC										
There were no significant defects noted.										
215			Abutment-RC	2	40	m	40	0	0	0
(215) Abutment-RC										
There were no significant defects noted.										
220			Pile Cap/Footing-RC	2	13	m	0	13	0	0
6000			Scour	2	13		0	13	0	0
(220-6000) Scour										
The pile caps at Bents 2 and 4 are exposed. The pile cap at Pier 2 is exposed up to 11 inches vertically for approximately 10 feet on the Span 2 side. The pile cap at Pier 3 is exposed full length on both sides, up to 60 inches vertically on the Span 2 side and 52 inches vertically on the Span 3 side of the cap. No undermining was noted at either location. Refer to Photos 20 and 21.										
228			Pile-Timber	2	1	ea.	1	0	0	0

Photo 20
Exposed pile cap at Bent 2.

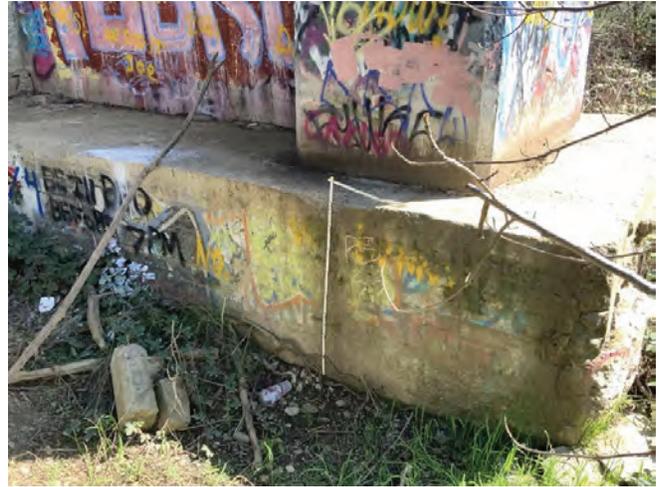
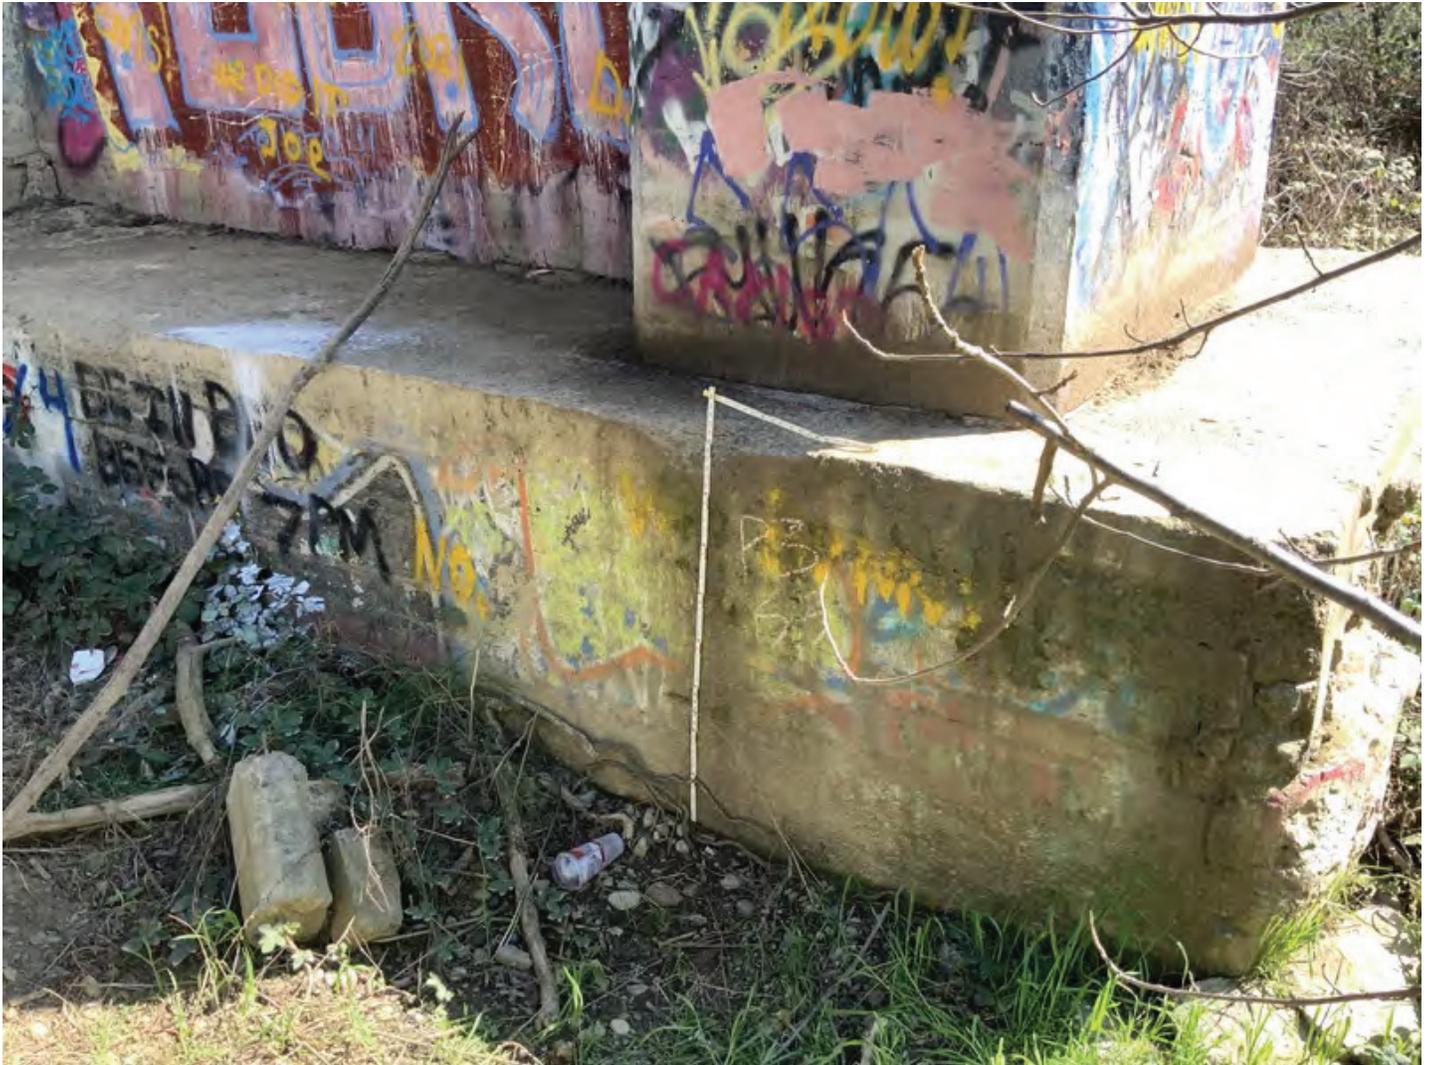
Photo 21
Exposed pile cap at Bent 3.
