# Safety Bulletin

U.S. Chemical Safety and Hazard Investigation Board

No. 2006-01-B | January 2006

## EXPLOSION AT ASCO: DANGERS OF FLAMMABLE GAS ACCUMULATION

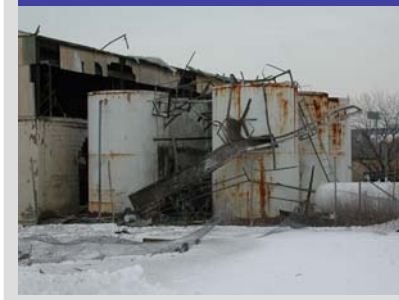
Figure 1. North side of ASCO facility. Damage to building 46 and debris around the decant water tanks.

The shed was completely destroyed. Its walls were highly fragmented, essentially reduced to splinters. Debris was hurled as far as 450 feet from the site. The explosion blew two large holes in the masonry wall of Building 46, toppling several cylinder manifolds and scattering acetylene cylinders across the filling room floor. Windows were shattered and several doors were blown into the building or knocked off their hinges or rails. No fire occurred after the explosion.

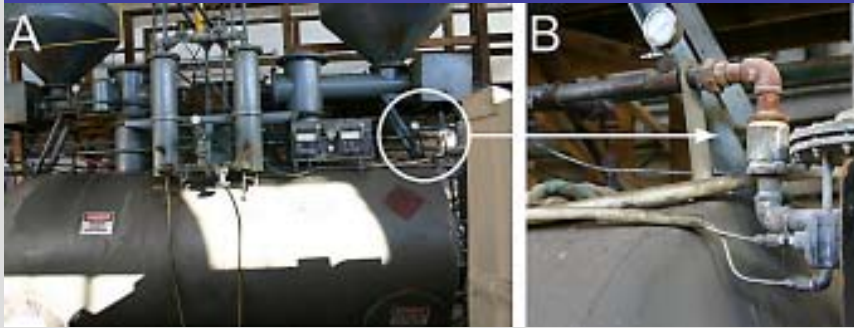
Figure 3. A. ASCO acetylene generator. The area (circle) enlarged in B shows a check valve on the water supply line.

The Rexarc Inc. designed and supplied check valve installed in the recycled water line (Figures 3B, 6) failed to prevent backflow of acetylene from the generator and out the open drain valve in the shed. Testing performed “in place” after the explosion demonstrated reverse gas flow through the valve, while x-rays taken by OSHA suggest that the valve guide pin was “hung up” on the lower pipe nipple (see Figure 8). The check valve had been observed to leak on at least one occasion in the past by an ASCO employee, who disassembled, cleaned, and reassembled the valve.

- The valve depends on gravity and back pressure to seal. No springs are used to assist seating of the plug.
- The plug is not effectively guided and is prone to misalignment.
- The check valve internal surfaces are susceptible to solids build up, such as scale or from lime particles entrained in the recycled water.

While check valves are valuable in preventing backflow in process lines, they should not be solely relied on in hazardous applications. It is good practice to provide a positive means of isolation, such as a double-block valve arrangement with a bleed to

a safe location, in addition to the check valve to ensure that backflow of explosive gases does not occur.

Replace check valves of this or similar design supplied by Rexarc with valves that will perform more reliably in recycle water service. (CSB2006-03-I-NJ-4)

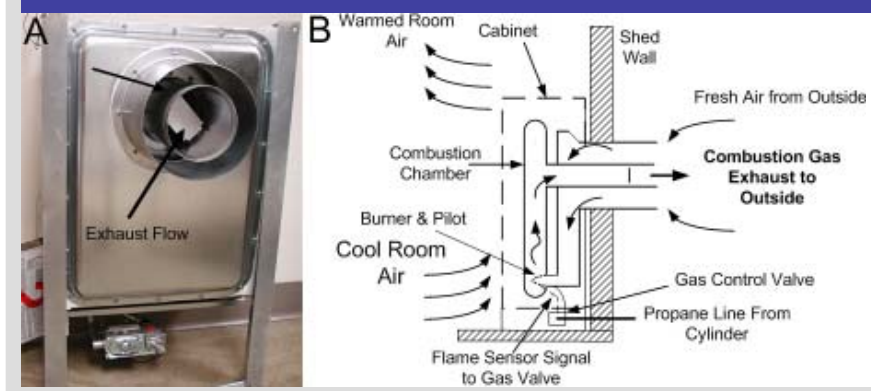
Figure 5. A. An exemplar of the ASCO shed heater (same make and model).  
B. Schematic diagram of the heater.

Due to the extremely cold weather and the lack of insulation in the shed, the heater was likely running or frequently cycling on and off at the time of the incident. Acetylene is reported to autoignite<sup>14</sup> at 580°F, well below the heaters combustion chamber surface temperature of 1100°F.

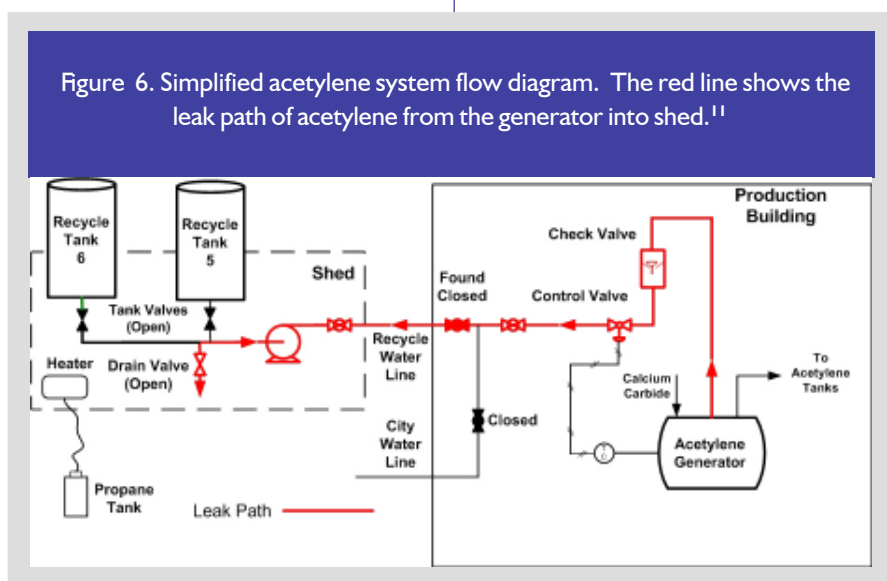
Acetylene produced in the generator flowed back past the check valve through the recycled water line into the shed by way of the open drain valve (Figures 6 and 7). The acetylene gas accumulated inside the shed, ignited, and exploded.

<sup>11</sup> CSB could not positively ascertain the position of the valve labeled "Found Closed". The plant manager stated after the incident that he closed "some" valves immediately after the explosion, one of which may have been the valve labeled "Found Closed". This valve was later tested at OSHA's Utah laboratory. The testing confirmed that this valve leaked significantly in the closed position.

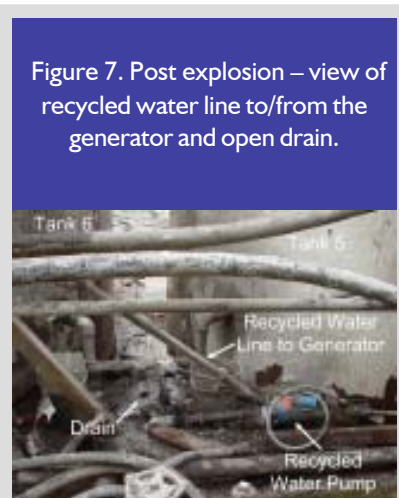
It was normal practice at ASCO to leave the decant water line open at night to drain to the shed floor through a low-point valve. This protected the outside section of the line from damage due to freezing during cold weather. The open valve created a potential pathway for acetylene to flow from the generator into the shed; an enclosed space that was not

designed for the presence of acetylene. This potential hazard was not recognized by ASCO.

- Examine lines connected to acetylene containing equipment and piping to identify vent and drain points that could create hazards in the event of an acetylene backflow or leak. Relocate all such vents and drains to safe locations, preferably to the outside.
