Safety Bulletin

U.S. Chemical Safety and Hazard Investigation Board

MANAGEMENT OF CHANGE

No. 2001-04-SB | August 2001

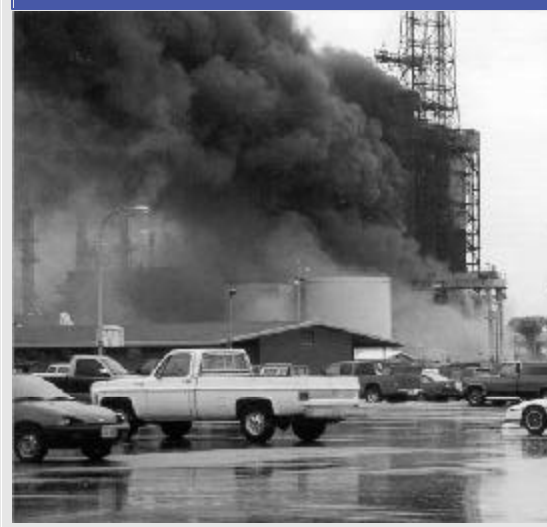
On November 25, 1998, a fire at the Equilon Enterprises oil refinery delayed coking unit in Anacortes, Washington, caused six fatalities (Figure 1). A loss of electric power and steam supply approximately 37 hours prior to the fire had resulted in abnormal process conditions.

● Figure 1. Equilon Enterprises oil refinery fire.

The top head was unbolted and lifted from the drum. The bottom head was also unbolted and held in place by a hydraulic dolly. The operator then activated a release mechanism to lower the dolly. Witnesses reported hearing a whooshing sound and seeing a white cloud of vapor emanate from the bottom of the drum. The hot petroleum vapor burst into flames. The process supervisor, an operator, and the four contract personnel assisting were caught in the fire and did not survive (Figure 2).

Unknown to the coker unit personnel present, the core of the mass remained insulated from heat loss. Within the core, residual heat continued to break down the petroleum, creating a pocket of hot pressurized volatile oil. Had the limitations of temperature-sensing devices been better understood, personnel may have realized that

After the incident, Equilon relocated the controls for the hydraulic dolly to allow workers to position themselves farther from a drum when opening it.

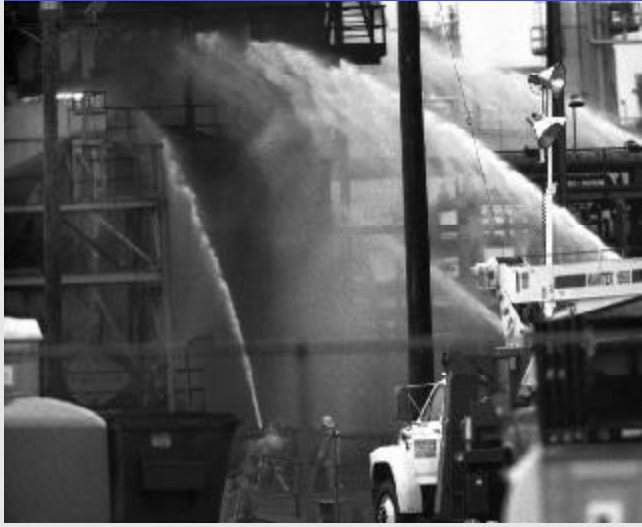
● Figure 2. Fire control efforts at Equilon refinery.

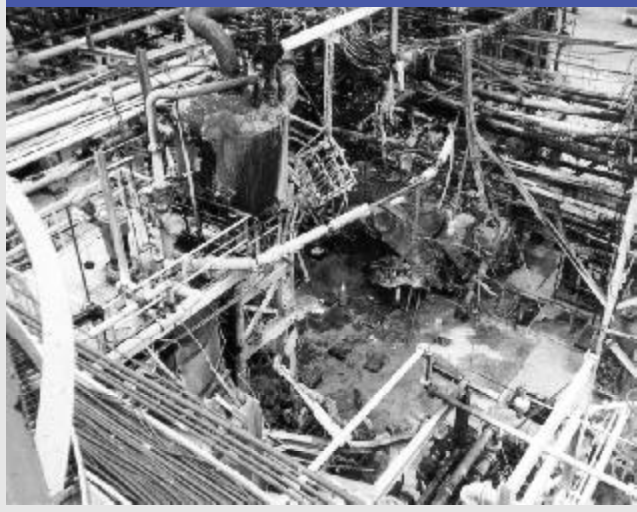
On October 13, 1998, a reaction vessel explosion and fire at the CONDEA Vista Company detergent alkylate plant in Baltimore, Maryland, injured four people (Figure 3).

When the process was shut down for maintenance, the operators were unable to empty the liquid that remained in the reactor. Sludge had settled in the vessel, plugging the bottom outlet nozzle.

● Figure 3. Site of ruptured reactor, CONDEA Vista Company detergent alkylate plant.

From both a project and an operational standpoint, the incident at CONDEA Vista emphasizes the importance of systematically managing changes. Post-incident investigations noted that the density of the new catalyst (powdered aluminum) was higher than that of aluminum chloride. The higher density material—combined with problems related to initial overfeeding of the aluminum—overtaxed the mixing capability of the agitator and allowed aluminum to settle in the bottom of the reactor, where it plugged the lower nozzle and accumulated as sludge.

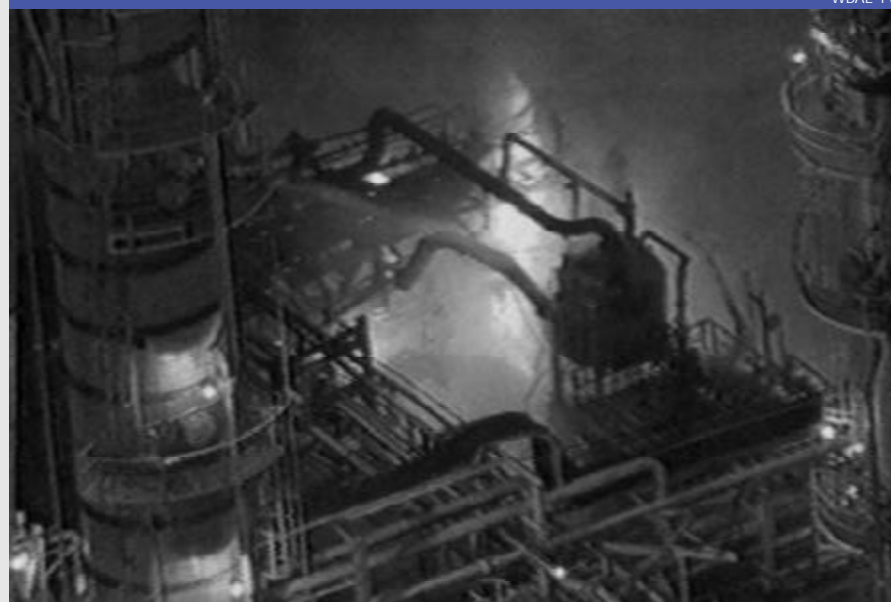
The night shift supervisor instructed an operator to add steam to the reactor. Minutes after the operator started to continuously inject the steam, it reacted with the metallic aluminum and the aluminum chloride residue in the sludge. The reactor vessel exploded (Figure 4).

contractor injured his back when he fell. Property damage was estimated at \$13 million.

● Figure 4. CONDEA Vista plant fire.
