# Project Report

**Putah Creek Bridge Rehabilitation at Stevenson Bridge Road  
Federal Project No. BRLS 5923(059)  
Bridge No. 23C0092**

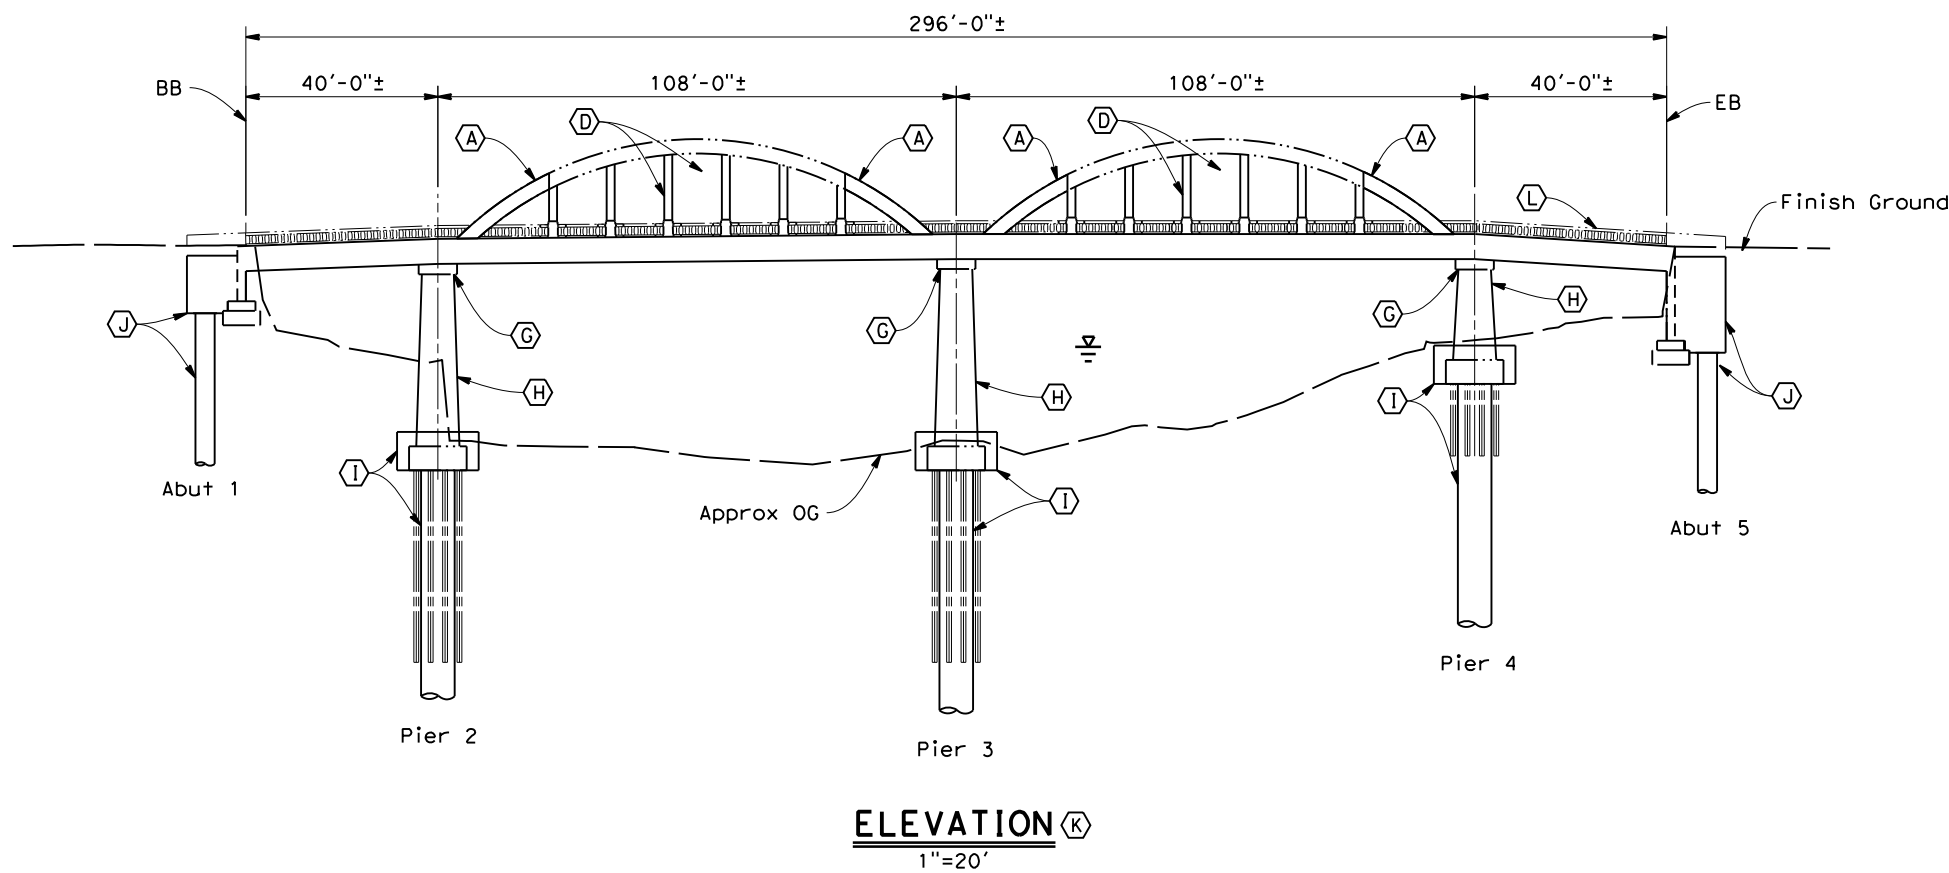
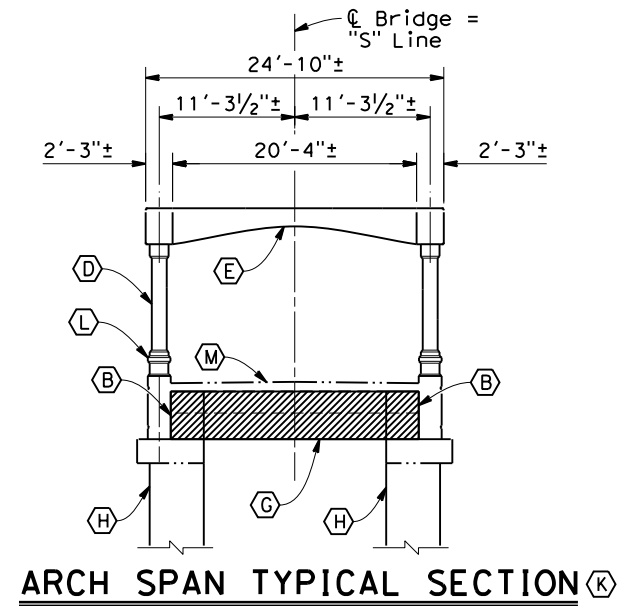
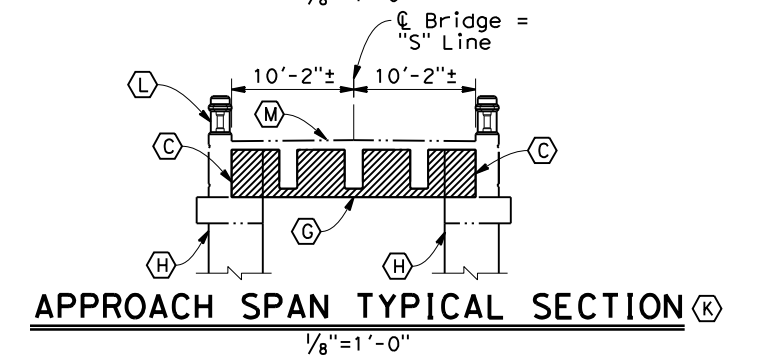
Given the seismic and hydraulic vulnerabilities, multiple rehabilitation alternatives were identified and evaluated. The proposed project will consist of installing new CIDH piles at each support, fiber wrapping of Arch, Portal, Vertical, and Pier members, reinforced concrete Tie Girder bolsters, removal and patch of unsound concrete, epoxy injection of larger cracks, deck methacrylate to seal minor cracks, repair/replacement of the existing concrete railing, installation of Rock Slope Protection and roadway approach improvements. The proposed retrofit is shown graphically in the attached planning study. The estimated project construction cost including roadway improvements are \$10,213,000.

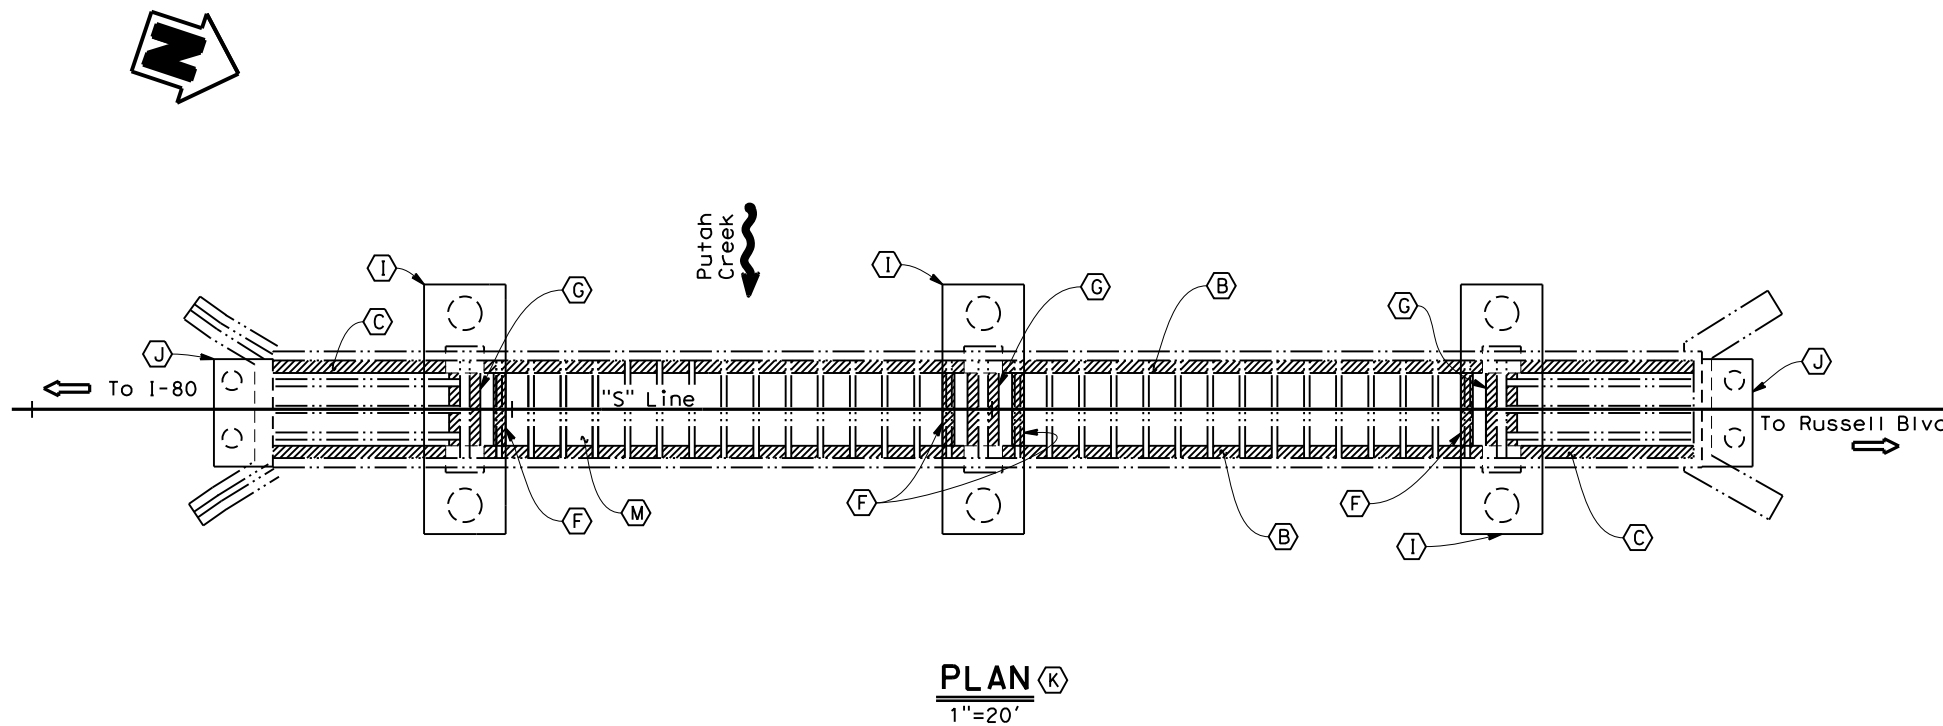
REVISIONS	NO.	DESCRIPTION	APPROVED BY	DATE	FIELD BOOK NO.	SCALE HORIZONTAL: AS NOTED VERTICAL: AS NOTED	DRAWN BY:	CHECKED BY:	SOLANO COUNTY TRANSPORTATION DEPARTMENT 333 SUNSET AVE. SUITE 230 SUISUN CITY CA 94585 TEL: (707) 421-6069 FAX: (707) 429-2894	APPROVED BY:	PUTAH CREEK BRIDGE REHABILITATION ON STEVENSON BRIDGE ROAD GENERAL PLAN	DATE	1-4-2018
	NO.	DESCRIPTION	APPROVED BY	DATE			SUBMITTED	R.C.E. No.		DATE		SHEET 1 OF 1	DWG

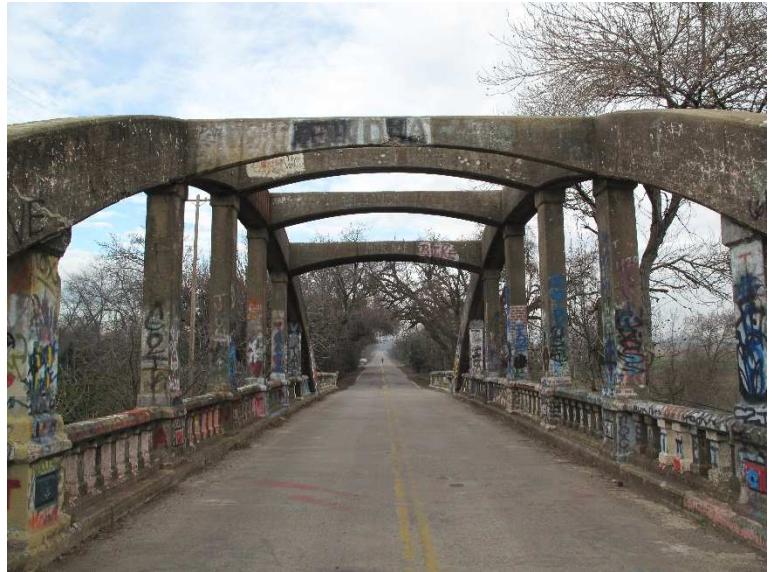
Quincy Engineering, Inc. (Quincy) will complete the PS&E for the roadway and bridge rehabilitation. Professional services will also include structure assessment, preliminary engineering, hydraulic studies, and geotechnical studies.

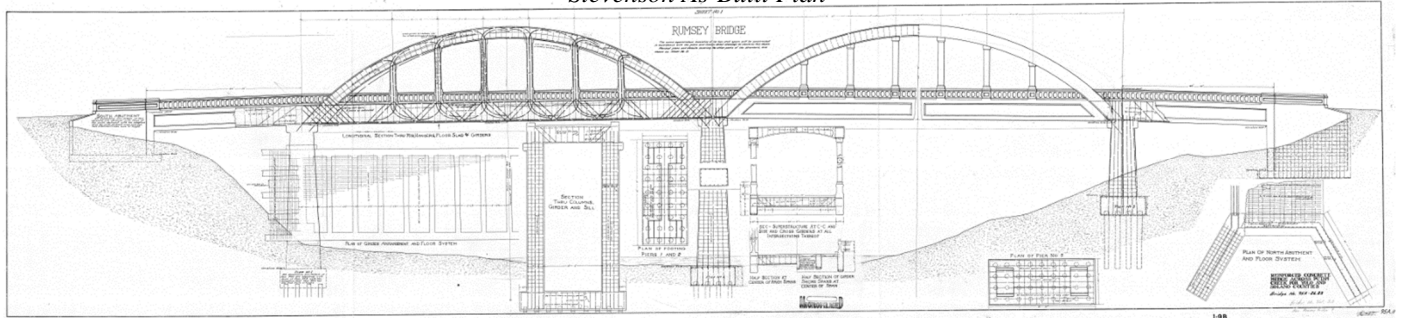
The Putah Creek Bridge, or the "Graffiti Bridge" as it is known locally, has considerable public and historical interest. The bridge is one of three tied arch bridges in Northern California, and is considered historically significant. The same plans were used to construct the Rumsey Bridge located approximately 40 miles to the northwest. The Rumsey Bridge is currently scheduled to be replaced, which only increases the historical importance of the Stevenson Bridge.

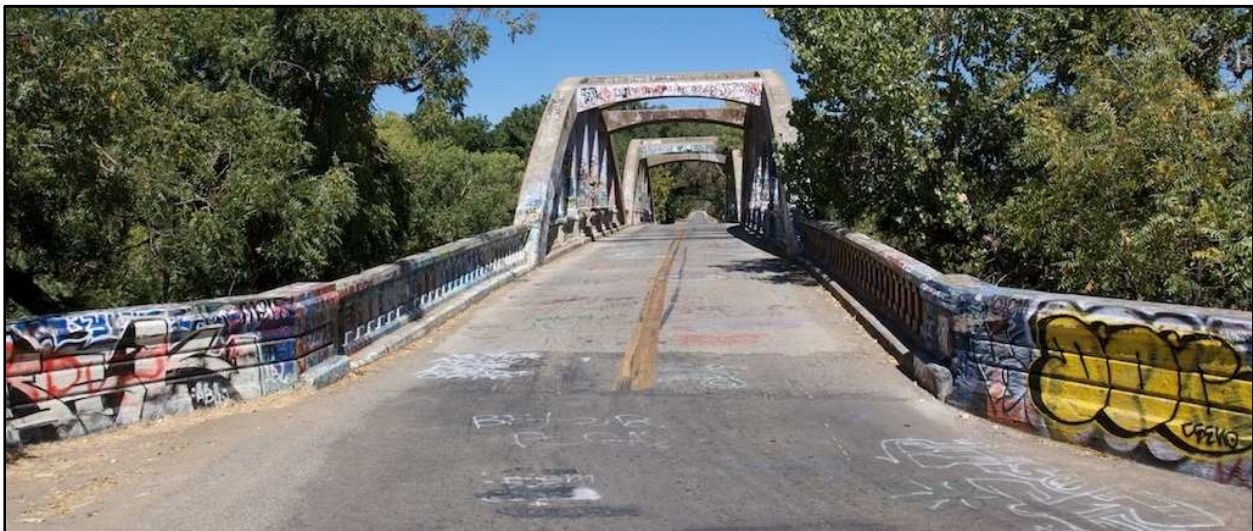
*Stevenson Bridge, standing at Abutment 1, looking north*

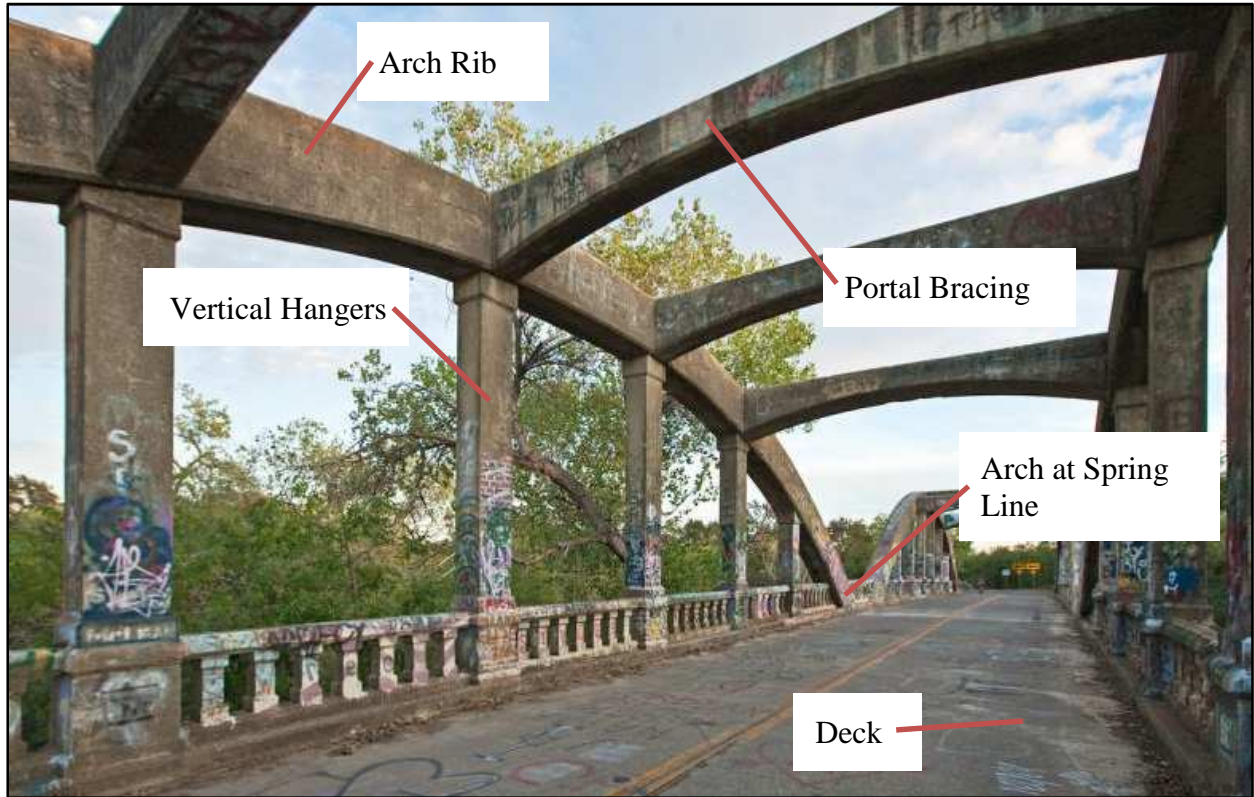
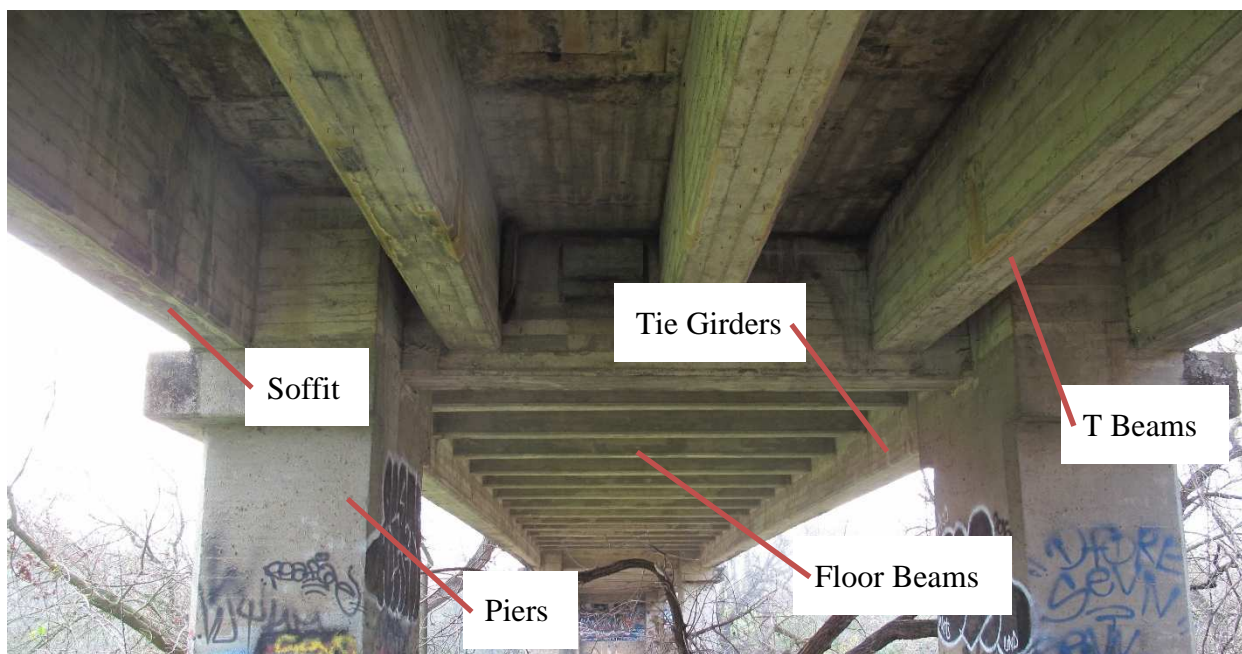
**Caltrans Bridge Inspection Reports**

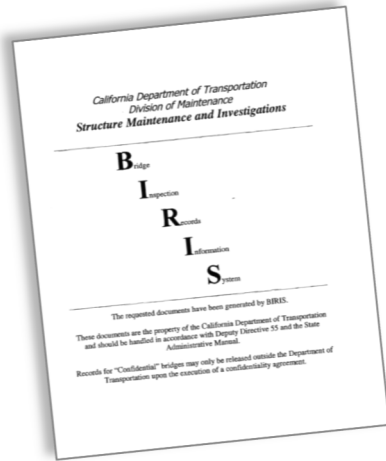
Caltrans Maintenance Report

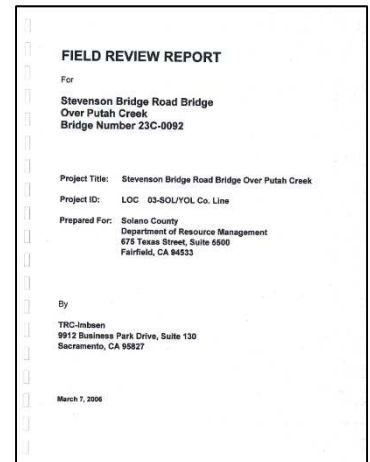
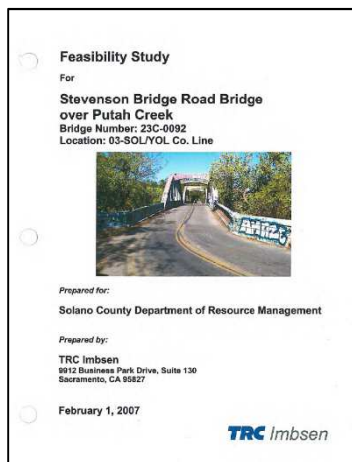
Using information presented in the feasibility study, the County has elected to rehabilitate the bridge, and has completed the environmental process for this option. The County utilized Sycamore Environmental Consultants, Inc. and Mead and Hunt, Inc. to produce technical studies to support environmental clearance.

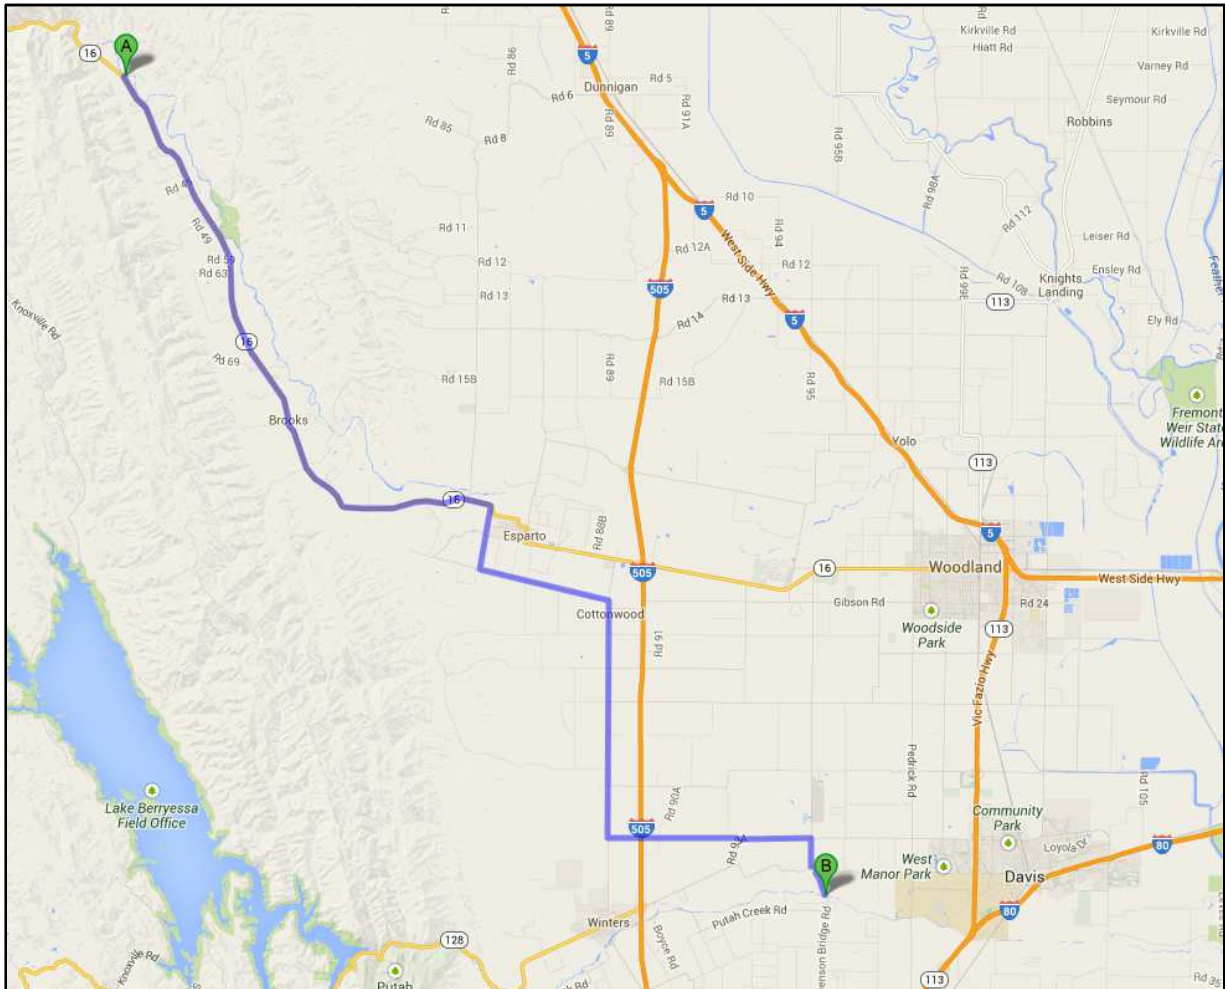
*Google Map of Rumsey Bridge at Location A and the similar structure Stevenson Bridge at Location B*

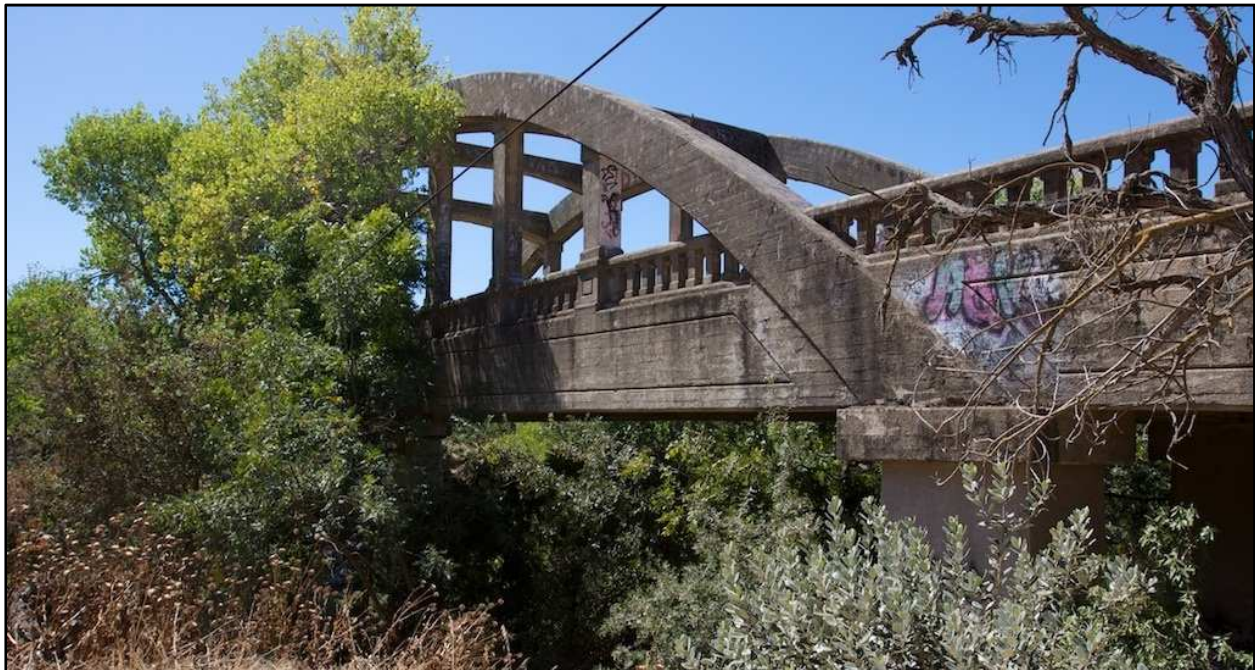
Under the National Bridge Inventory, this structure has a Historical Bridge Inventory Category Rating of 2, meaning this bridge is eligible for the National Register of Historic Places. Mead and Hunt, Inc. was retained to develop the Finding of Effect document which is required when historical resources are involved. The document concluded with a finding of no adverse effect. Therefore, the rehabilitation project will not adversely affect the historic resource as long as the PS&E can be completed within the parameter stipulated in the Finding of Effect document. Consequently, repairs must be in-kind or minimize changes to the member shapes and sizes visible to the public. Based on our analysis, the proposed repairs are consistent with those assumed for the Finding of Effect document. Therefore the proposed retrofit will not adversely affect this historic resource.

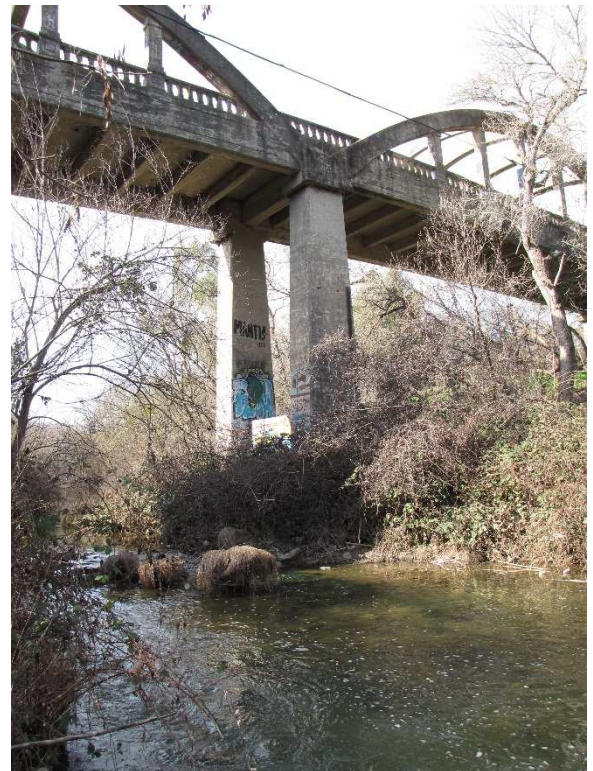
## 2. DESIGN AND CONSTRUCTION CONSIDERATIONS

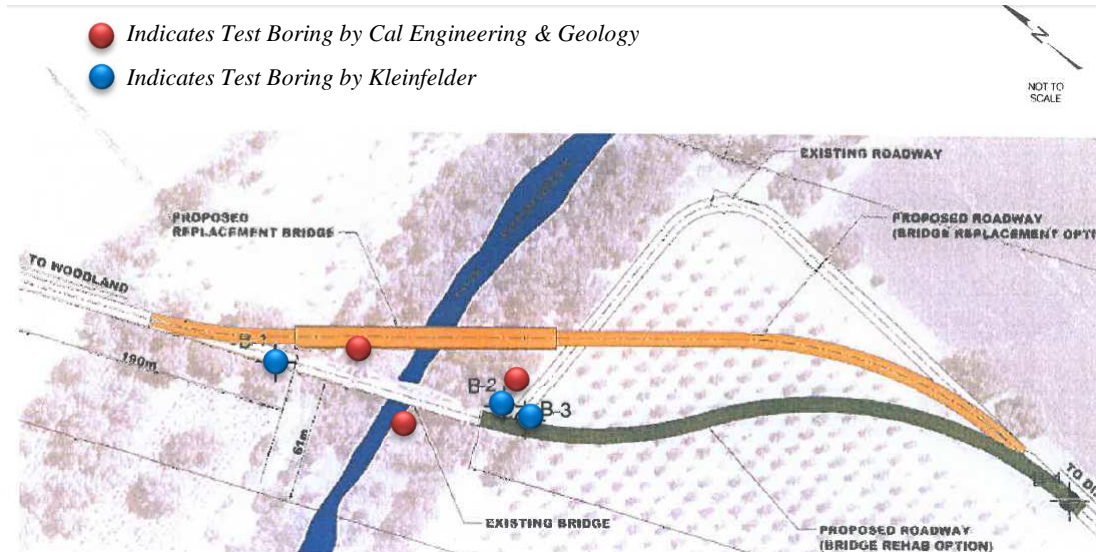
The project site is situated within the Great Valley Geomorphic Province near the western boundary. This portion of Solano and Yolo Counties is comprised of primarily marine and non-marine sediments deposited within the late Cenozoic Era. Material primarily consists of gravels, sands and silts.

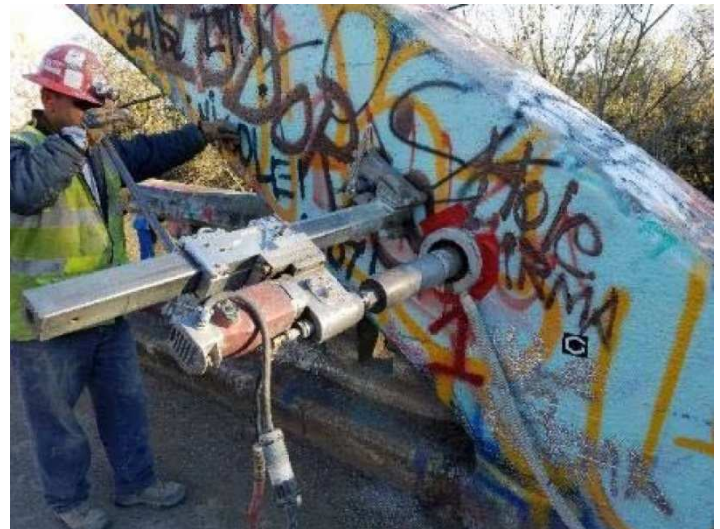
A detailed structural assessment was performed by Alta Vista in late 2016. A field investigation report is located in **Appendix G**. Alta Vista utilized visual inspection, borescope observations, ground penetrating radar (GPR) scanning and concrete core testing methods to assess the condition of the existing structure. This report plays a vital role in the rehabilitation design. Since the existing bridge is over 94 years old, repairs are required in order to restore the structure back to the existing as-built condition. The seismic assessment (as-built model) presented in the following sections of this report assumes that these repairs have been made so that as-built details can be used in the analysis with no reductions for damaged areas.

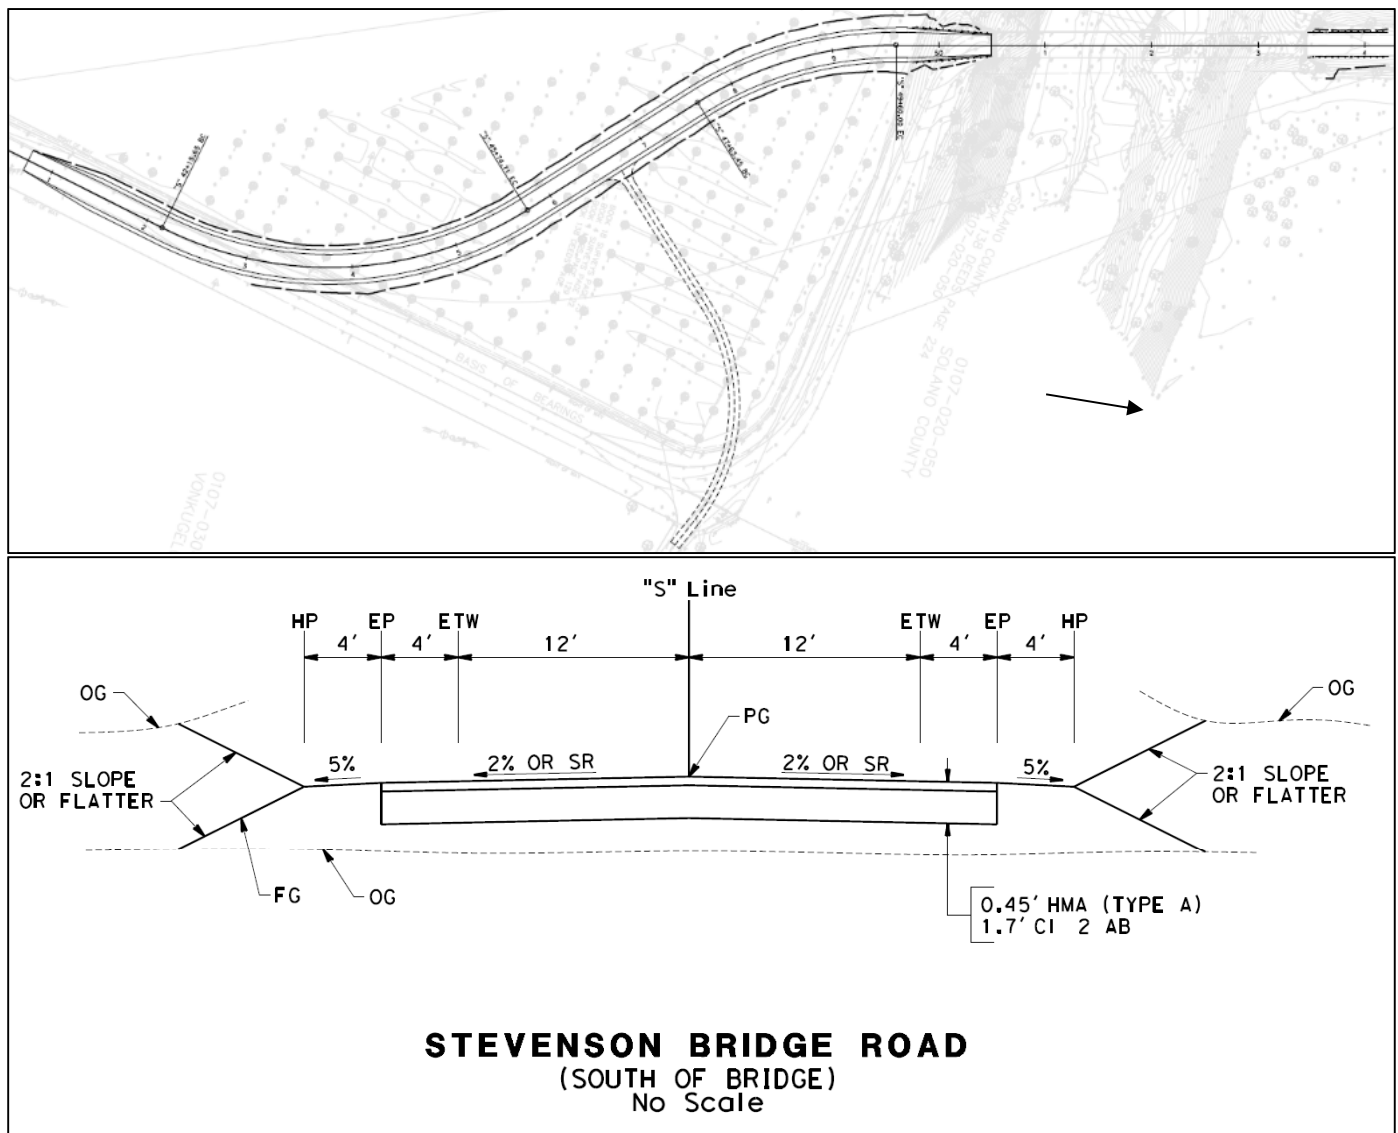
## 7. EXISTING BRIDGE SEISMIC ASSESSMENT (AS-BUILT MODEL)

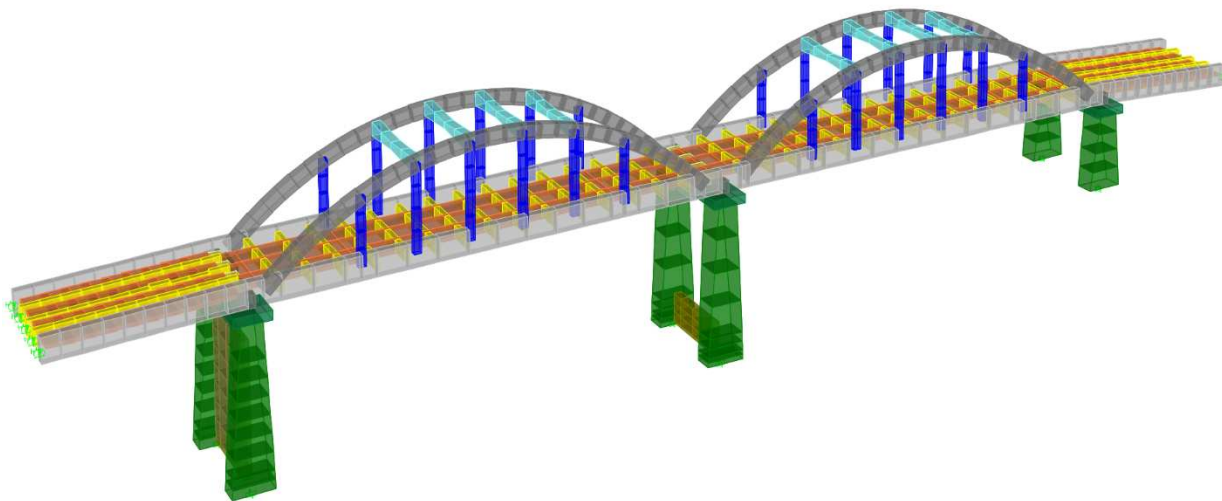
*Elevation View of the Existing Bridge As-Built Model*

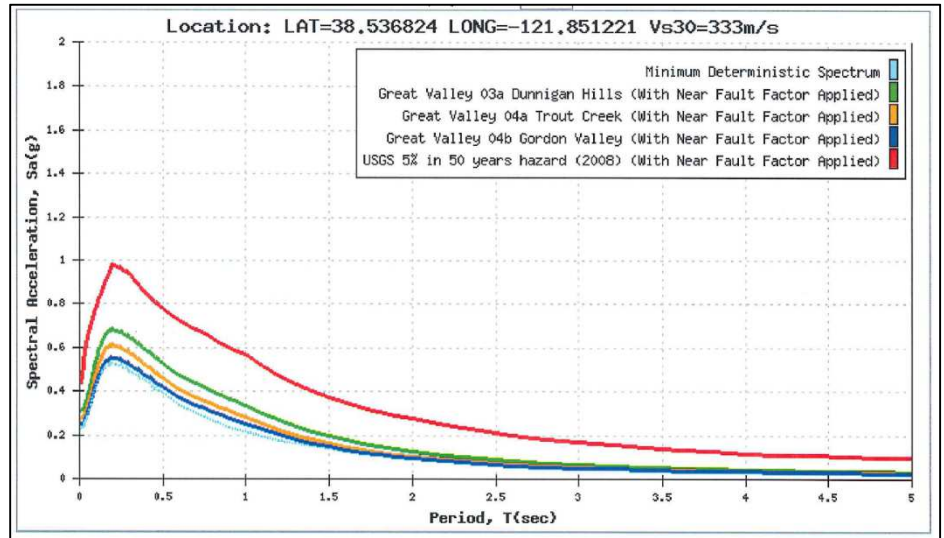
The structure was modeled explicitly with individual member properties (both gross and cracked inertia as discussed further below) along with boundary condition restraints, releases, and springs where applicable (also discussed in more detail below).

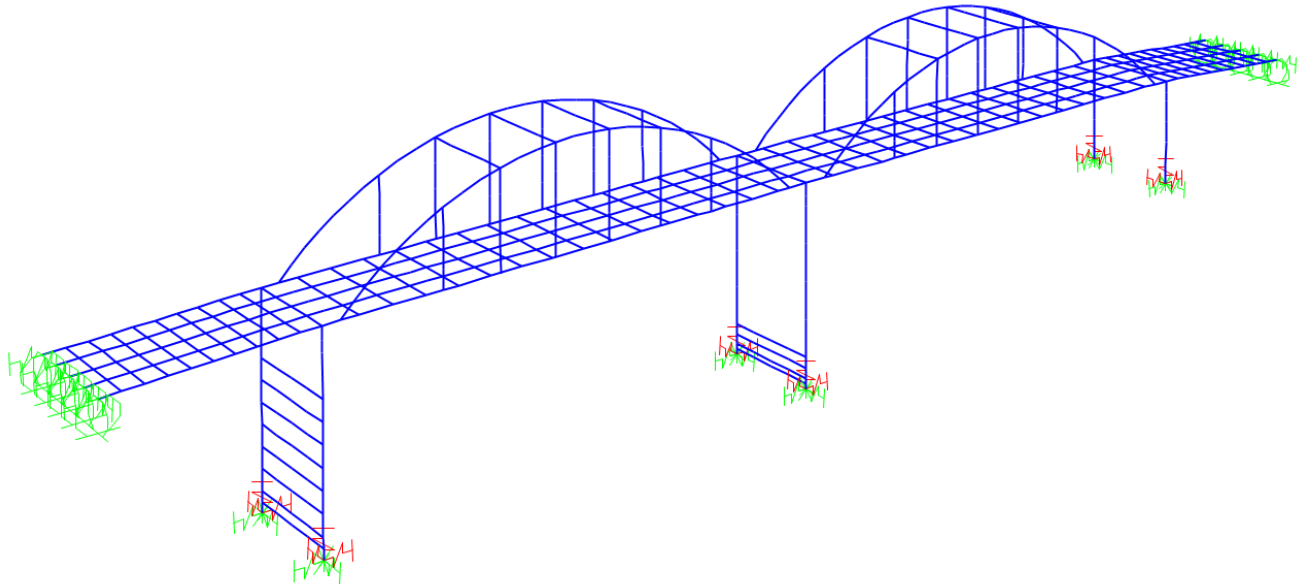
Abutments for the As-built model were fixed for translation in the vertical direction. Springs were used for translations in both the longitudinal and transverse directions.

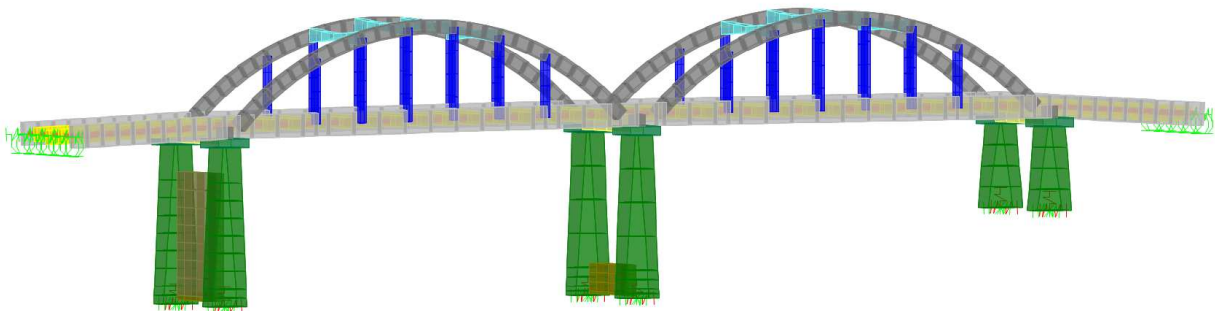
Since these members contain lap splices and a very limited amount of confinement reinforcement, the forces in these members should be limited to their yield capacity. In other words, inelastic, ductile behavior should not be permitted in primary members as failure occurs shortly after yield. The existing As-built plans also do not show any lap splices, however lap splices must exist based on the member lengths. Inelastic behavior beyond yield could result in loss of concrete cover which could affect the integrity of the lap splices. Ensuring that primary load carrying elements behave essentially elastic during a seismic event would thereby prevent the spans from collapsing. The primary member acceptance criterion for the As-built model is a force demand-to-capacity ratio of less than 1 (the demand on the member must be less than its capacity).

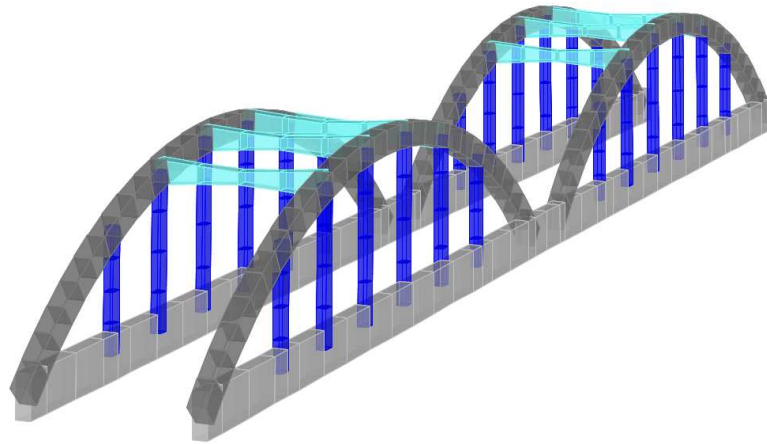
Flexural moment demand-to-capacity ratios could be greater than 1 for secondary elements, provided there is enough ductility and shear capacity to withstand the demands. Like the primary members, these secondary members also have a limited amount of confinement reinforcement. Local moment curvature models were run in SAP for these secondary elements. The analysis showed that they had very little ductility and failure could occur shortly after member yield. In addition to low ductility, secondary members were also deficient in shear. Consequently, it was determined that it would not be prudent to allow these members to behave inelastically in the As-built model. The secondary member acceptance criterion for the As-built model is a force demand-to-capacity ratio of less than 1 (the demand on the member must be less than its capacity).

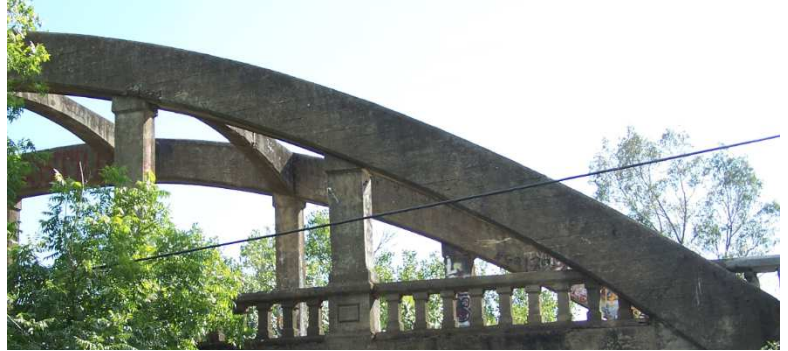
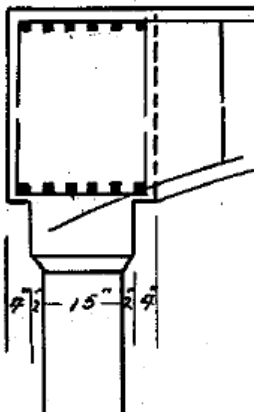
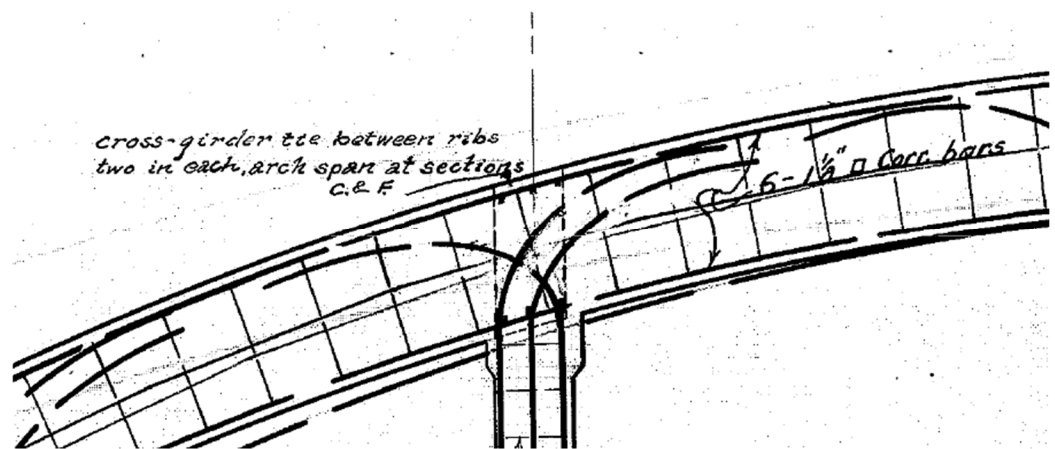
Under seismic loads, the arch members do not have sufficient capacity to meet the seismic bending and shear demands in both major and minor axes. The maximum moment demand occurs near the "spring line" adjacent supports of the arch. Based on the existing condition of the bridge, the maximum Demand-to-Capacity ratio of the Arch Rib elements for combined axial and flexural is 1.35. The shear strength comes mostly from the concrete since the shear reinforcement is minimal. The shear  $D/C = 0.70$ .

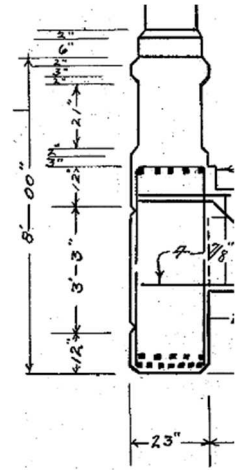
Under earthquake loads, the Tie Girders are most vulnerable to transverse ground motions. Because these Tie Girders were primarily designed to handle vertical loads, they have very little strength in the transverse direction to handle lateral seismic forces. Lateral bending in the tie girder induced by frame action between the Vertical Hangers, Portal Bracing, and Floor Beams as well as direct transverse bending from the arch at the spring line near the piers result in a high transverse moment demand. The maximum bending for this behavior occurs near Pier 3 where the Tie Girder connects with the arch at the spring line.

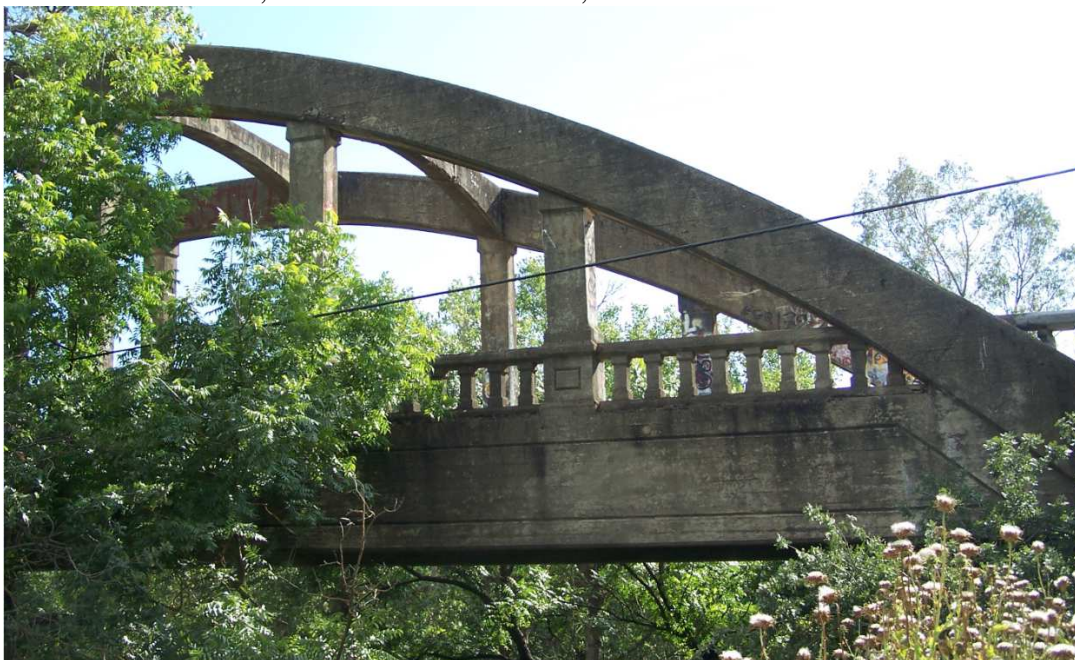
The maximum demand-to-capacity ratio of the Tie Girders for combined axial and flexural loads is 3.31. The maximum shear D/C = 1.86, which occurs near Piers, where the arch meets the Tie Girder.

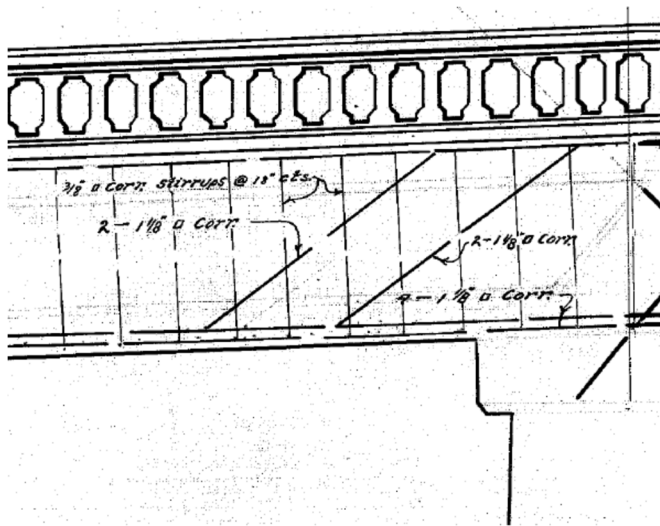
The approach spans (spans 1 & 4) are 40 feet long and consist of five concrete "T" beams. Large transverse deck cracks have been observed in both approach spans. Cracks for both spans occur about 3/4 of the way along the span (closer to the pier) which also correlates closely to the where the As-built plans show that the Tie Girder negative moment steel angles down towards the bottom fiber. The location of the cracks would suggest that both abutments have settled over the life of the bridge, or that the structure experiences a larger negative moment in the approach span near the support than originally considered in design. Other than these cracks which appear stable and not progressing no other deficiencies have been identified.

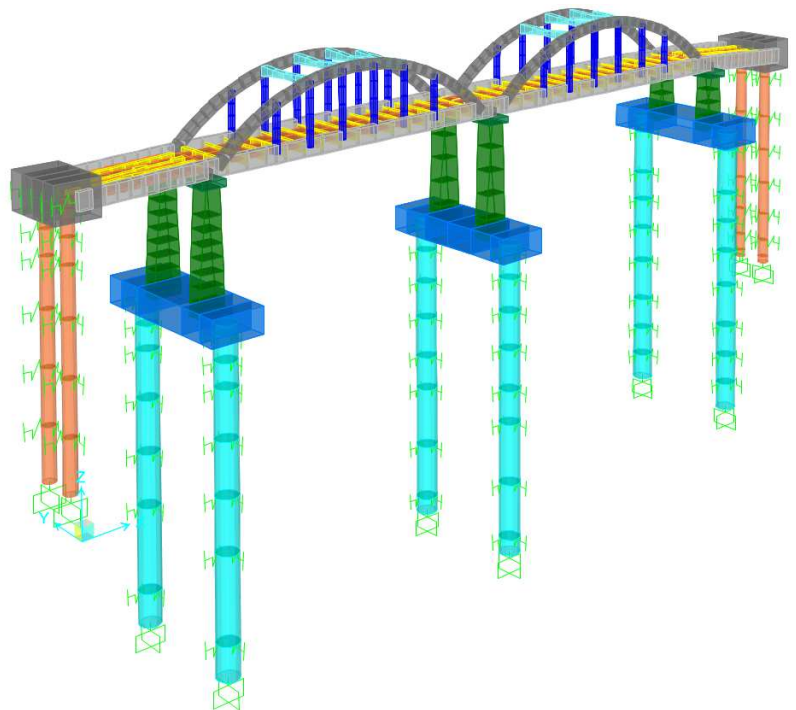
Substructure retrofit measures include the retrofit of all abutment and pier footings to resist both scour and seismic deficiencies. Large diameter piles would be added to the outside of the existing pier footings and a new pier footing cap would tie the new piles to the existing footing. At the abutments, large diameter piles would be added behind the existing abutment wall to address both scour and seismic deficiencies.

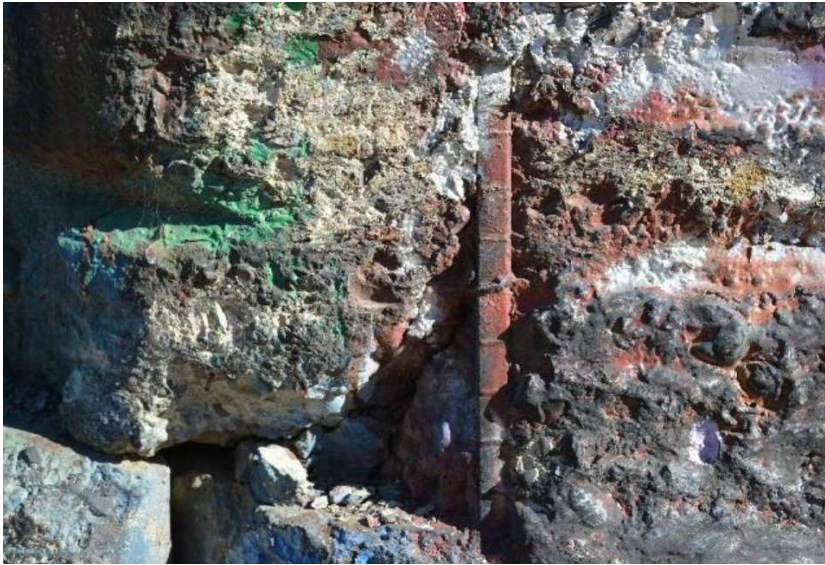
Before installing FRP, the surface of the member must be prepared. First, unsound concrete must be removed and replaced. Corrosion on bars should be removed by abrasive blasting (water blasting may also be feasible). Then the surface is repaired by injecting epoxy into any cracks in the concrete. For surfaces requiring repair with an area greater than one square foot, concrete screws should be installed to provide better bond to the new concrete. Next, all concrete surfaces to be wrapped with FRP should be abrasive blast cleaned or ground to provide a rough bonding surface. Corners of the FRP retrofitted members must also be rounded to a minimum radius of 2" so that a sharp corner does not induce high stresses in the FRP, that could cause it to fail.

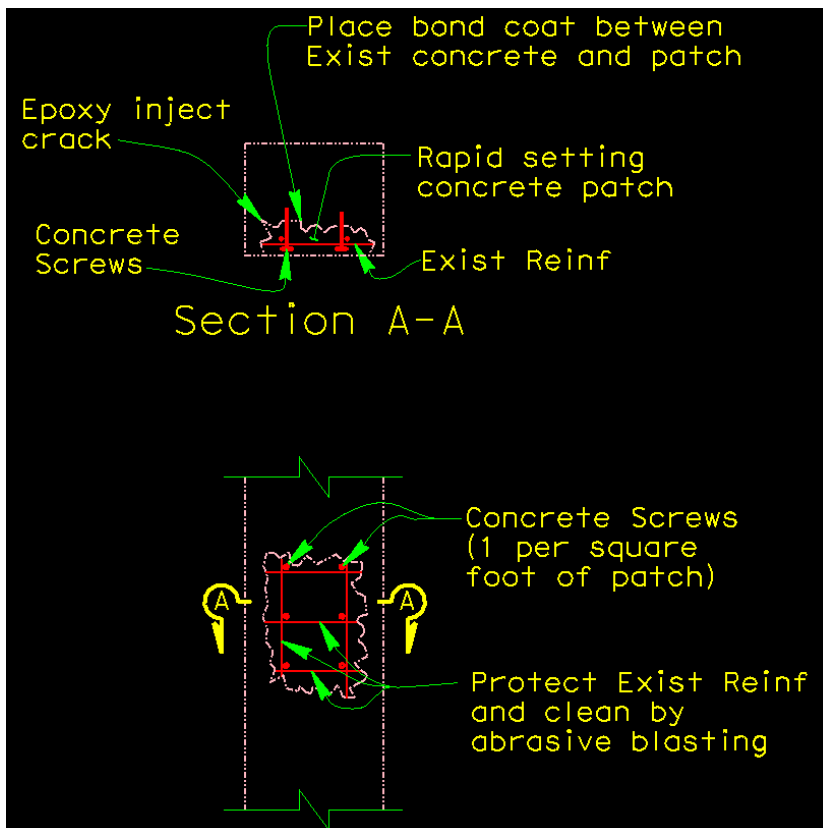
### RFP Maintenance/Appearance

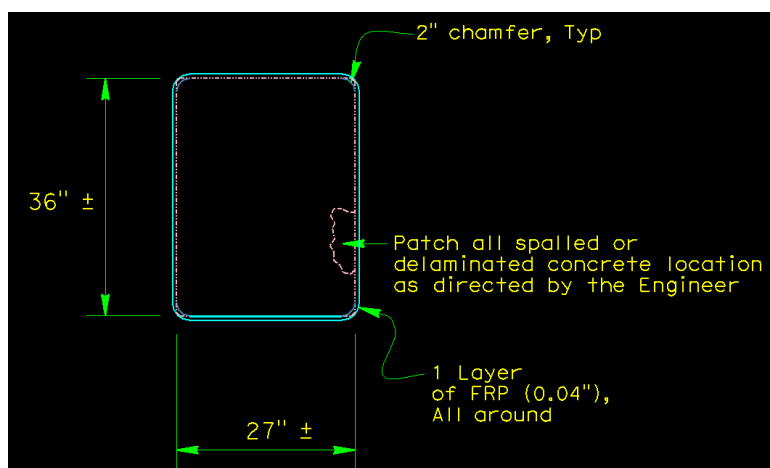
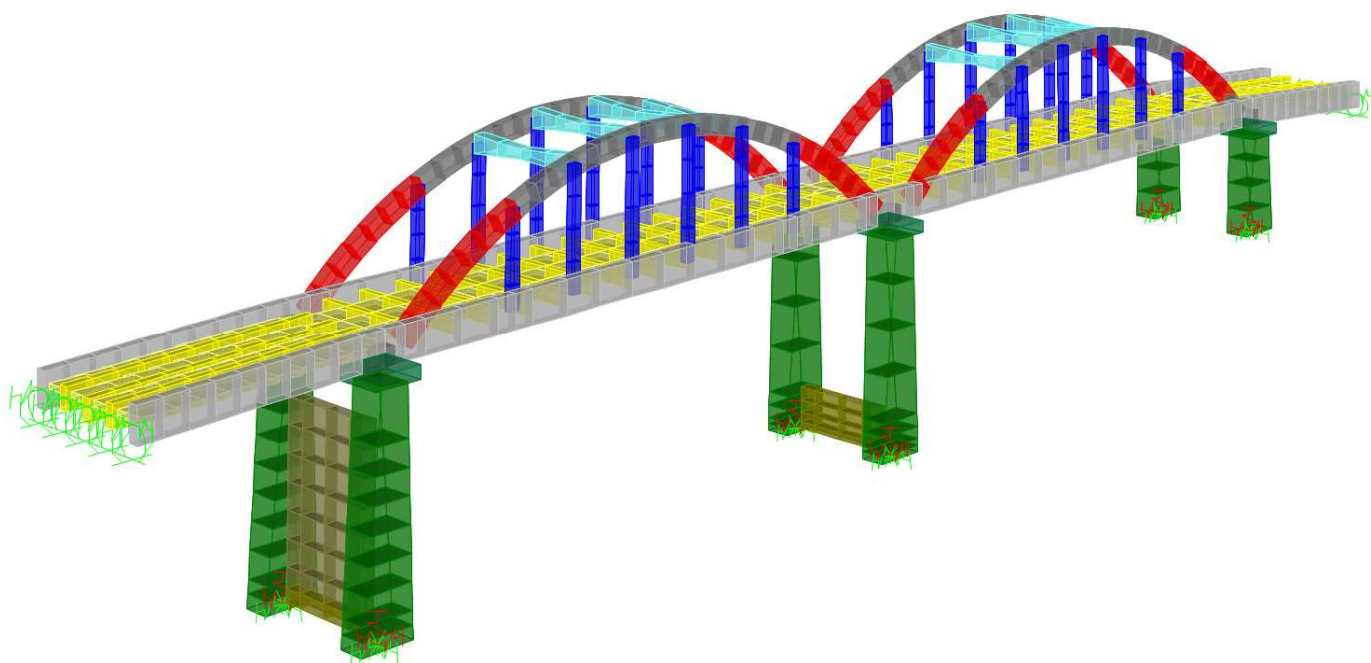
### Tie Girder Retrofit
