# Project Report

**Putah Creek Bridge Rehabilitation at Stevenson Bridge Road  
Federal Project No. BRLS 5923(059)  
Bridge No. 23C0092**

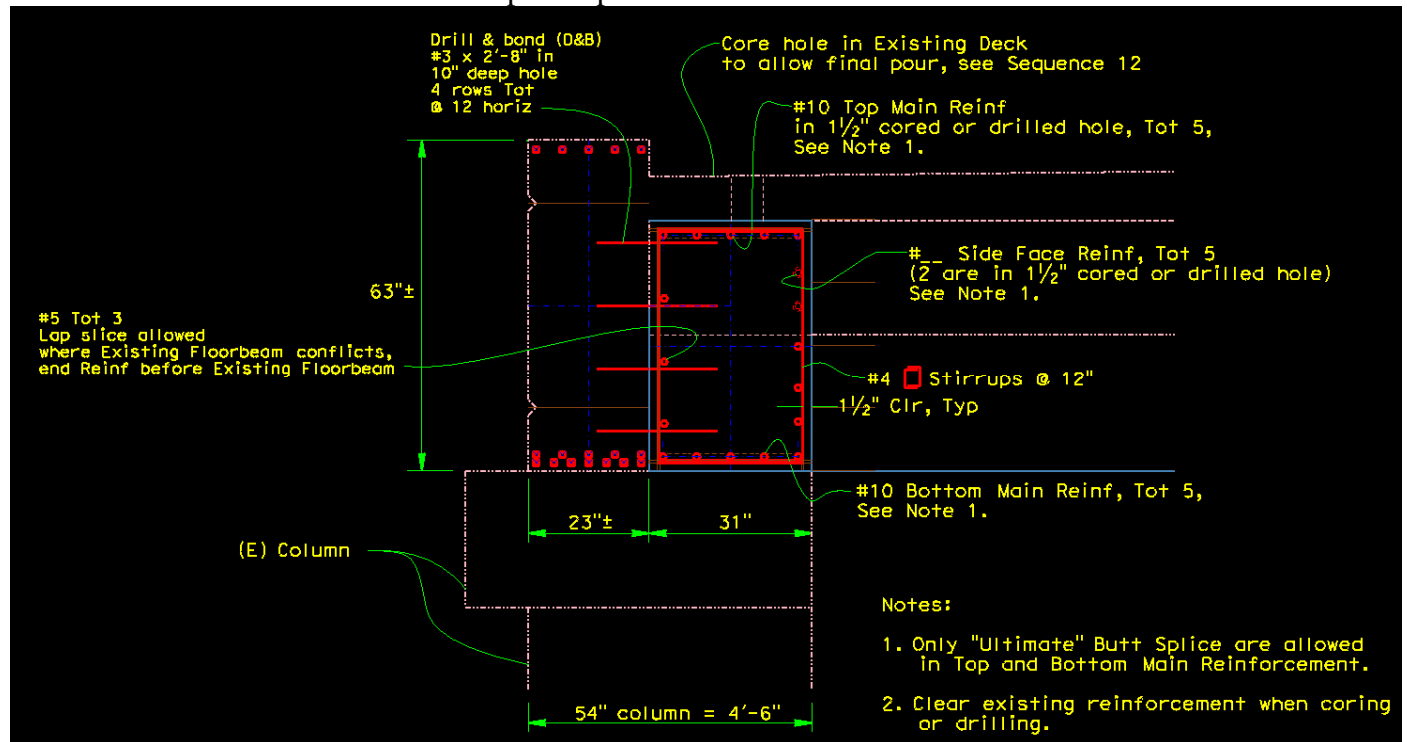
Red elements in the figure below indicate the approximate location of where the Tie Girder will be retrofitted with section enlargement. The retrofit model did account for increased mass as a result of this retrofit.

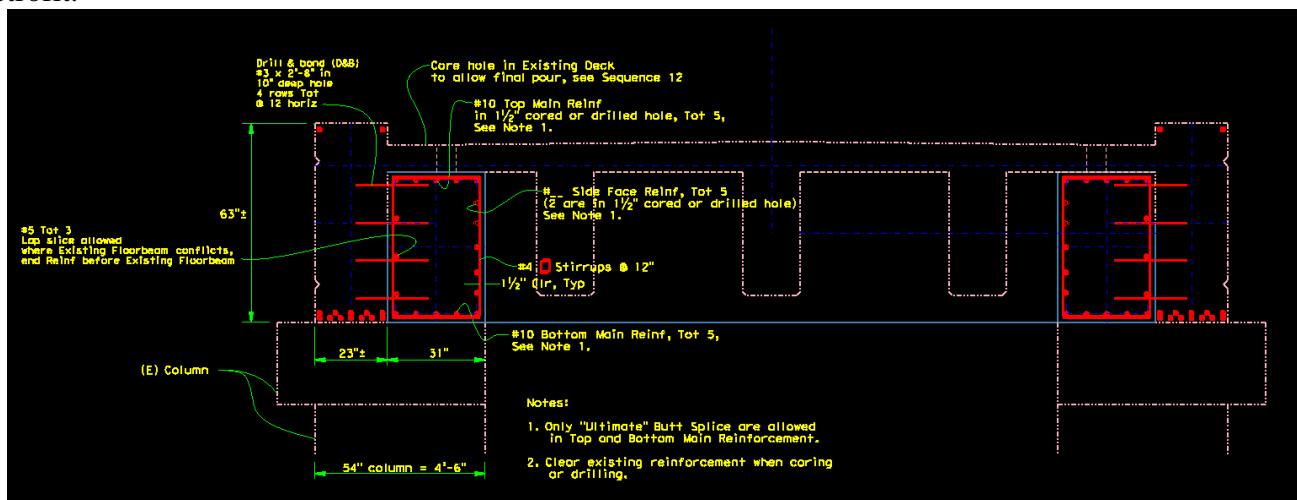
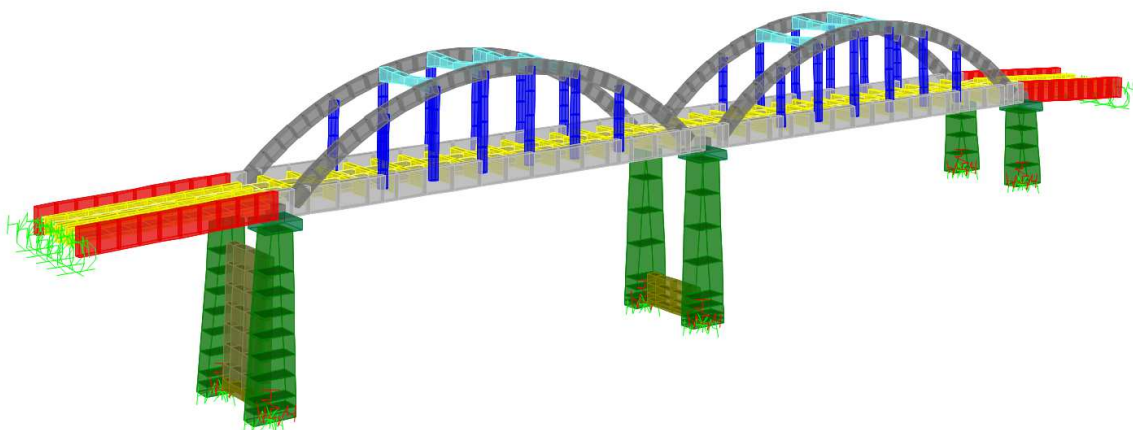
Vertical Hanger Retrofit

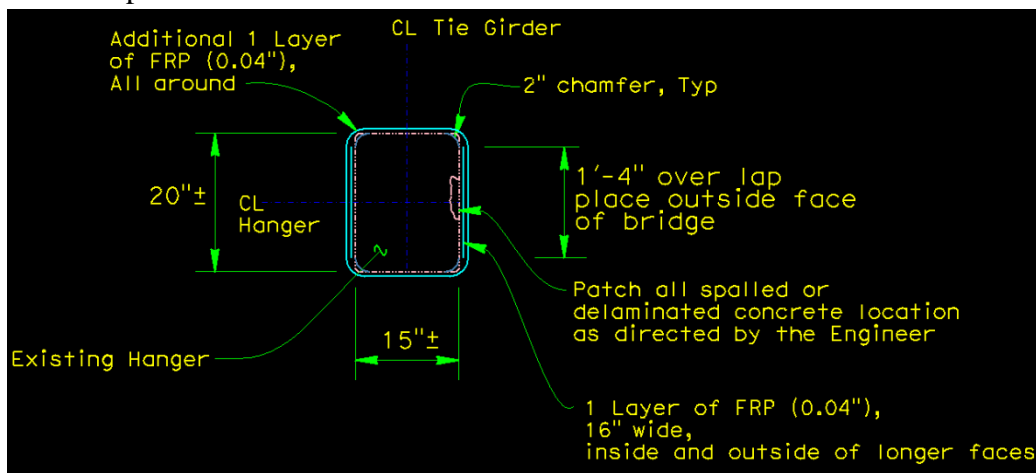
Section of Vertical Hanger FRP Retrofit

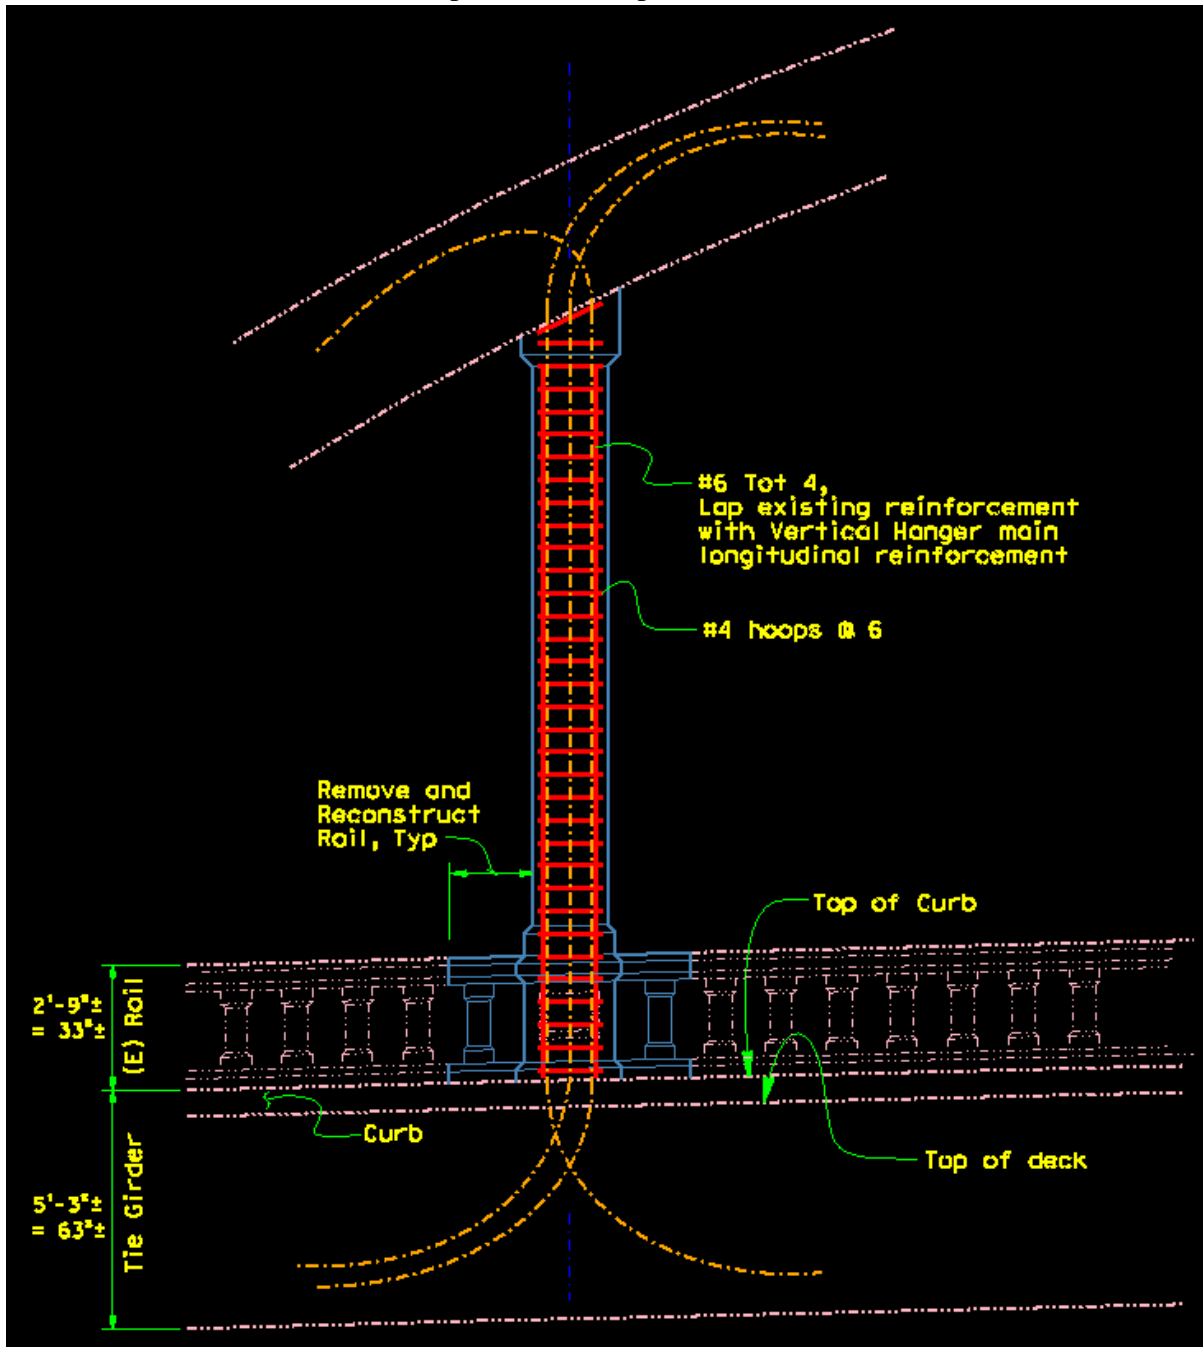
### Portal Bracing Retrofit

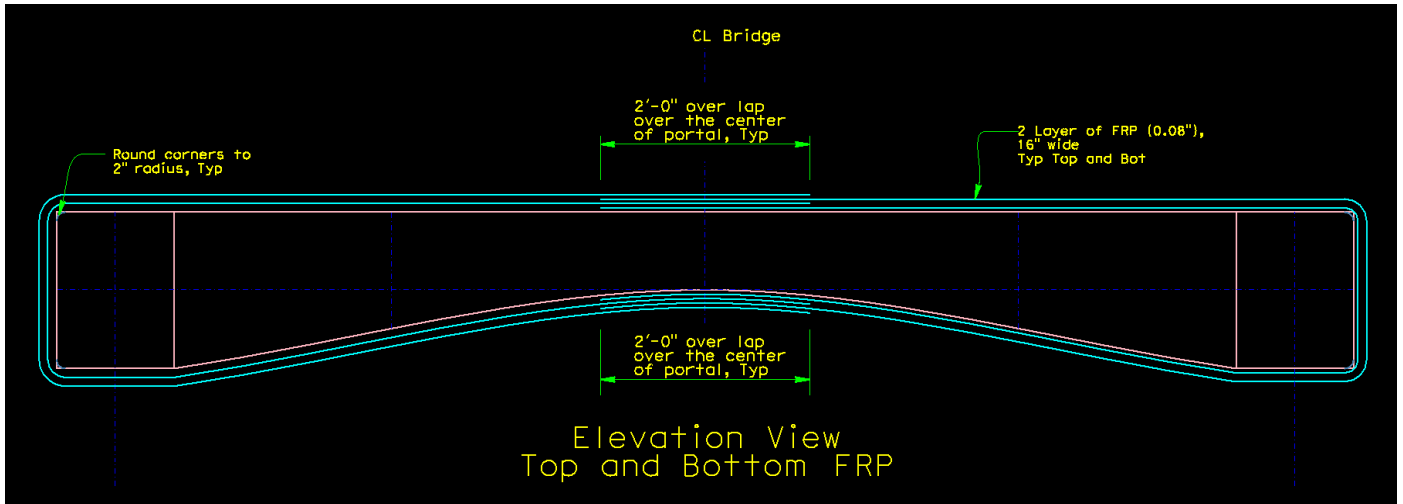
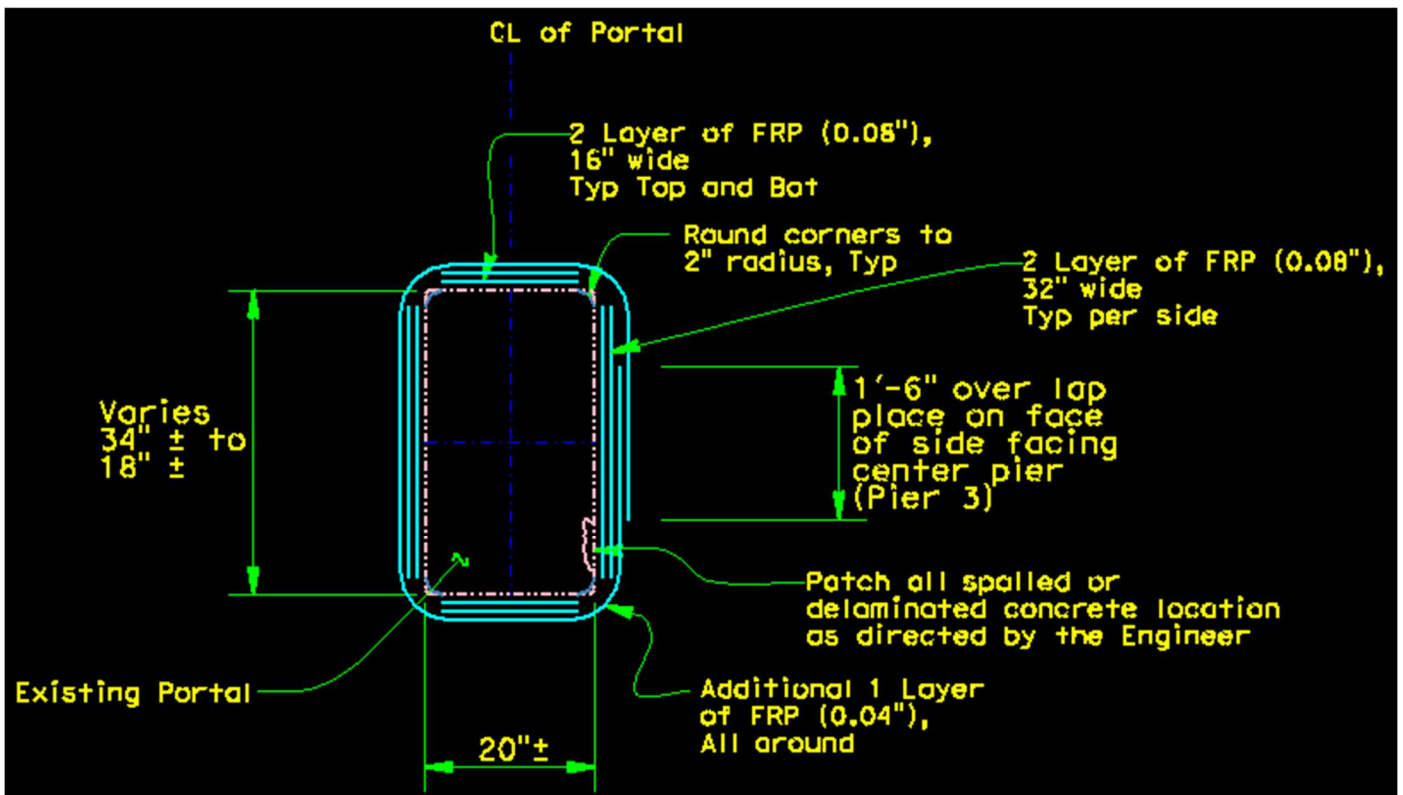
### Floor Beam Retrofit

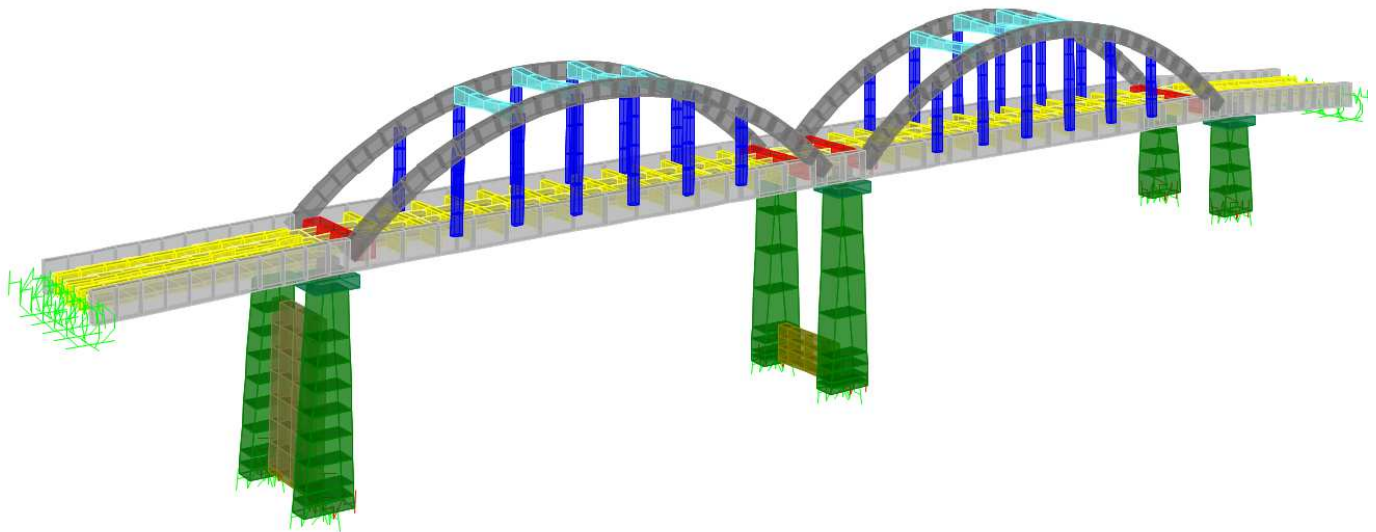
*Limits of Floor Beam Retrofit shown in Red*

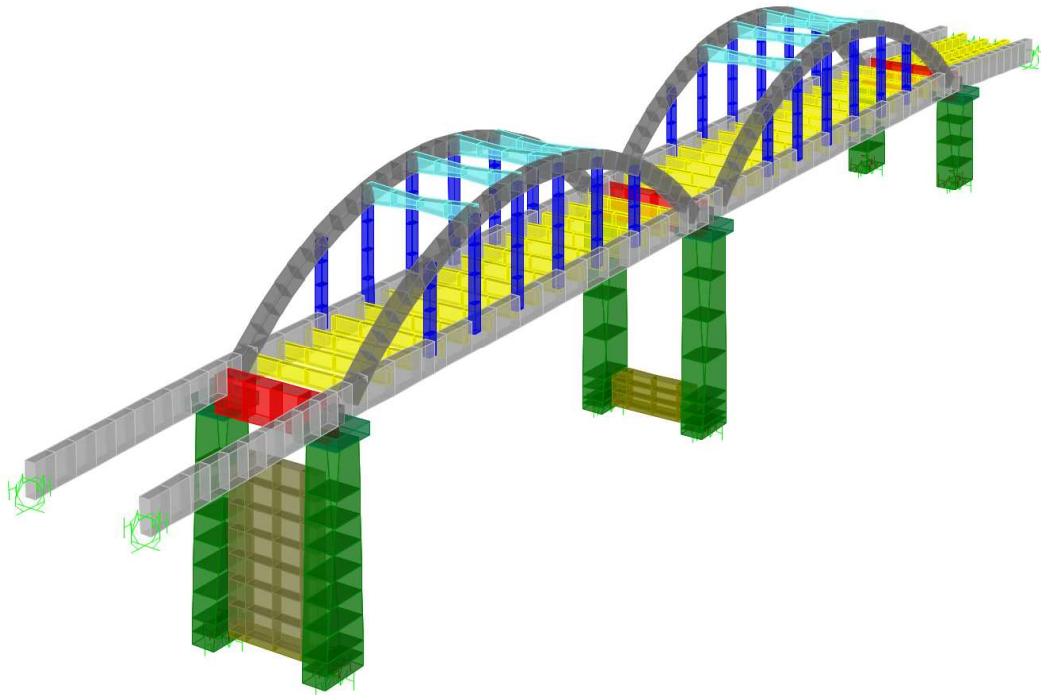
Limits of Pier Cap Retrofit shown above in Red

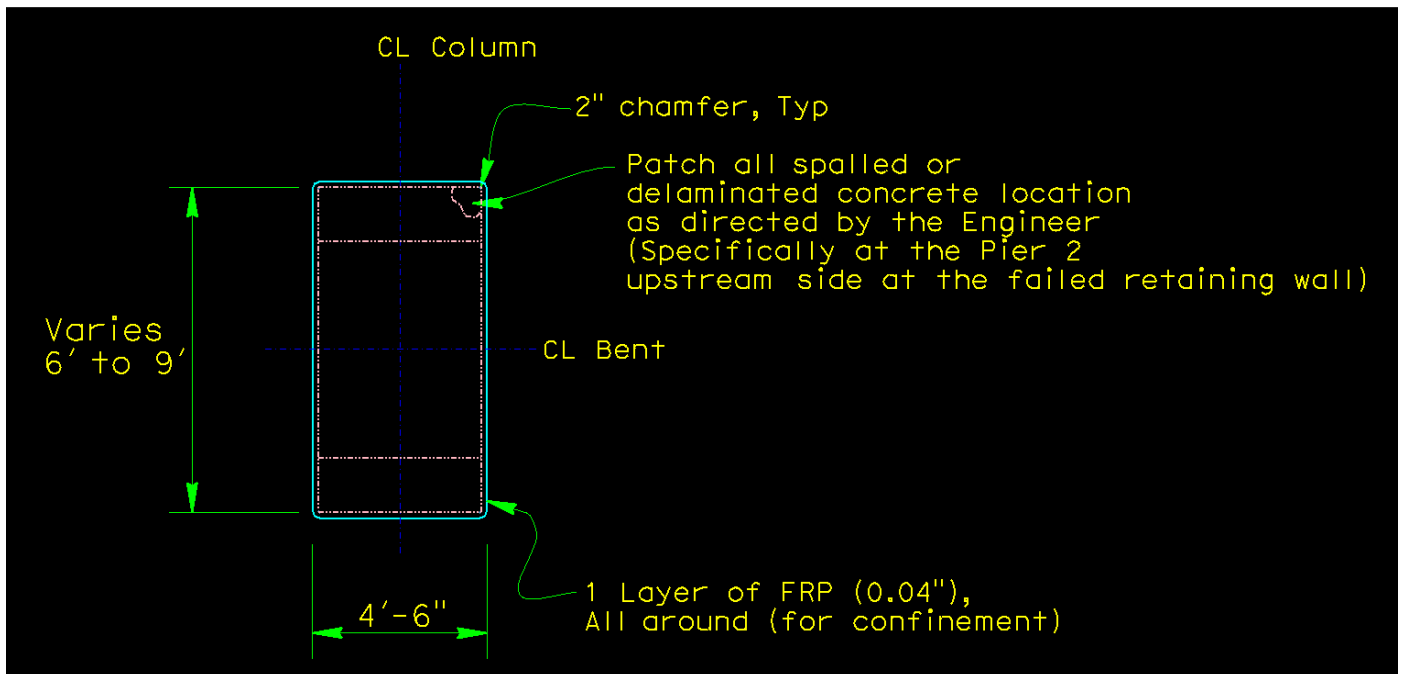
Pier Footing and Piles Retrofit

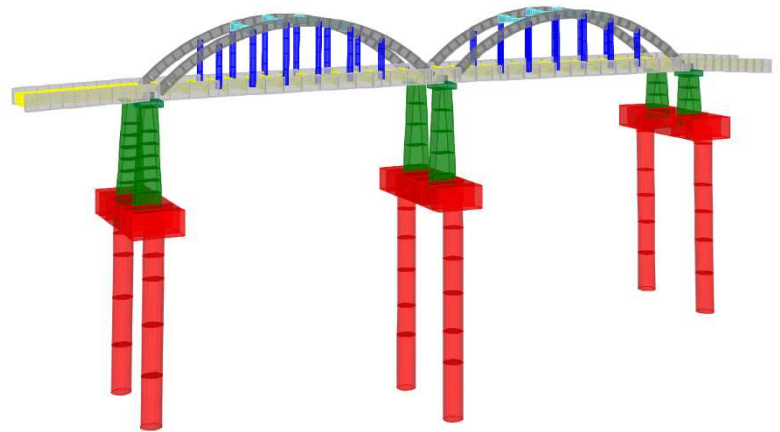
Limits of Pier Footing and Pier Piles shown in Red

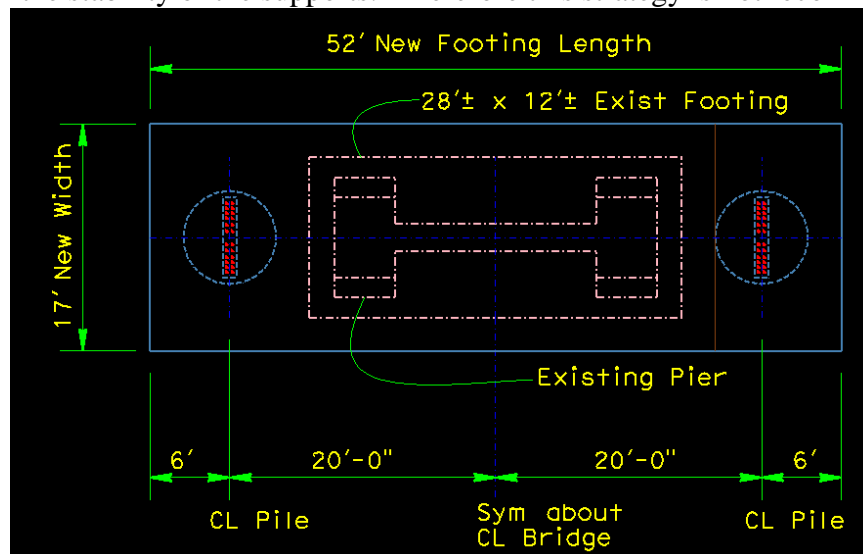
Another strategy considered included separating the superstructure from the substructure by the means of “Base Isolation”. Base Isolation is a strategy where bearings are installed between the superstructure and the substructure which effectively allows these two components to move independently. These bearings would decrease the seismic demands in the entire bridge by effectively lengthening the structural period, i.e., making the bridge more flexible. This strategy was not considered feasible due to a host of structural complications associated with disconnecting the arch spans from their supports. In addition, it would not address scour issues that threaten the stability of the supports. Therefore this strategy is not recommended.

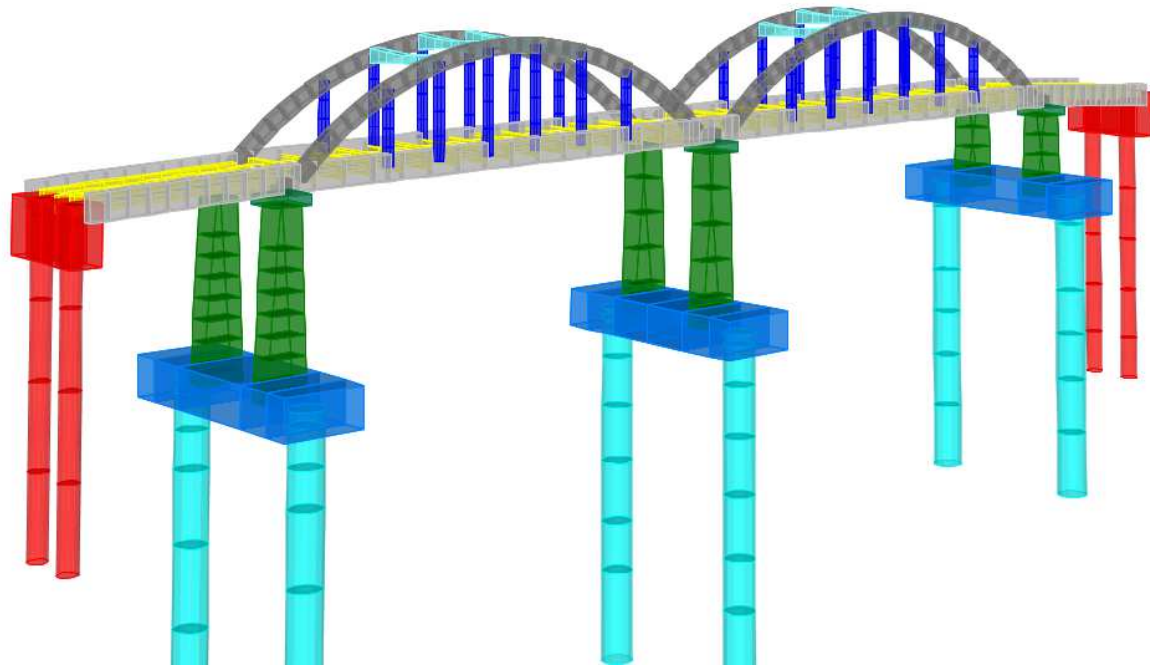
Limits of Abutment Diaphragm Bolster and Abutment Piles shown in Red

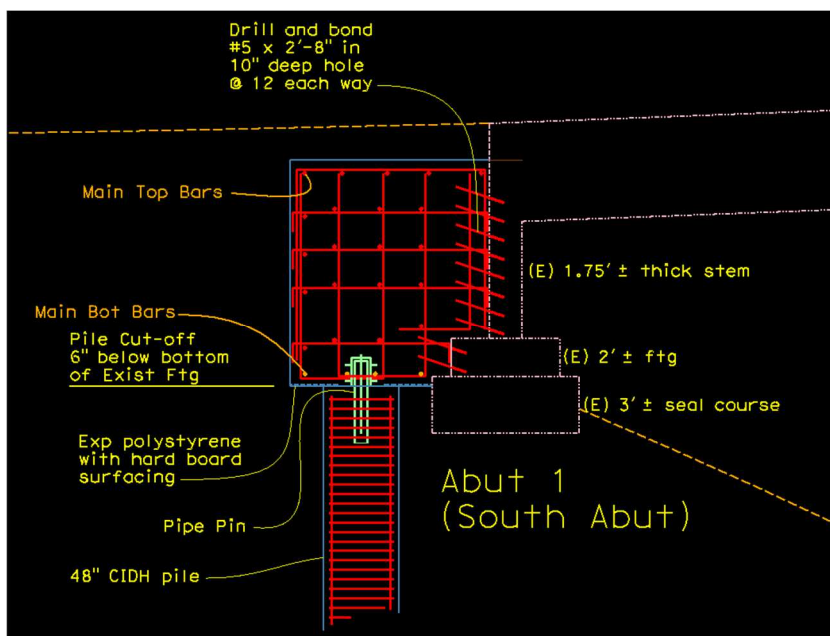
### Concrete Railing Repair/Replacement

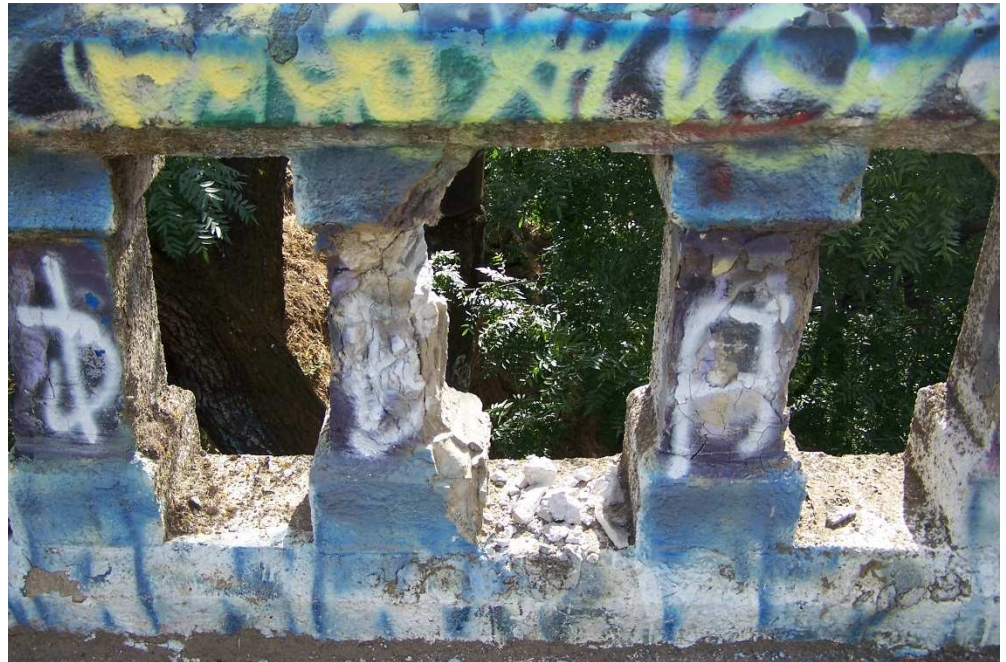
Preservation of the existing rail is preferred and replacement on the rails will

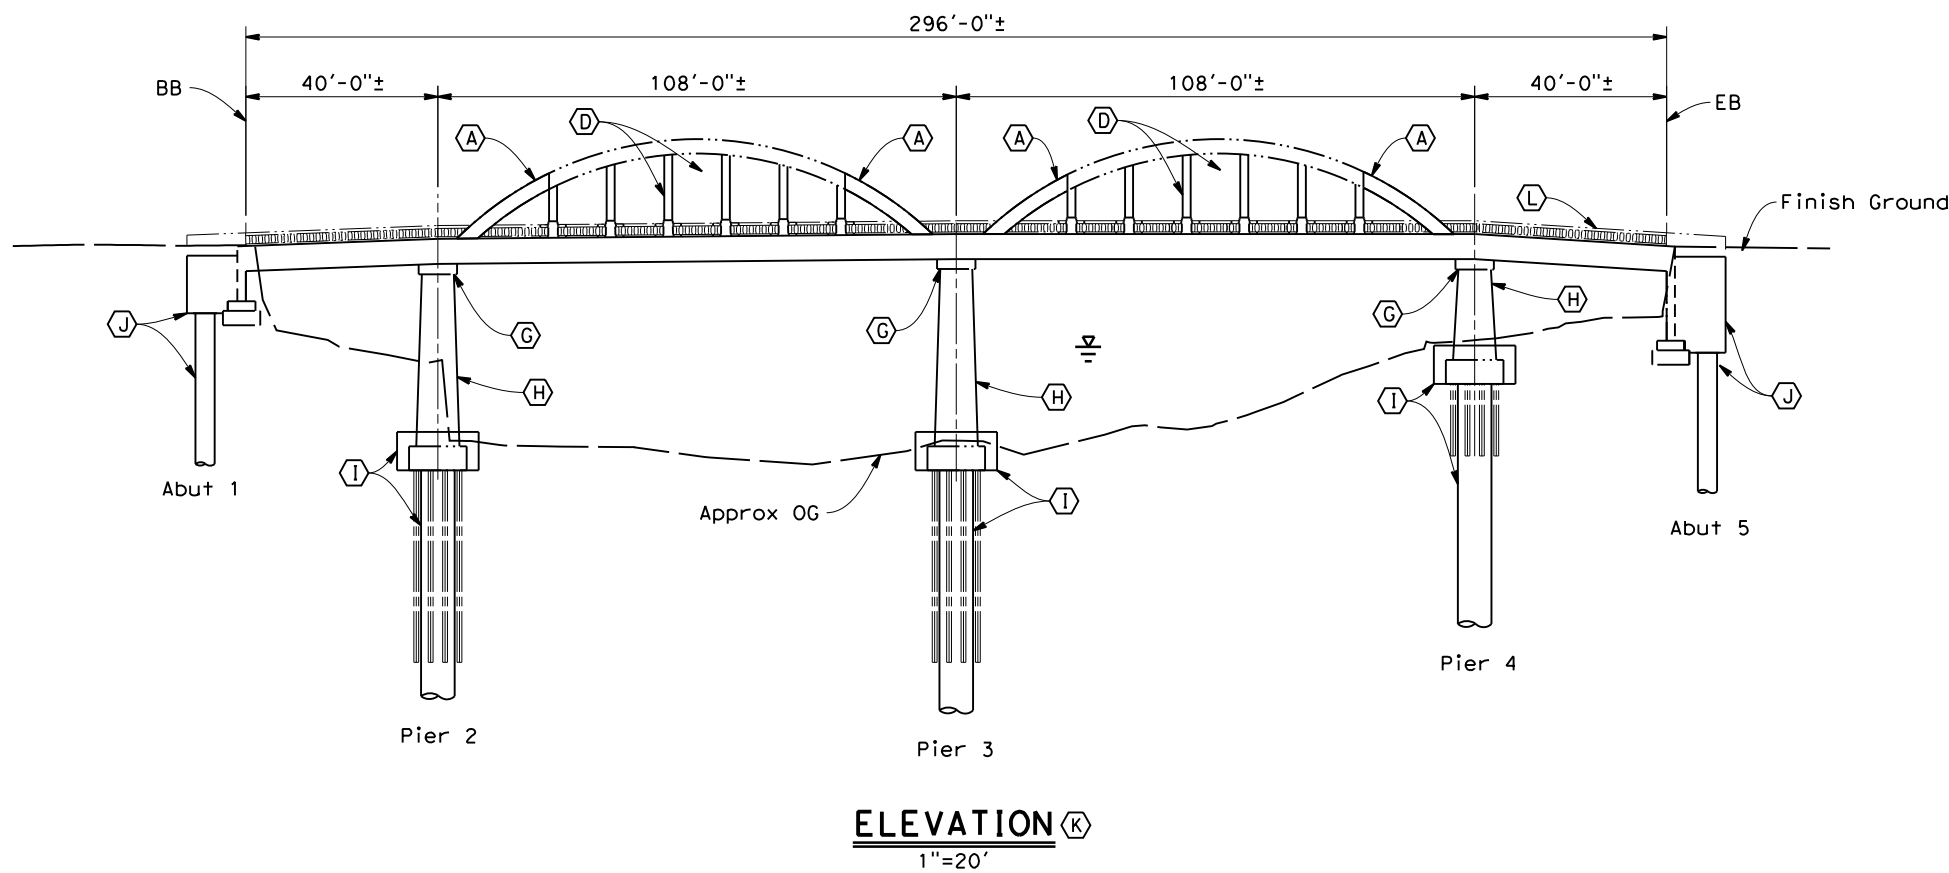
**ELEVATION (K)**  
1"=20'

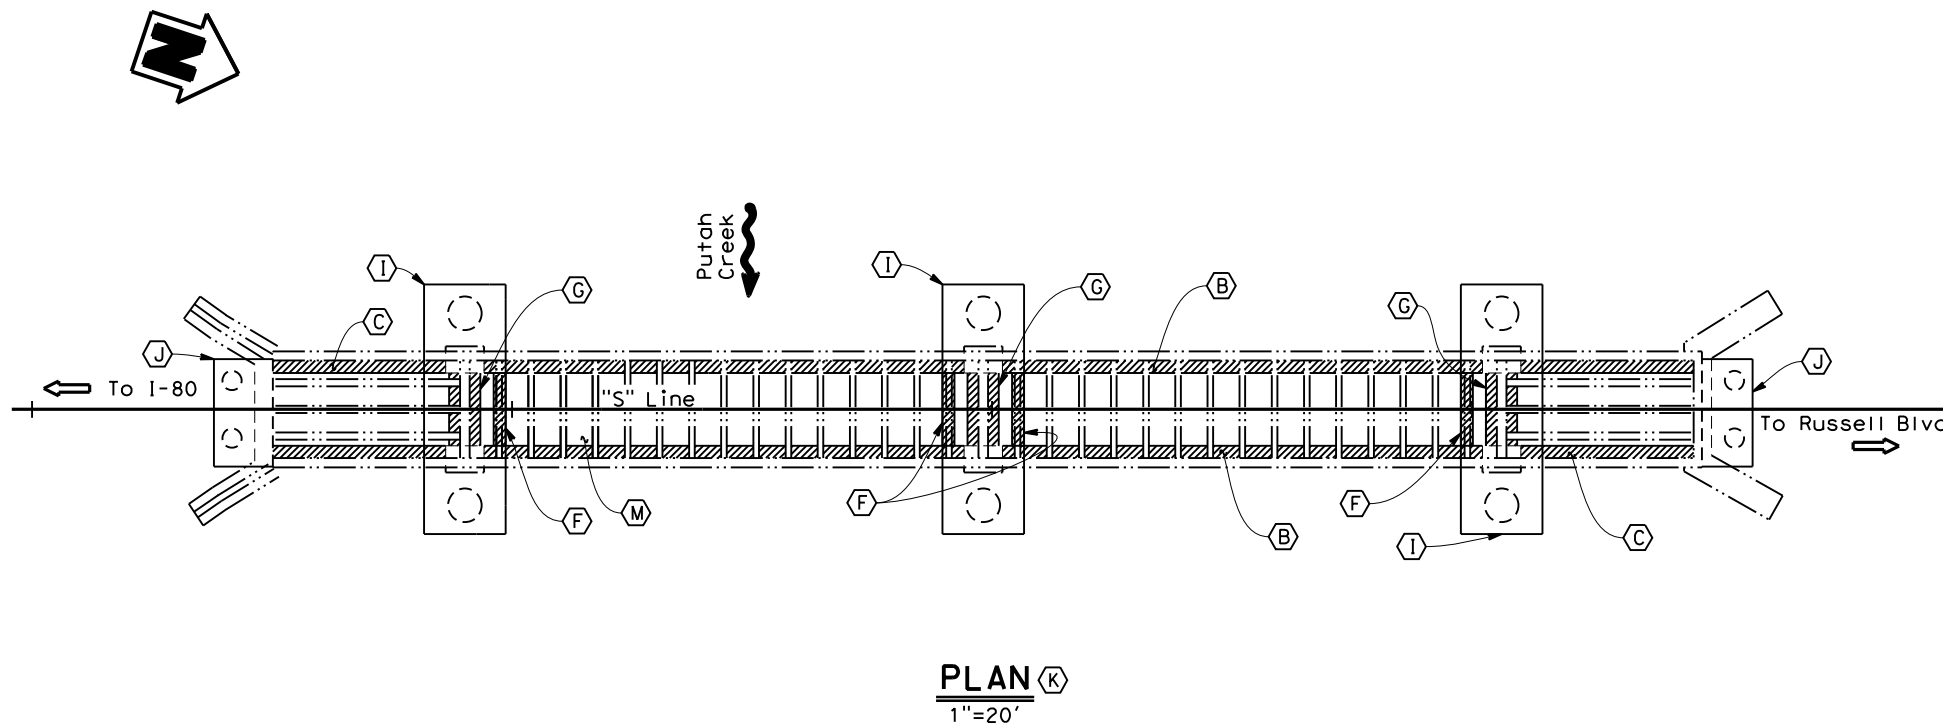
**PLAN (K)**  
1"=20'

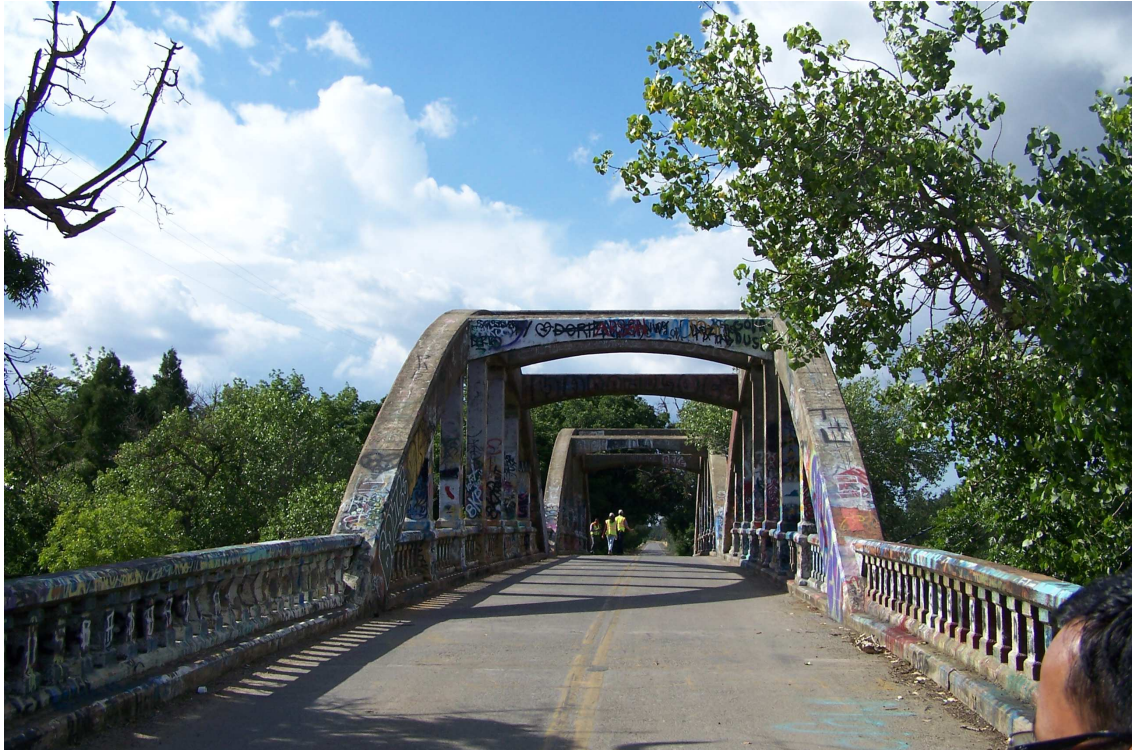
## Table of Contents

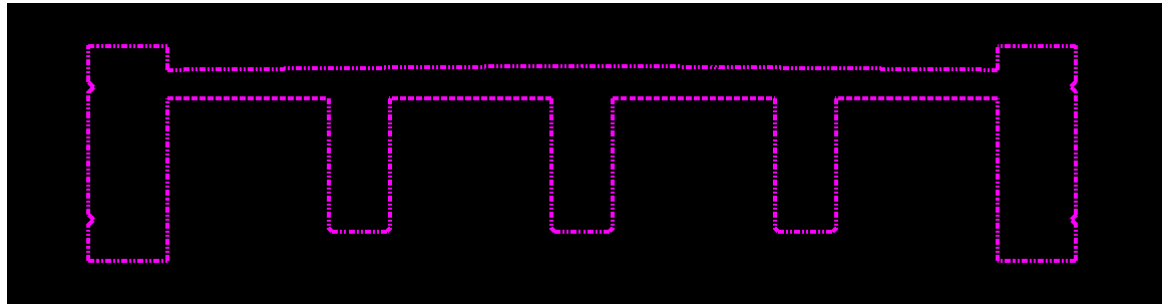
<u>Item No. / Description</u>	<u>Unit</u>	<u>Dist</u>	<u>Qty</u>	<u>Unit Price</u>	<u>Adj Price</u>
<input checked="" type="checkbox"/>	600003 - INJECT CRACK (EPOXY)	LF	11	180	\$55.00	\$55.00
<input checked="" type="checkbox"/>	600003 - INJECT CRACK (EPOXY)	LF	11	180	\$70.00	\$70.00
<input checked="" type="checkbox"/>	600003 - INJECT CRACK (EPOXY)	LF	11	180	\$25.00	\$25.00
<input checked="" type="checkbox"/>	600003 - INJECT CRACK (EPOXY)	LF	11	180	\$60.00	\$60.00
<input checked="" type="checkbox"/>	600003 - INJECT CRACK (EPOXY)	LF	11	180	\$80.00	\$80.00
<input checked="" type="checkbox"/>	600003 - INJECT CRACK (EPOXY)	LF	11	180	\$46.10	\$46.10

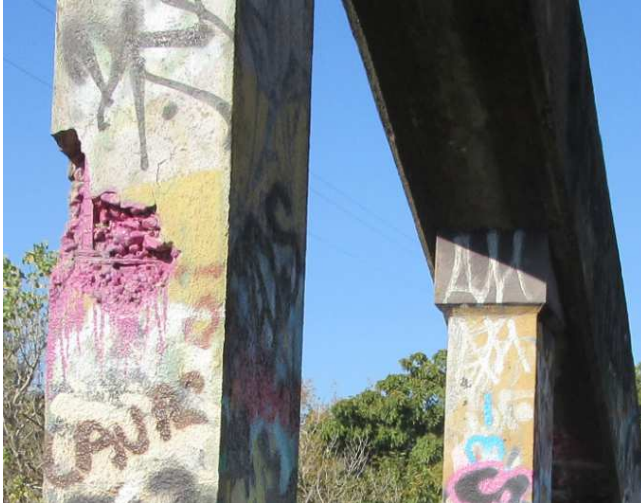
Work includes removal of unsound concrete, installing of new concrete screws (one at every square foot patch), placing bond coat between existing concrete and patch, and setting concrete patch. Work also includes protecting the existing reinforcing bars and cleaning the reinforcing bars by abrasive blasting. This item covers all spalled areas except the deck.

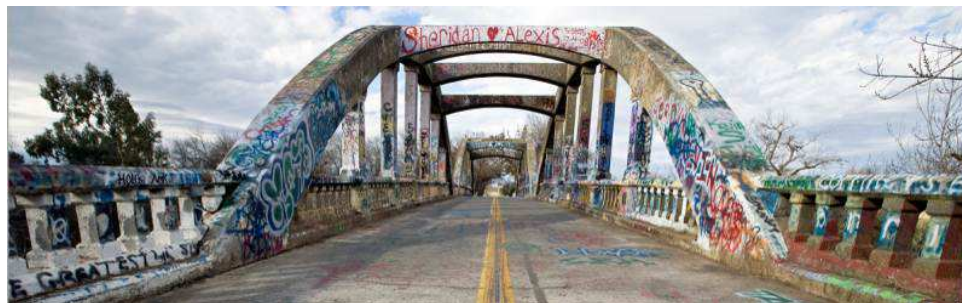
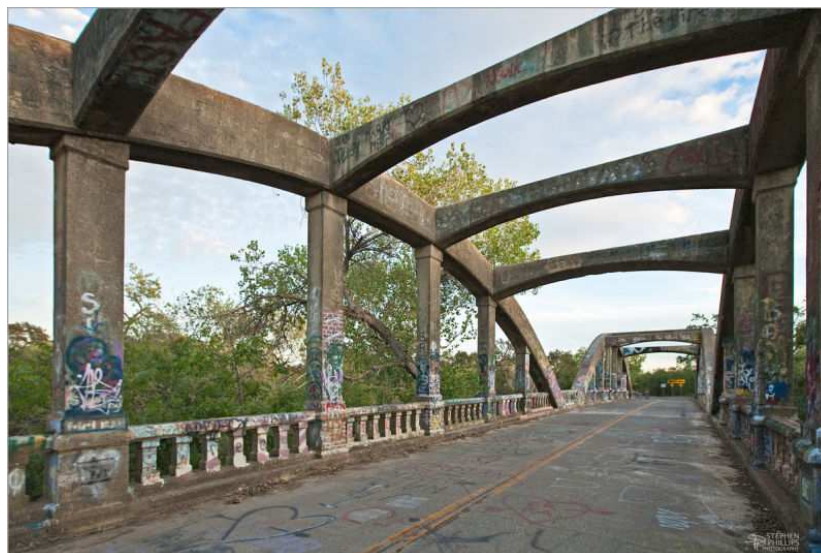
**Fiber Wrap [SOFT]**

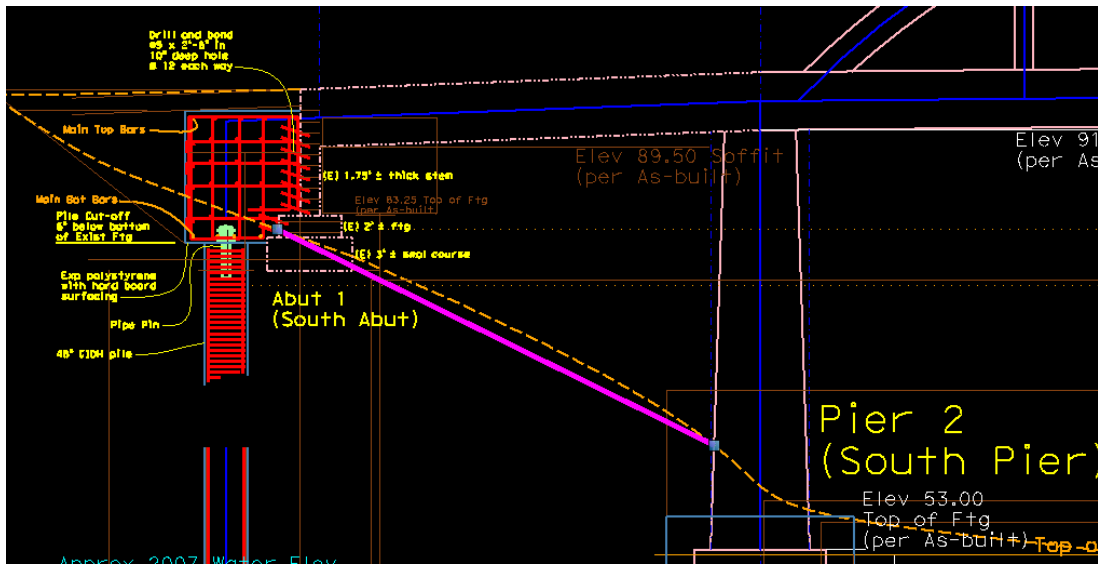
immediately downstream of the bridge. The minimum RSP class for the existing bridge abutments calculated in accordance with the HEC-23 method is Class III. However, Class IV RSP is recommended based on engineering judgment. Per the *Highway Design Manual*, Class IV RSP at the Project site requires a Class 8 RSP geotextile filter. The minimum RSP layer thickness is 2.5 ft, and detailed RSP calculations are in Appendix D.

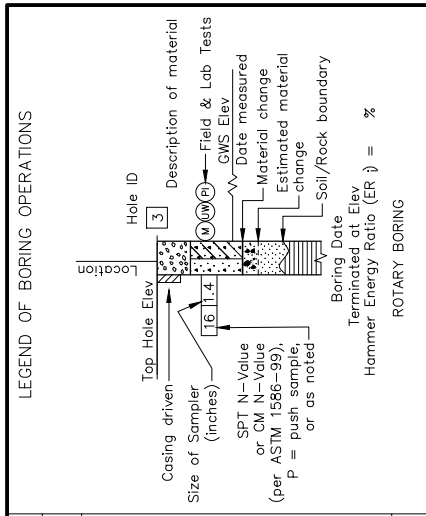
BOREHOLE IDENTIFICATION	
Symbol	Description
A	Auger boring (hollow or solid stem bucket)
R	Rotary drilled boring (conventional)
RW	Rotary drilled with self-casing wire-line
RC	Rotary core, with continuously-sampled, self-casing
P	Wire-line rotary percussion boring
R	(Air) Rotary drilled diamond core
HD	Hand driven (1-inch soil tube) hand auger
HA	Dynamic cone penetration boring
D	Cone Penetration Test (ASTM D 5778)
CPT	Other (note on LOTB)
O

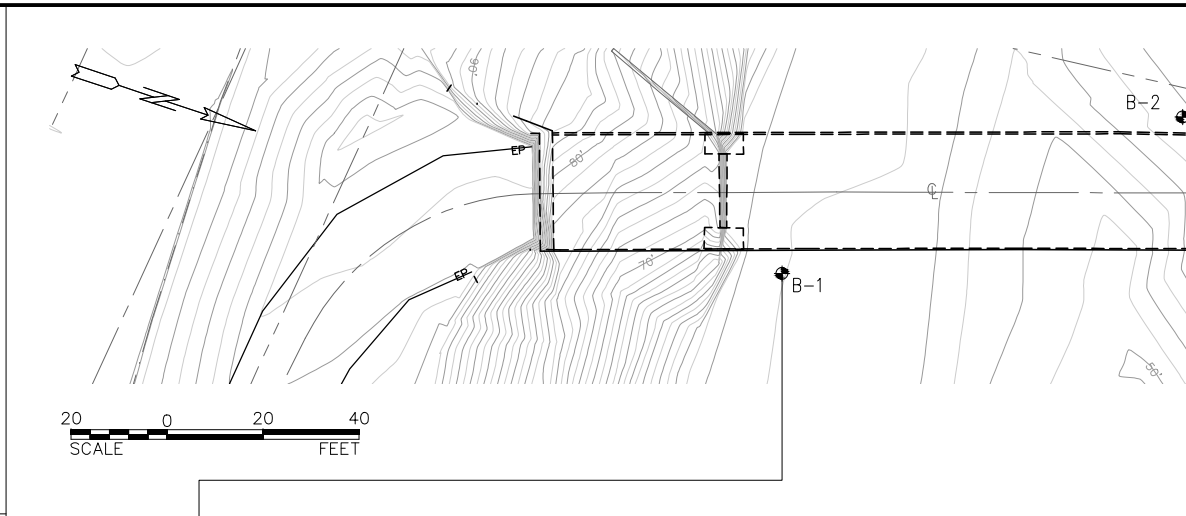
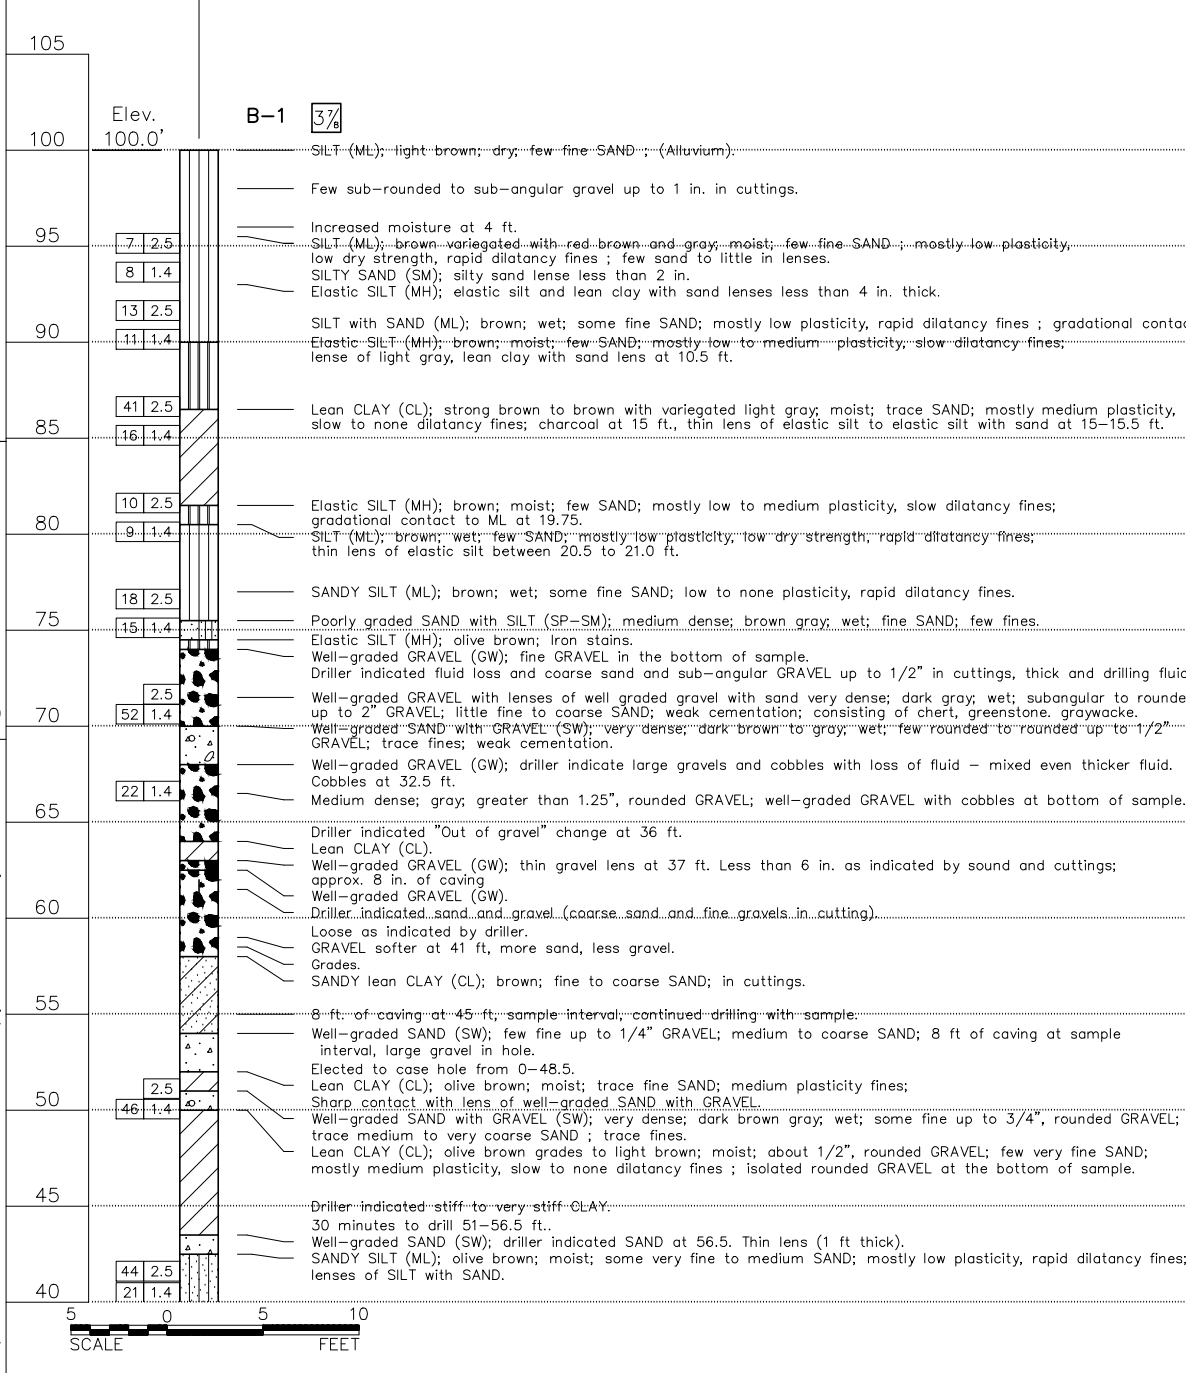
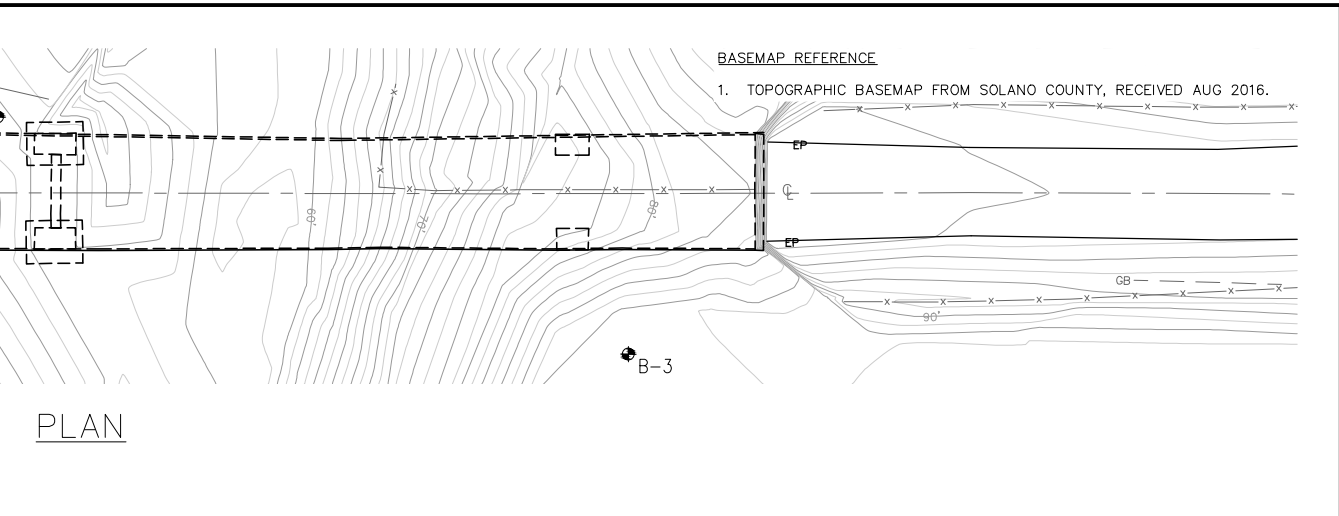
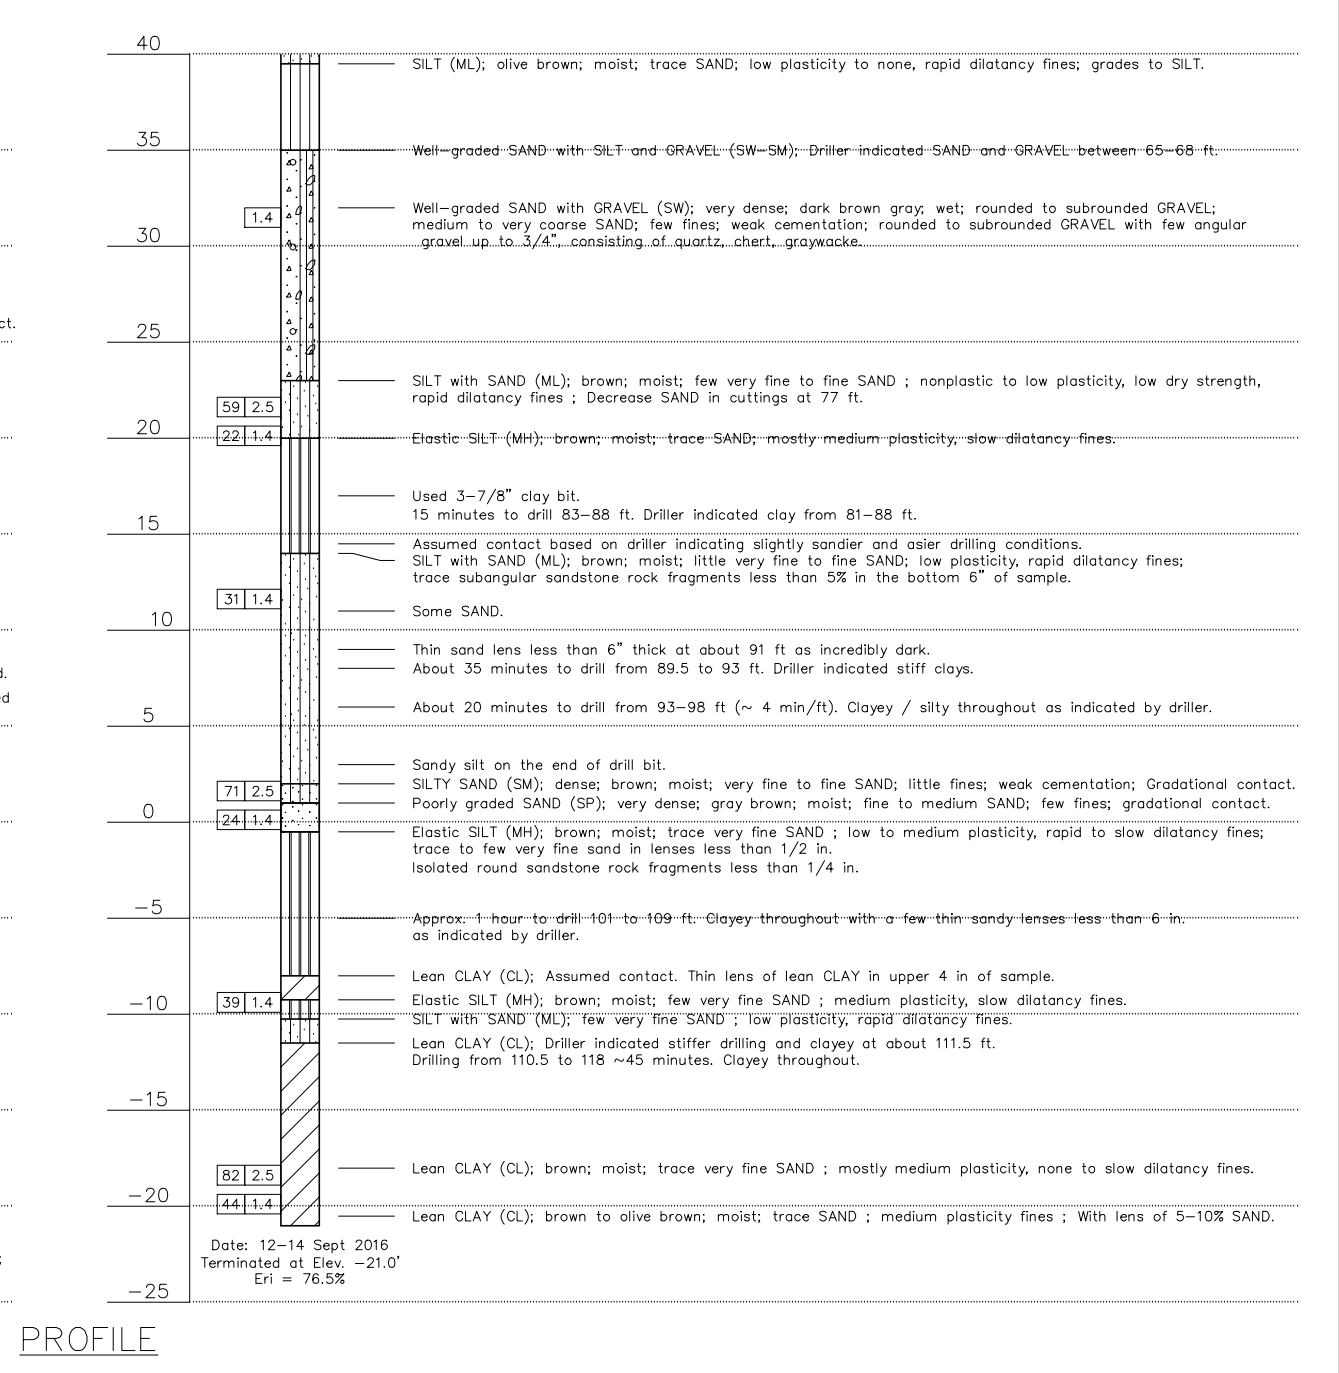
NOTE: Classification of earth material as shown on this sheet is based upon field inspection and is not to be construed to imply mechanical analysis.
