# Project Report

**Putah Creek Bridge Rehabilitation at Stevenson Bridge Road  
Federal Project No. BRLS 5923(059)  
Bridge No. 23C0092**

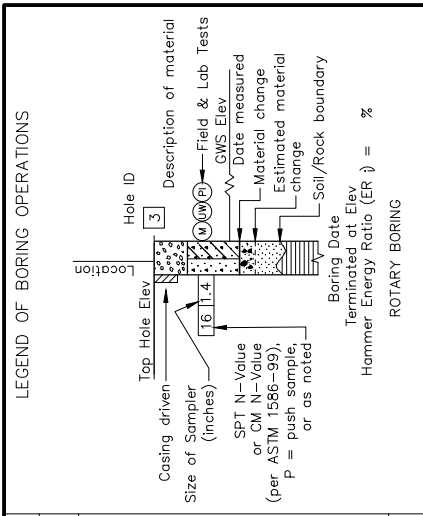
BOREHOLE IDENTIFICATION	
Hole Type	Description
A	Auger boring (hollow or solid stem bucket)
R	Rotary drilled boring (conventional)
RW	Rotary drilled with self-casing wire-line
RC	Rotary core, with continuously-sampled, self-casing
P	Wire-line rotary percussion boring
R	(Air) Rotary drilled diamond core
HD	Hand driven (1-inch soil tube) hand auger
HA	Dynamic cone penetration boring
CPT	Cone Penetration Test (ASTM D 5778)
O	Other (note on LOTB)

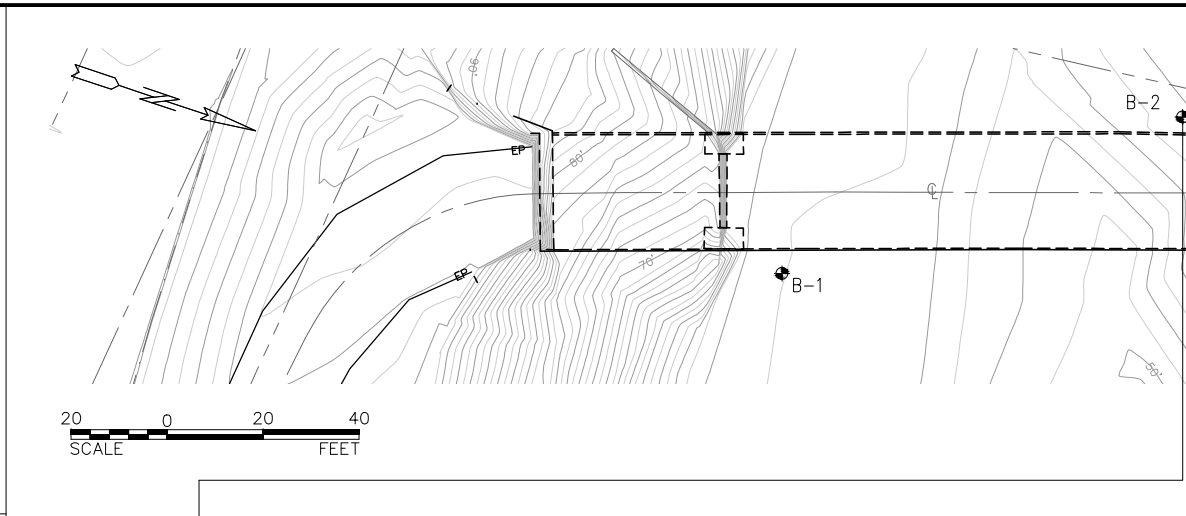
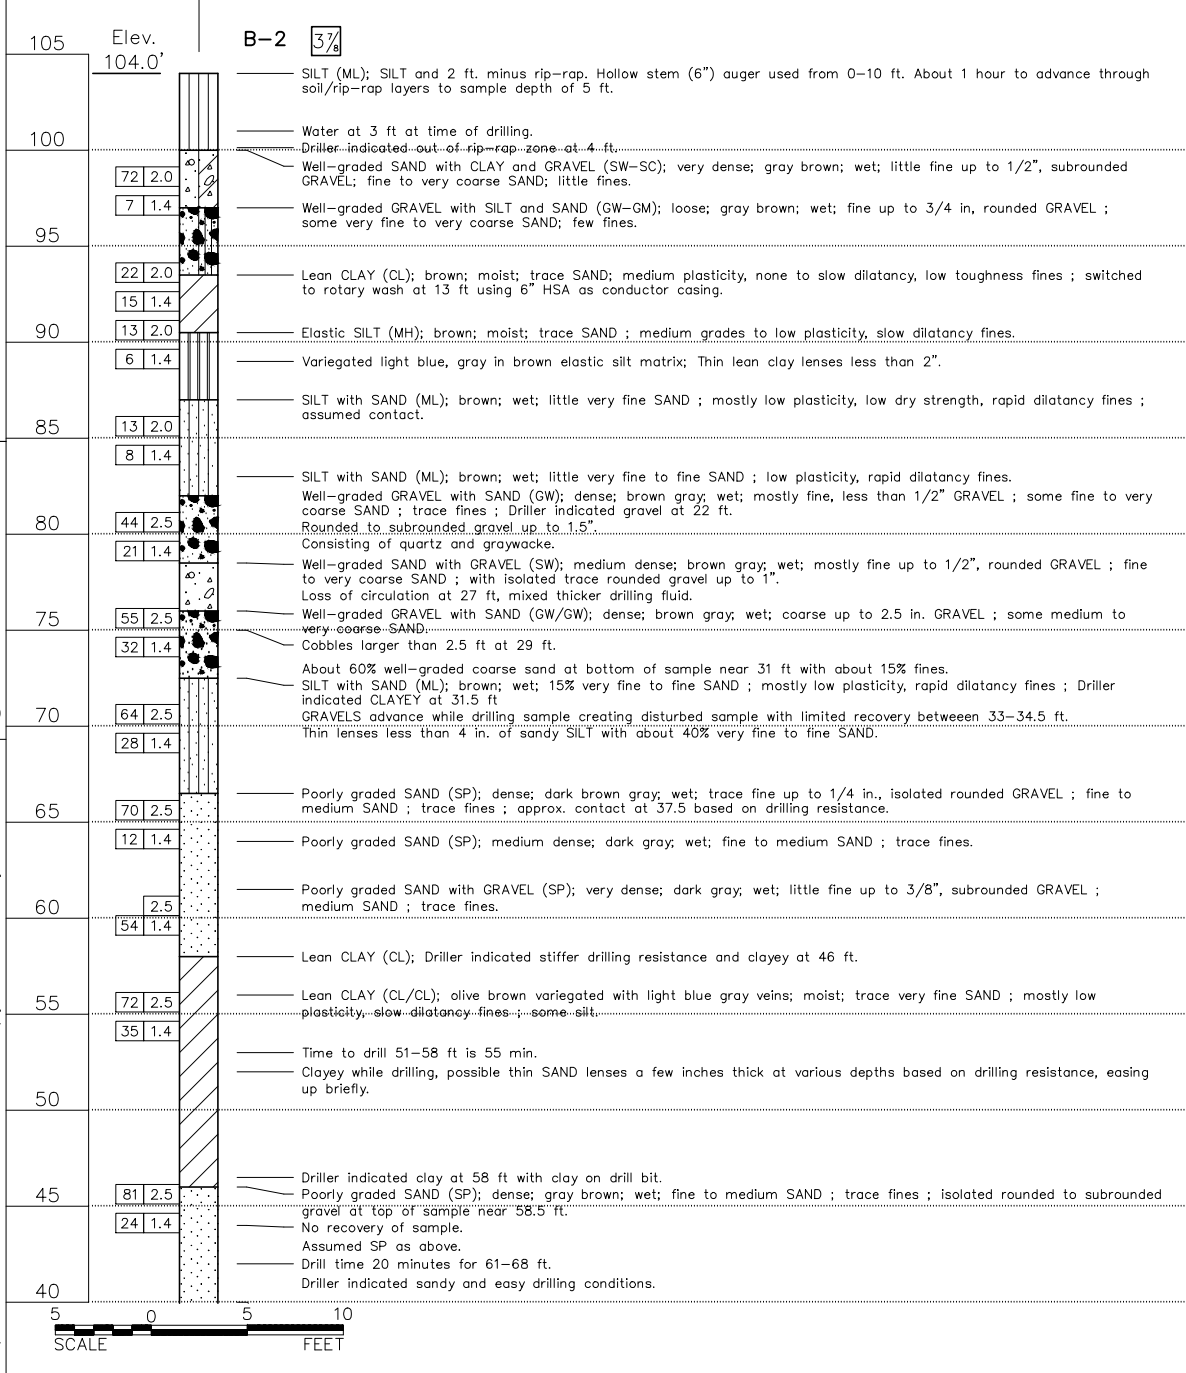
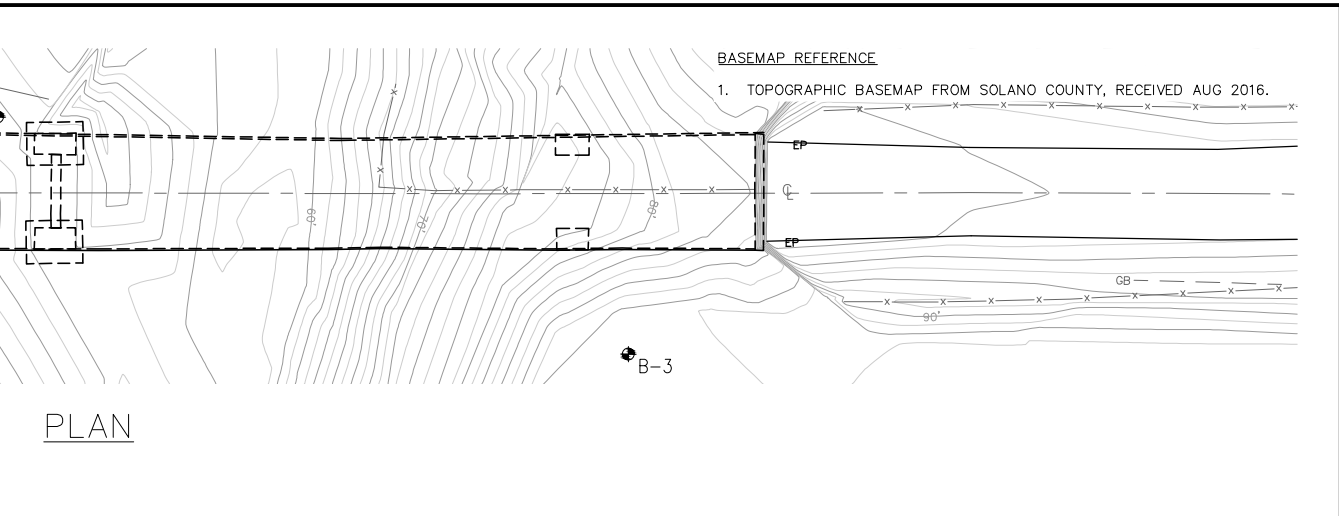
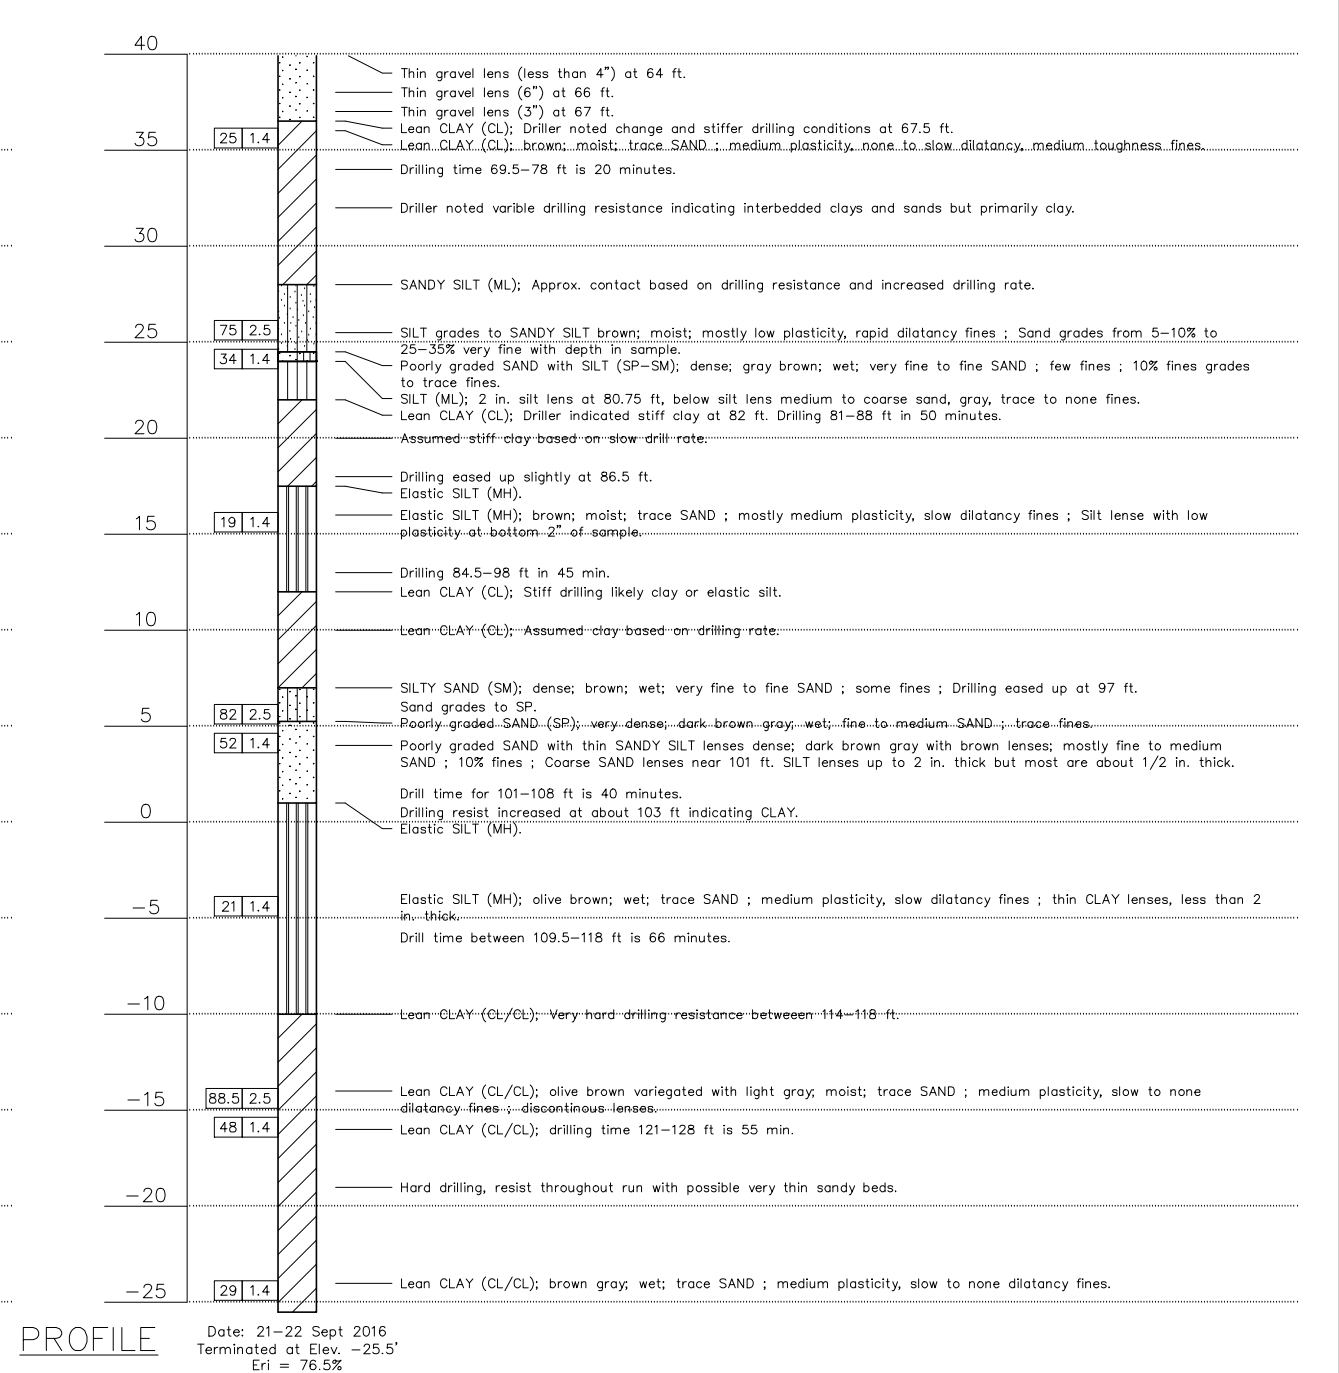
NO.	DESCRIPTION	APPROVED BY	DATE

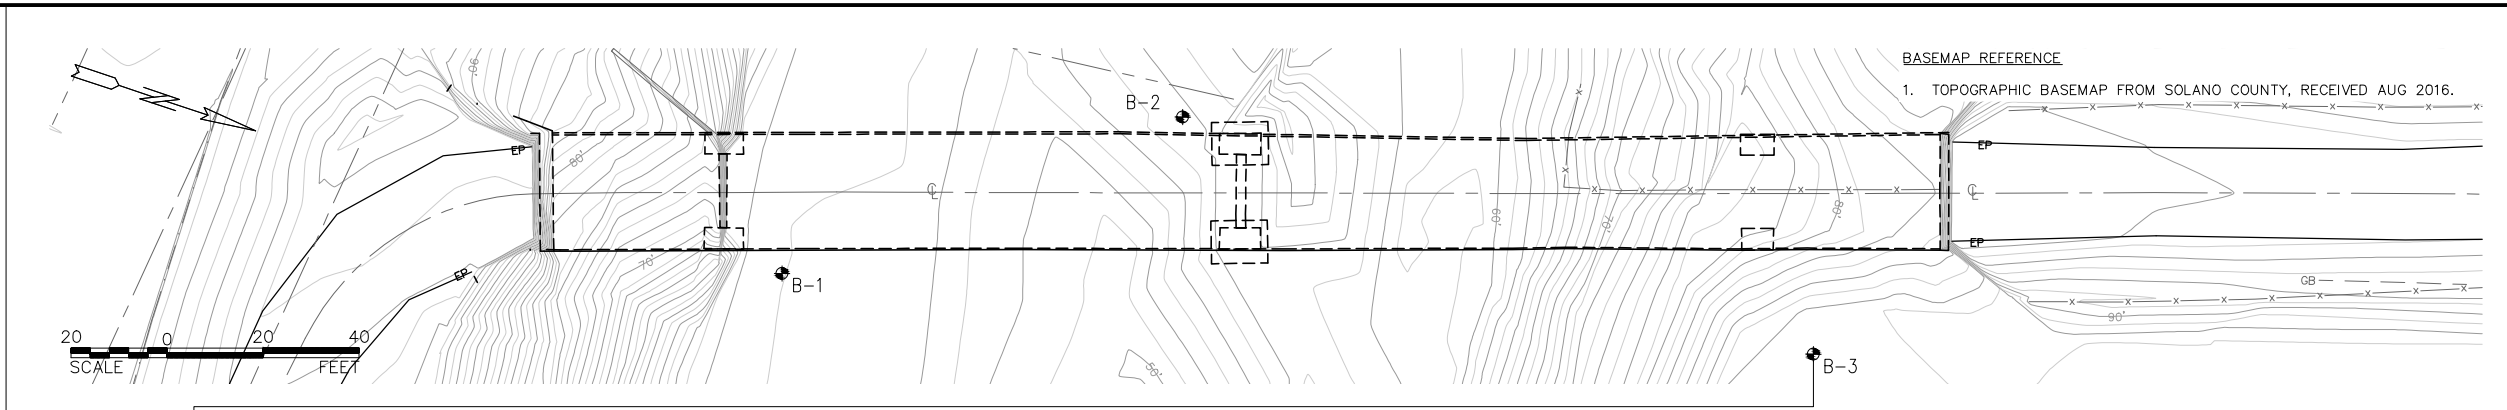
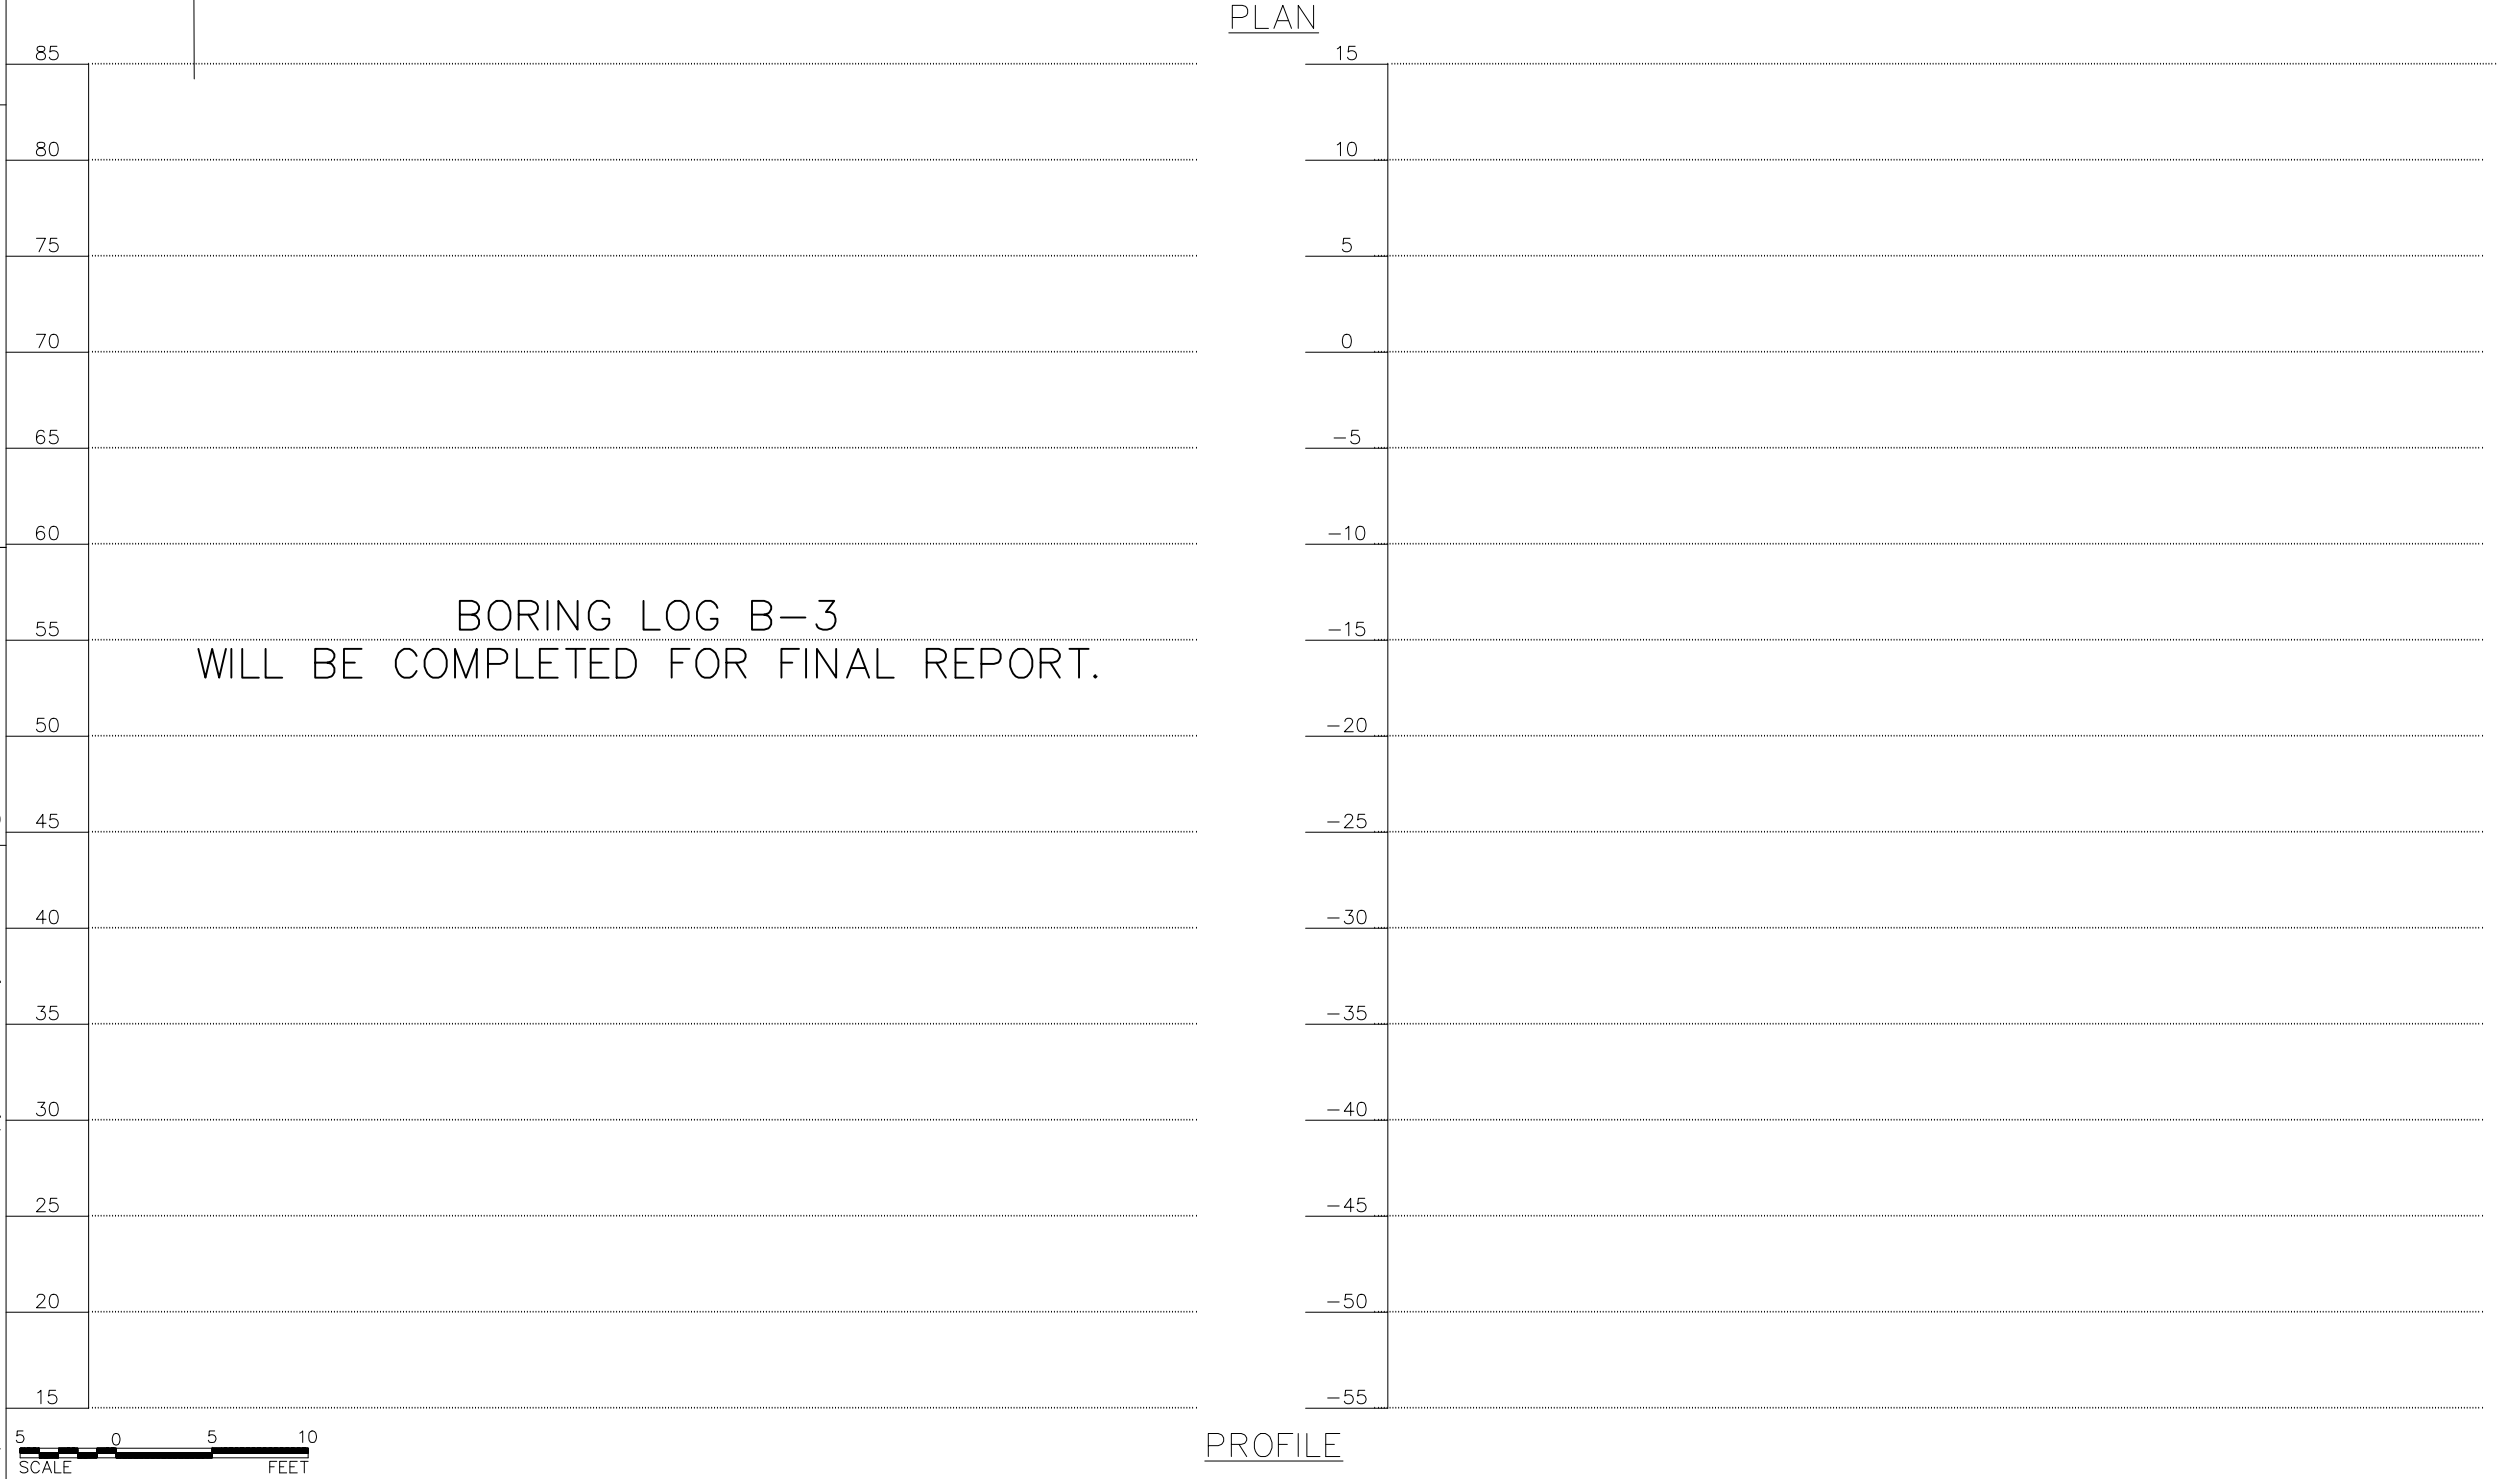
NO.	DESCRIPTION	APPROVED BY	DATE	FIELD BOOK NO.	SCALE HORIZONTAL: AS NOTED VERTICAL: AS NOTED	DRAWN BY: SUBMITTED	CHECKED BY: R.C.E. No.	SOLANO COUNTY TRANSPORTATION DEPARTMENT 333 SUNSET AVE. SUITE 230 SUISUN CITY CA 94585 TEL: (707) 421-6069 FAX: (707) 429-2894	APPROVED BY: DATE:	STEVENSON ROAD BRIDGE LOG OF TEST BORINGS B-3	DATE 10/31/16 SHEET 3 OF 3 DWG
-----	-------------	-------------	------	----------------	---	------------------------	---------------------------	--	-----------------------	---	---

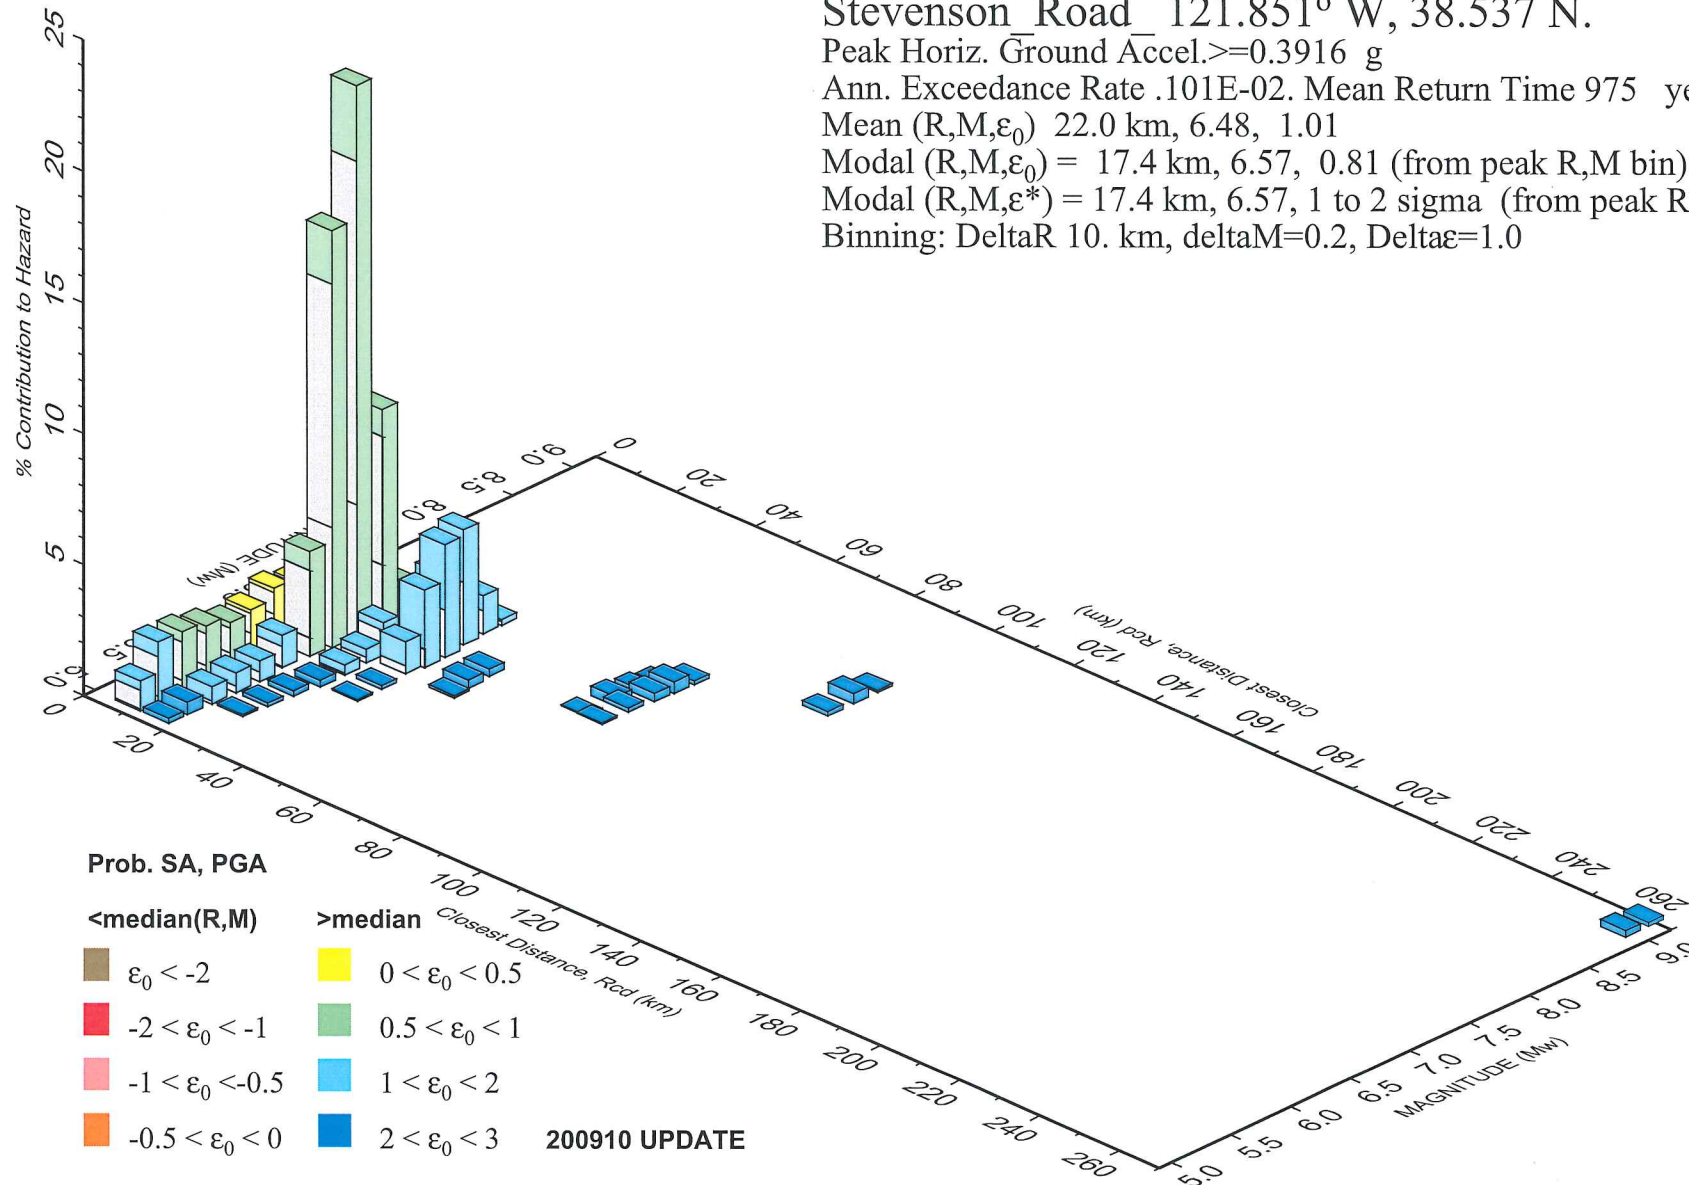
Binning: DeltaR 10. km, deltaM=0.2, Delta $\epsilon$ =1.0

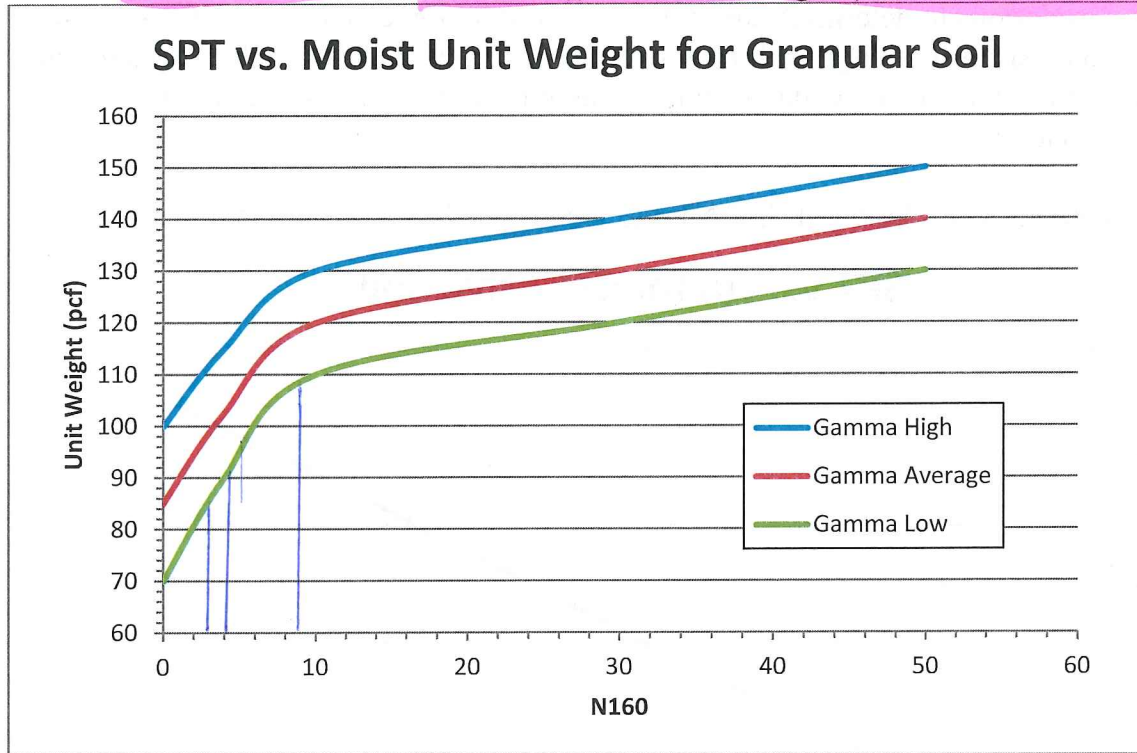
Choose the unit weight expressed to the nearest five pcf for the soil type based on the following guidelines:

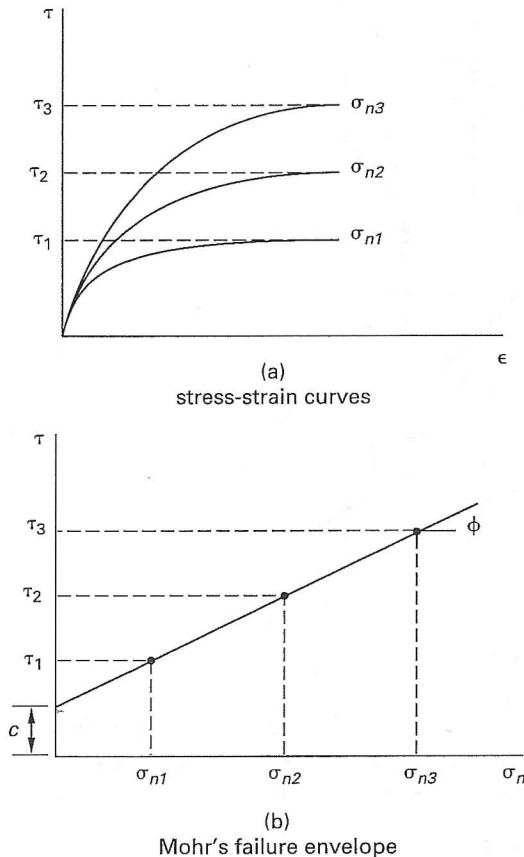
Figure 35.13 Graphing Direct-Shear Test Results

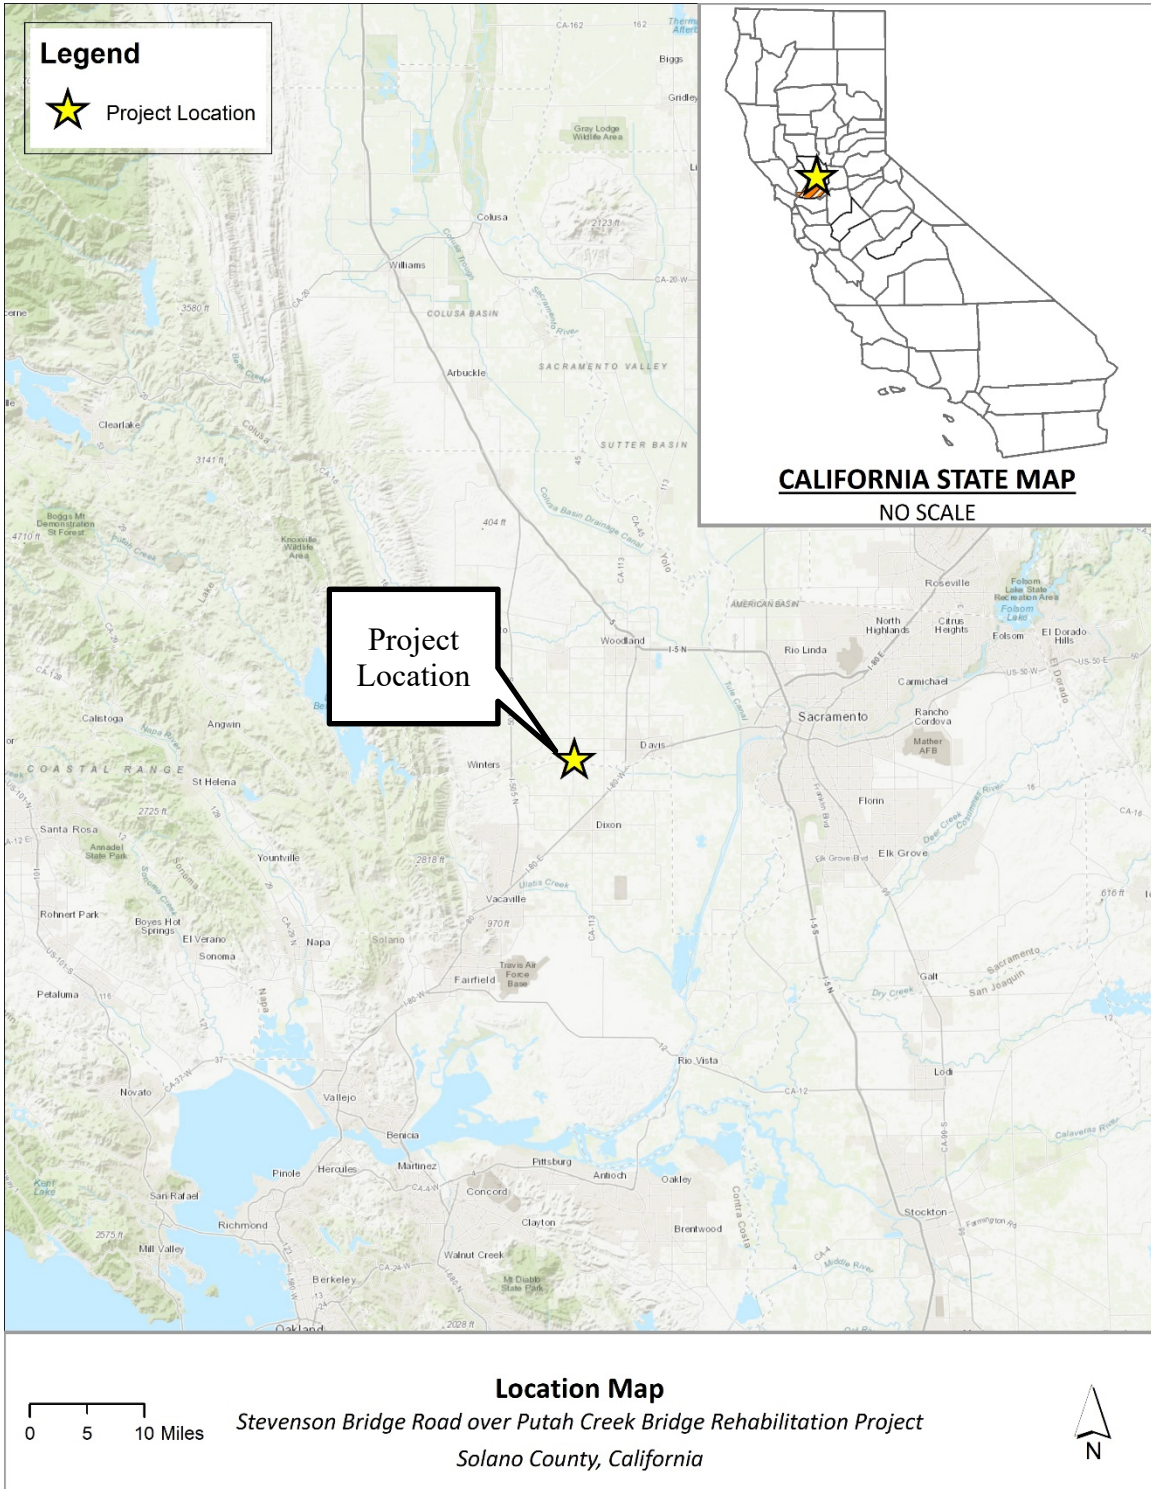
**Figure 1. Project Location Map**

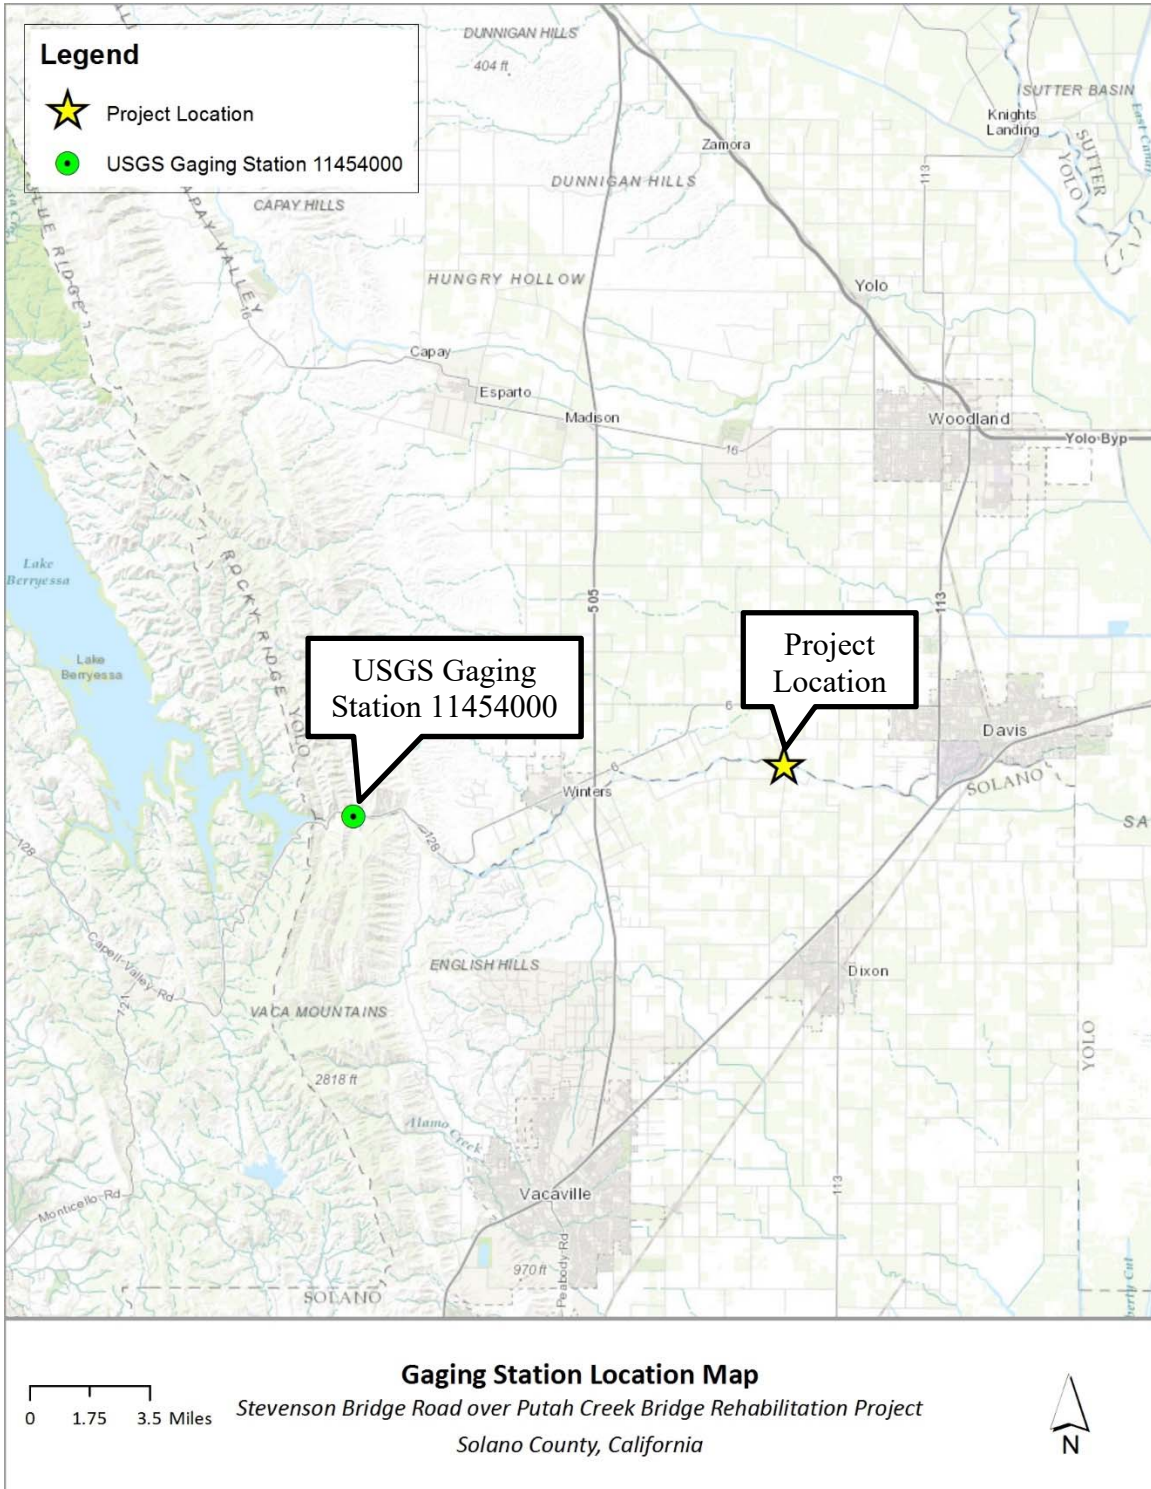
Figure 6. Gaging Station Location Map

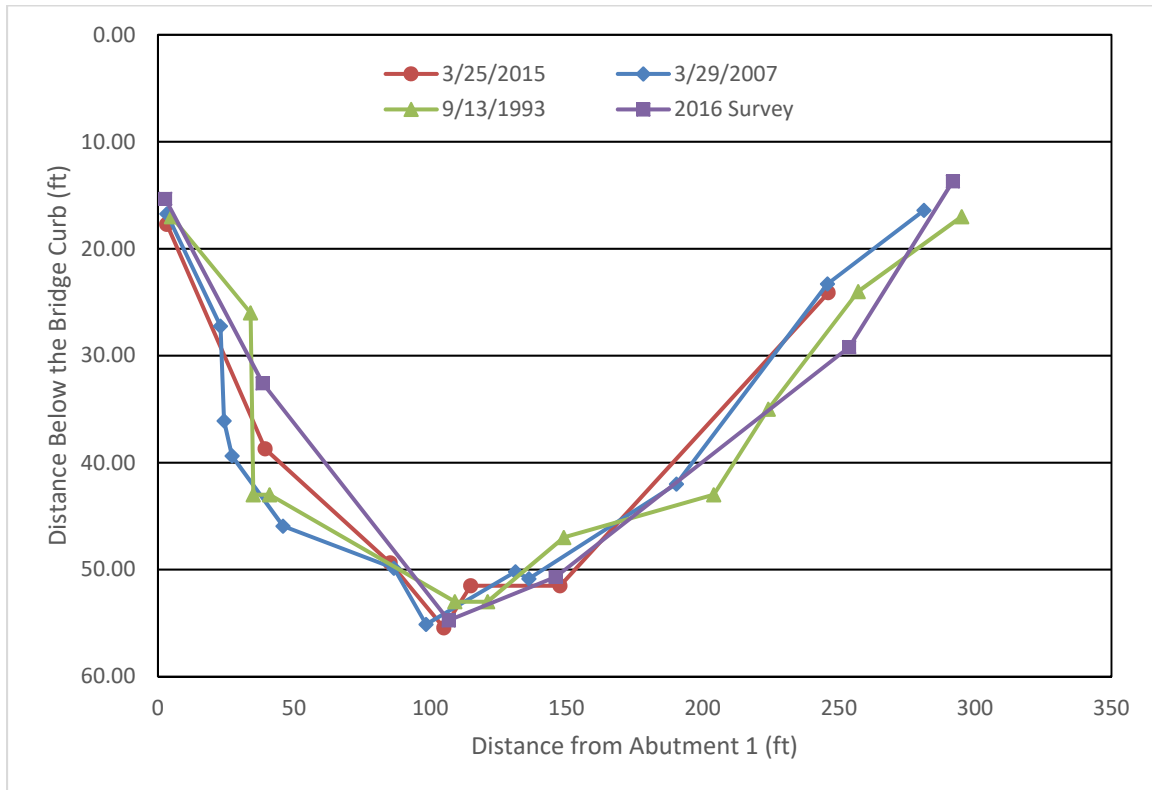
Figure 12. Historical Stream Measurements

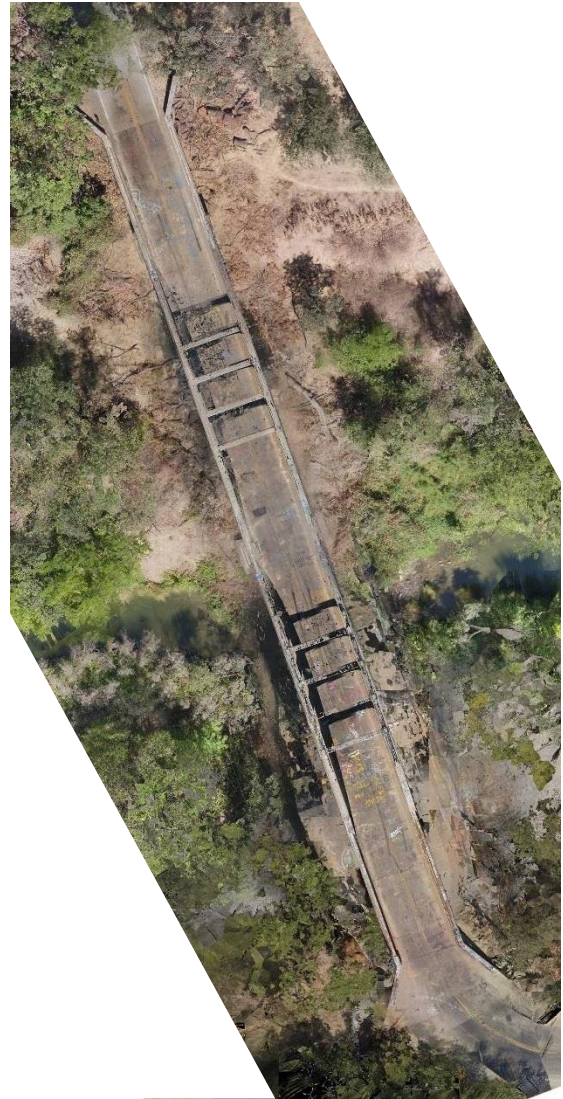
Figure 1 - Overhead view of Stevenson Bridge and surrounding area taken with unmanned aircraft system

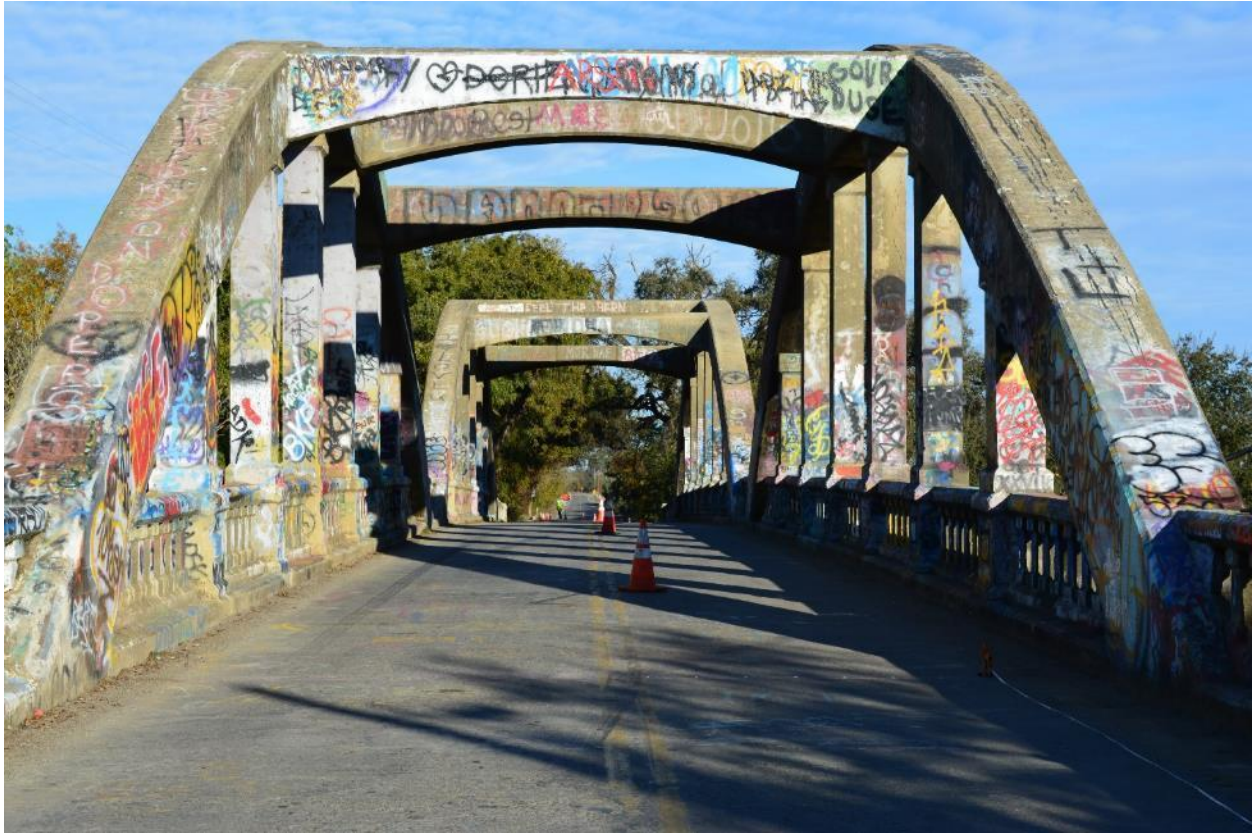
Figure 2 - Street view of Stevenson Bridge

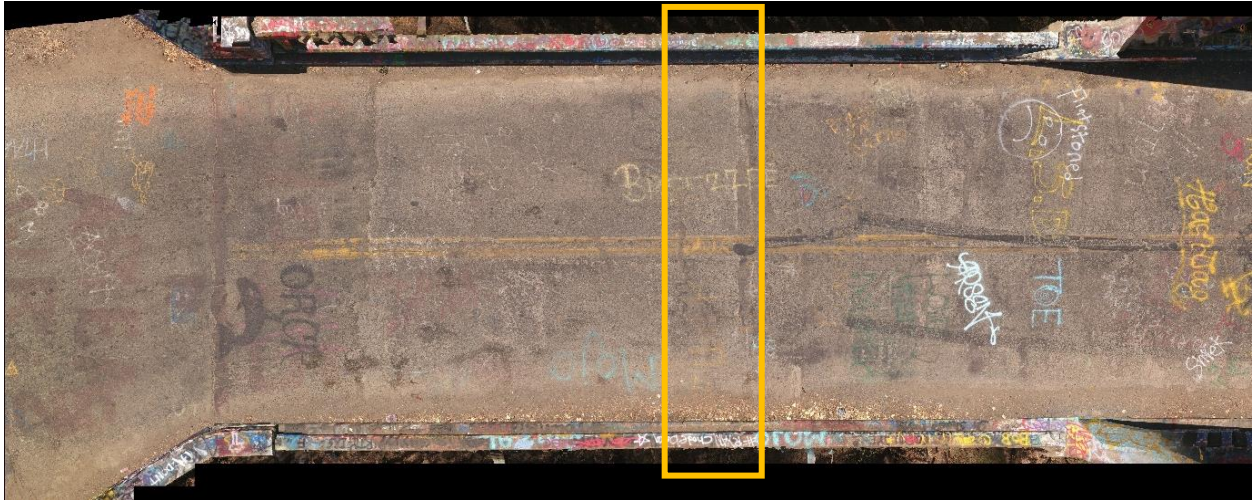
Figure 7 - Location of crack between Abutment 1 and Pier 2 as shown through UAS image

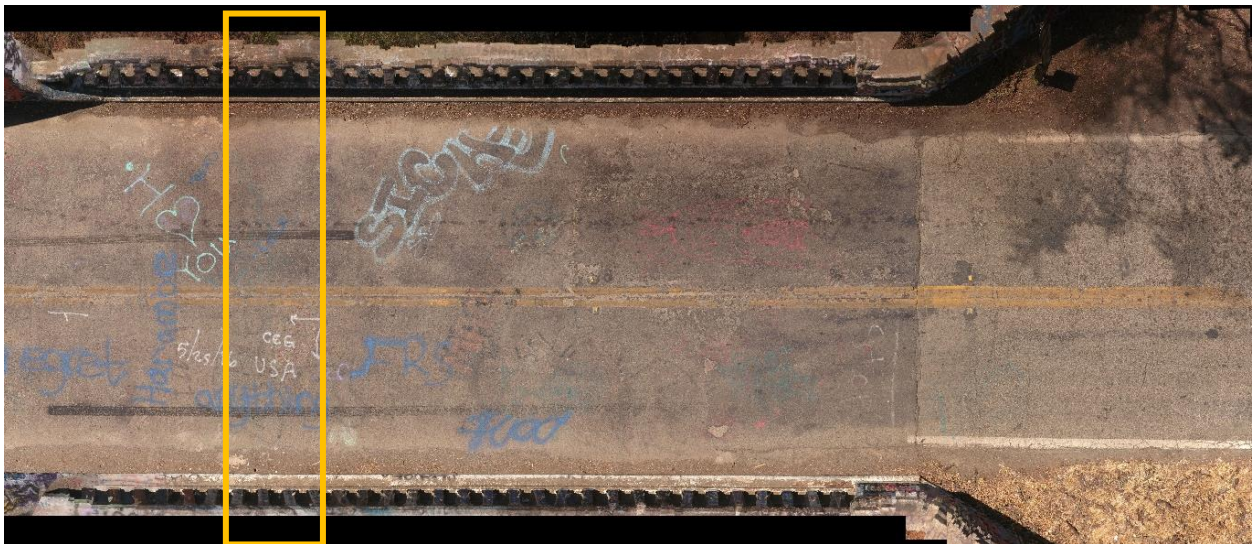
Figure 8 - Location of crack between Pier 4 and Abutment 5 as shown through UAS image

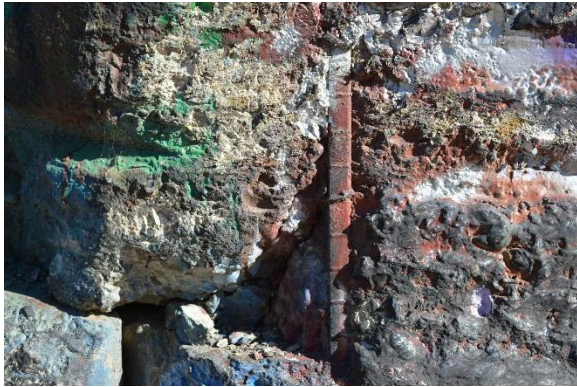
*Figure 9 - Exposed rebar at east Abutment 1 railing*

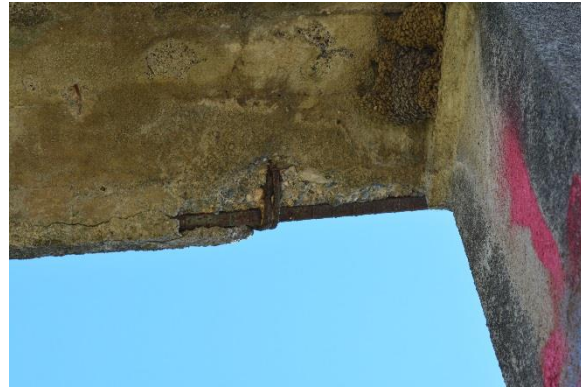
*Figure 10 - Spalled overhead section of arch*

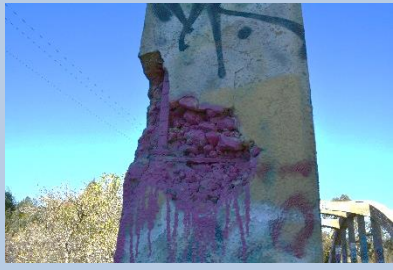
<p>Hanger 5 West (Repair area: 6 sq.ft.) Exposed reinforcement, heavy spalling, and visible aggregate. <i>Remove unsound material and bond inhibiting substances. Clean rebar and patch. Fiber wrap at this location if loss of cross section for reinforcement is discovered, or if seismic calculations require additional capacity.</i></p>
	 	<p>Hanger 11 East (Repair area: 6 sq.ft.) Heavy spalling, cracking, unsound concrete. <i>Remove all unsound material, clean rebar and patch. Fiber wrap at this location if loss of cross section for reinforcement is discovered, or if seismic calculations require additional capacity.</i></p>
Arches

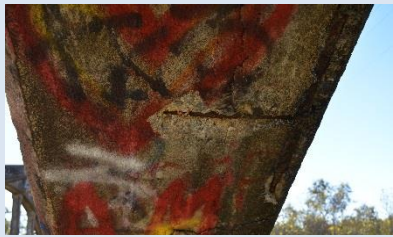
<p>West at Hanger 7 (Repair area: 4 sq.ft.) Exposed reinforcement under arch, cracking and spalling <i>Remove unsound concrete, clean rebar and patch. Fiber wrap at this location due to proximity to pier.</i></p>

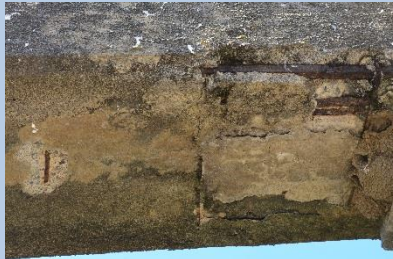
<p>West at Hanger 8 (Repair area: 6 sq.ft.) Exposed reinforcement under arch, cracking, heavy spalling, loose material. <i>Remove all unsound material, clean rebar and patch. Fiber wrap at this location if loss of cross section for reinforcement is discovered, or if seismic calculations require additional capacity.</i></p>

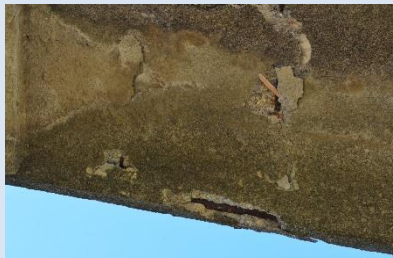
<p>West at Hanger 11 (Repair area: 4 sq.ft.) Exposed reinforcement, cracking, some spalling, possible loose material <i>Remove unsound concrete, clean rebar and patch.</i></p>

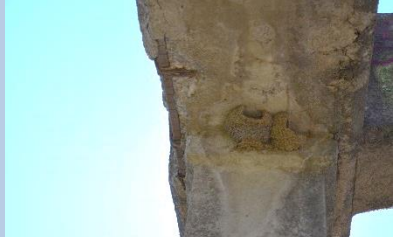
<p>East at Hanger 11 (Repair area: 6 sq.ft.) Exposed reinforcement, cracking, spalling, loose material. <i>Fiber wrap at this location if loss of cross section for reinforcement is discovered, or if seismic calculations require additional capacity.</i></p>

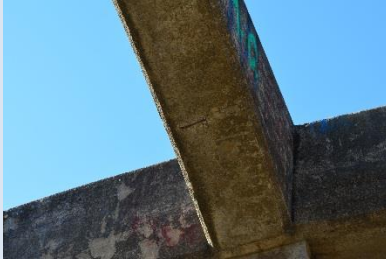
<p>Bracing at Hanger 2 (Repair area: 2 sq.ft.)                      Exposed reinforcement and spalling  <i>Remove unsound concrete, clean rebar and patch.                      Use fiber wrap or wire reinforcement to secure overhead patch material from falling.</i></p>

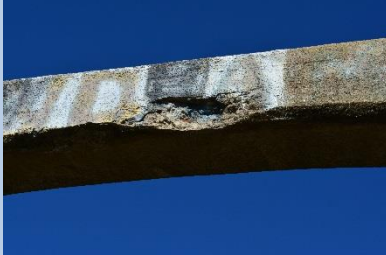
<p>Portal Bracing at Hanger 8: (Repair area: 3 sq.ft.)                      Corner spalling, cracking, exposed reinforcement.  <i>Remove unsound concrete, clean rebar and patch.                      Use fiber wrap or wire reinforcement to secure overhead patch material from falling.</i></p>
Railing

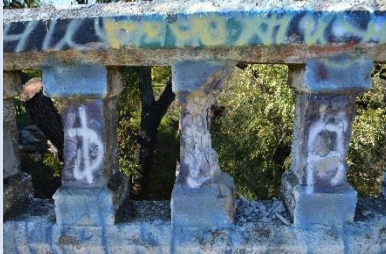
<p>Between Abutment 1/Pier 2 (Repair area: lumpsum)                      Spalled railing posts, exposed reinforcement.  <i>Remove unsound material, clean surface and patch. If majority of section is damaged, individual posts should be replaced in kind.</i></p>

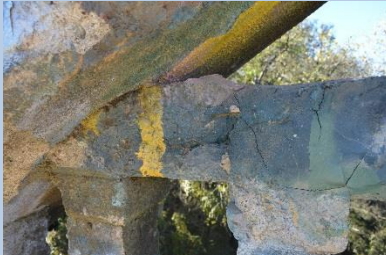
<p>At Arch 1 West (Repair area: lumpsum)                      Cracking at what appears to be patched area.  <i>Remove unsound material, clean surface and patch.</i></p>

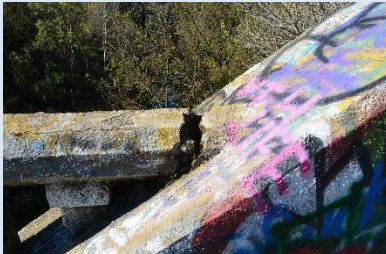
<p>At Arch 3 west (Repair area: lumpsum)                      Crack and void between railing and arch.  <i>Remove unsound material, clean surface and patch.</i></p>

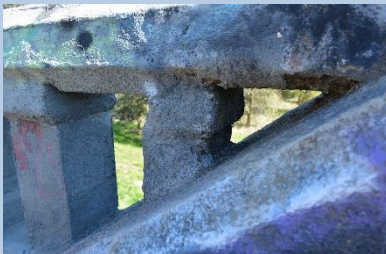
<p>At Arch 4 East (Repair area: lumpsum)                      Appears to be an uneven repair area.  <i>Remove unsound or uneven material, clean surface and patch.</i></p>
