# Project Report

**Putah Creek Bridge Rehabilitation at Stevenson Bridge Road  
Federal Project No. BRLS 5923(059)  
Bridge No. 23C0092**

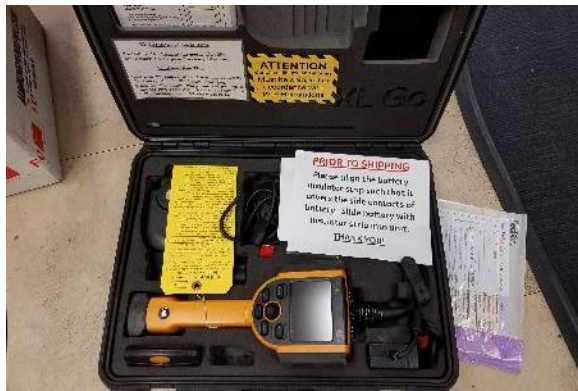
Figure 11 - Borescope equipment used for field inspection

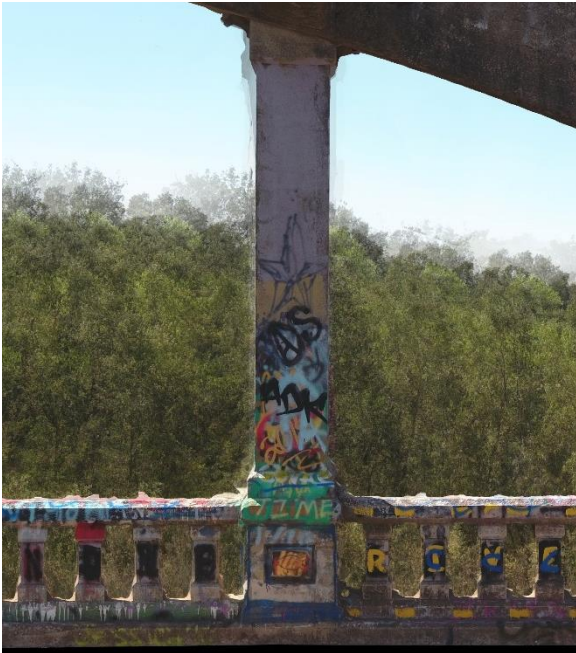
Figure 13 - Hanger 5 West borescope location

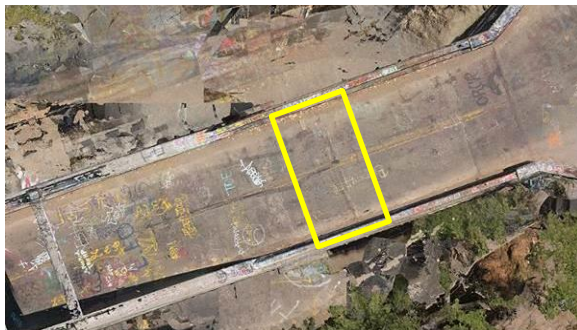
Figure 16 – GPR scan area at Abutment 1/Pier 2

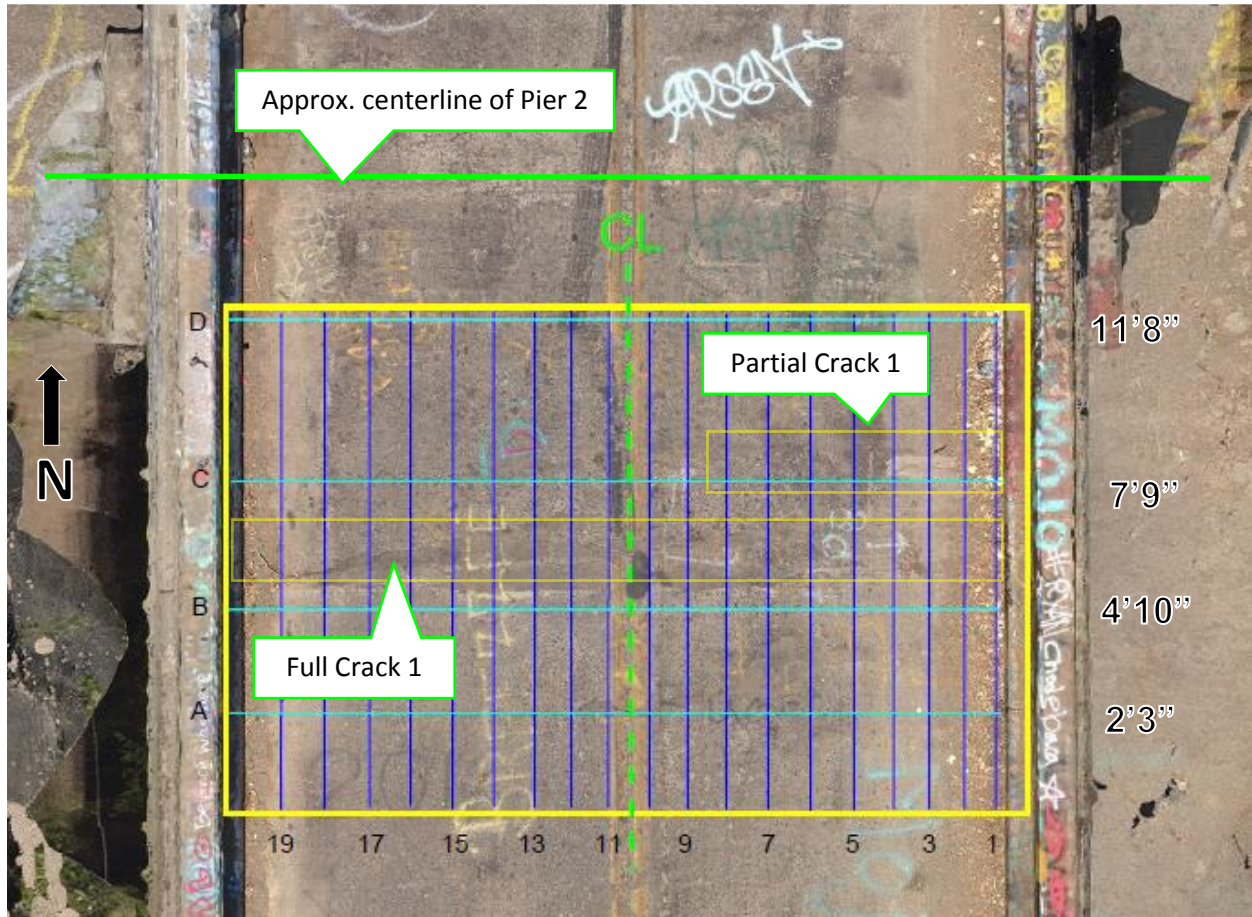
Figure 20 - Approximate GPR scan lines at Abutment 1/Pier 2 bridge deck

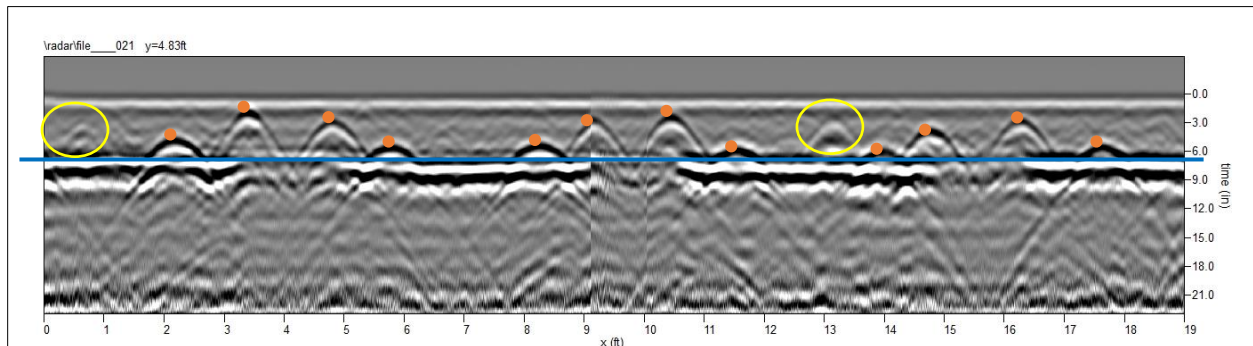
Figure 21 - Transverse scan at Abutment 1, Line B. Anomalies are circled.

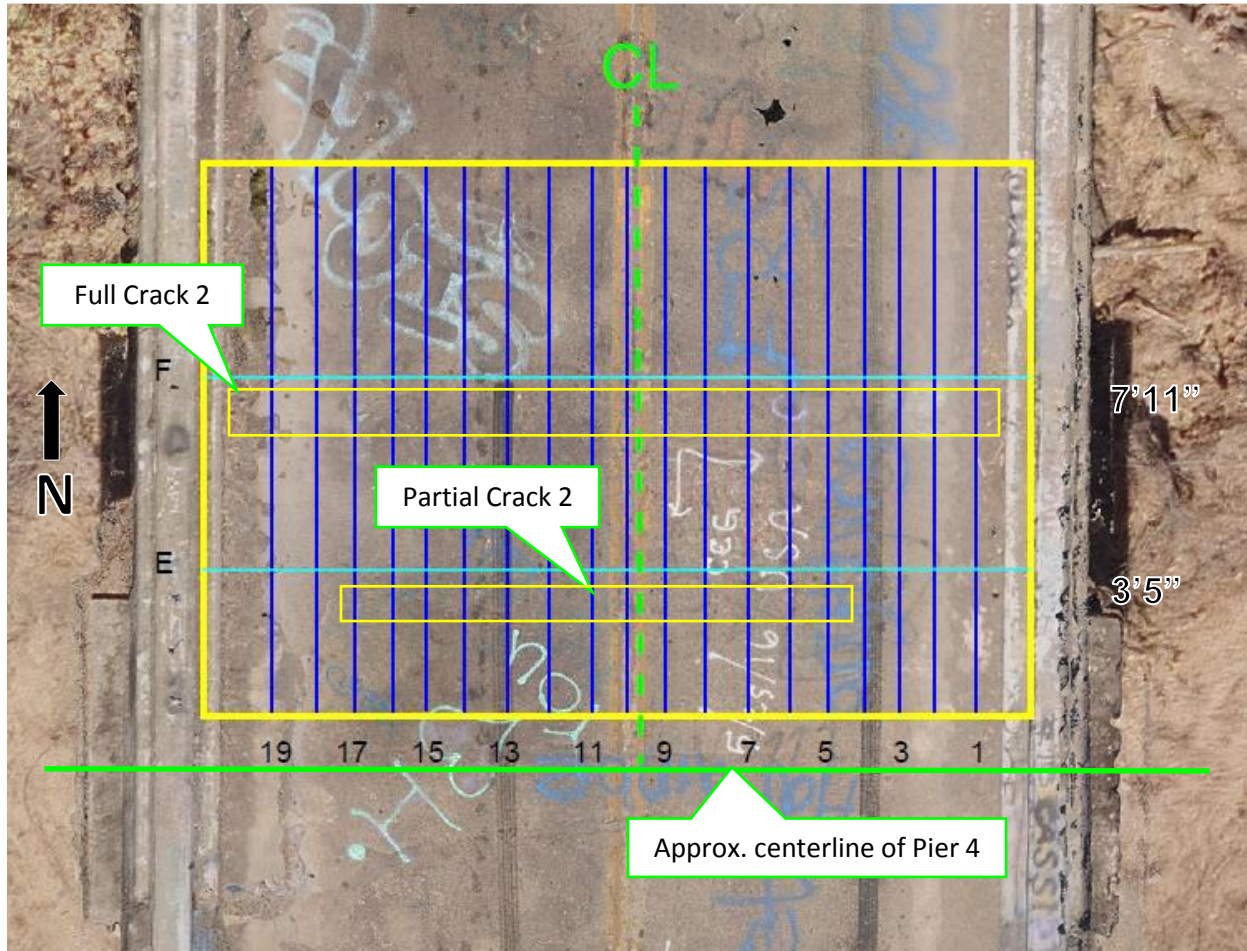
Figure 22 - Approximate GPR scan lines at Pier 4/Abutment 5 bridge deck

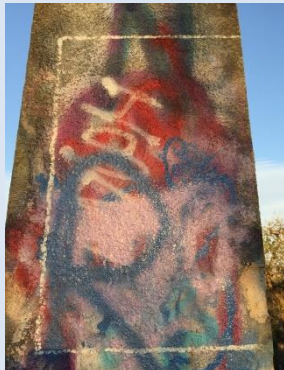
GPR Location	Observations
Hanger 5 West (SB side) <i>See Fig 25 and 27</i>	<ul style="list-style-type: none"> <li>● Location selected based on heavy spalling on column</li> <li>● 12" W x 24" H with 2" scan spacing</li> <li>● First rebar layer ~3" deep. Second rebar layer ~8" deep.</li> <li>● Possible, hard to see material variation at ~8" deep which coincides with depth of lower reinforcement layer.</li> </ul>

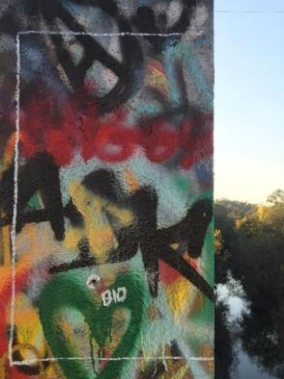
Arch 2 East at Spring Line (NB) <i>See Fig 28 and 30</i>	<ul style="list-style-type: none"> <li>● 24"x24" with 2" scan spacing</li> <li>● First rebar layer ~2" deep. Second rebar layer ~4" deep.</li> <li>● Possible material variation at ~8.2" deep with another material variation layer at ~14.3" deep.</li> </ul>

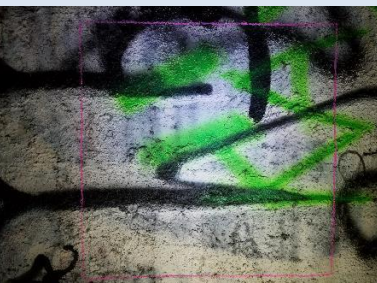
Based on review of the processed data for each of the locations, it appears there are no major defects observed in the areas inspected. While slight material variation are identified at all locations, this may be due primarily to slight differences in physical properties in the material. For example, at Arch 3 West a vague material variation was detected about 9.2" deep. At this same location a concrete core over 10" long was extracted that did not show any obvious interface at that depth. Based on GPR observations noted for the areas above, no additional repairs are recommended.

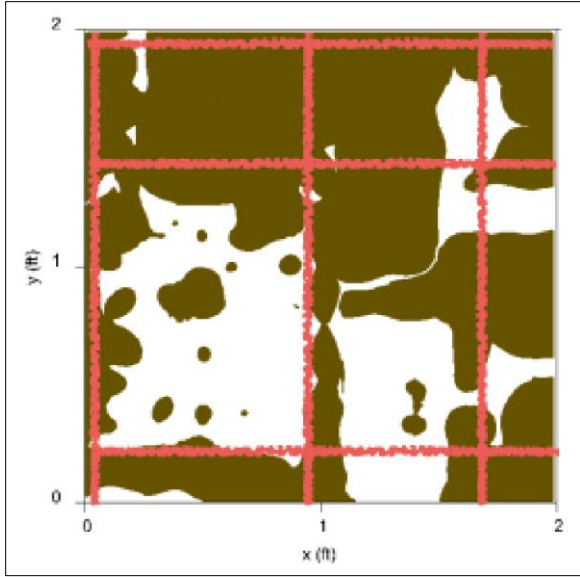
Figure 24 – Hanger 11 East

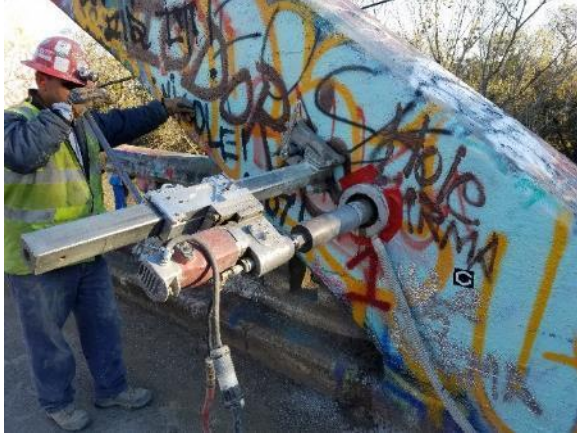
Figure 33 - Arch 1 East (Core 1B)

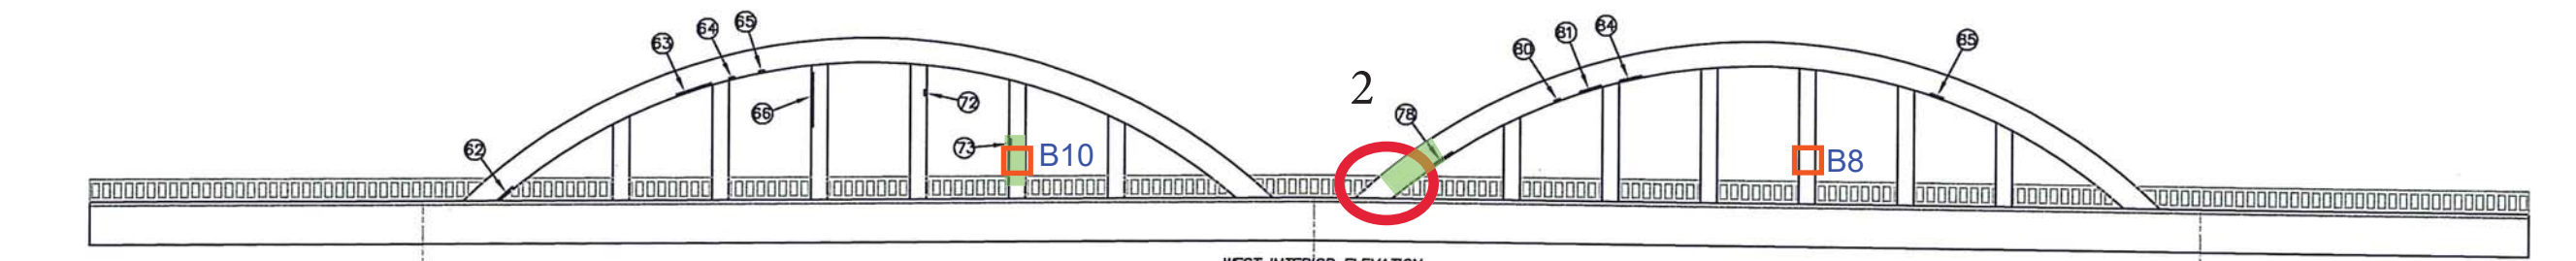
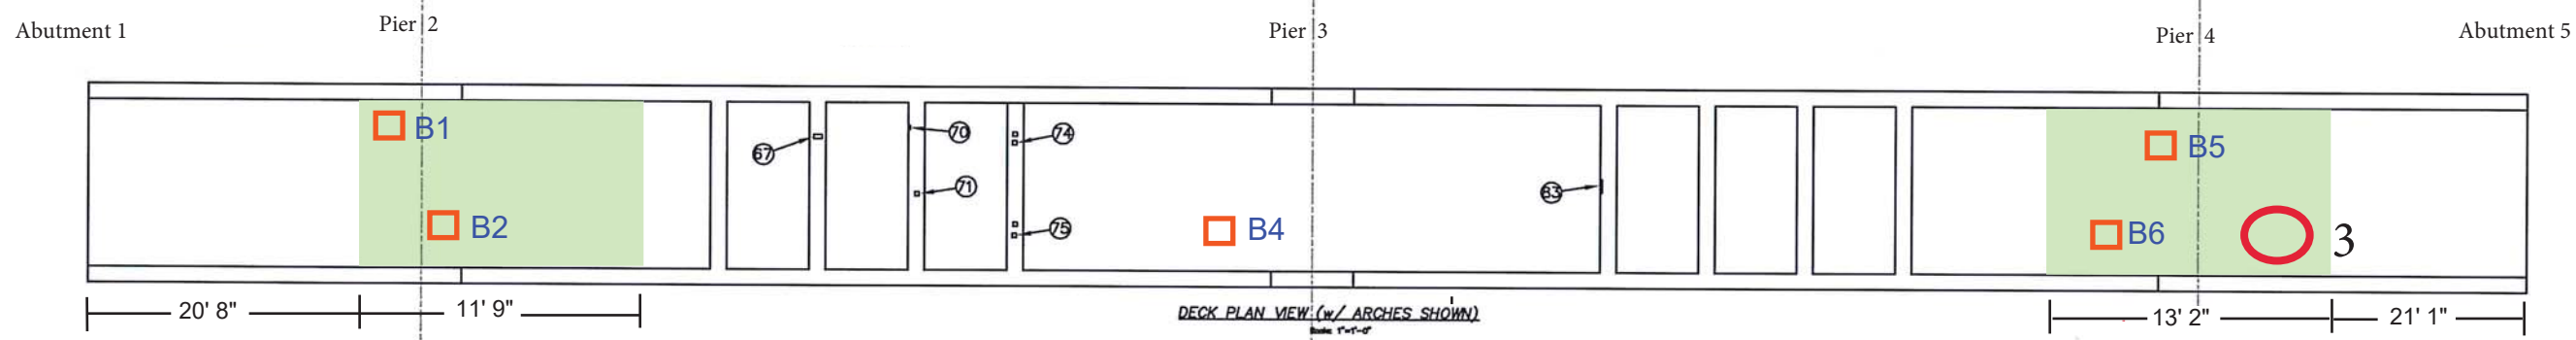
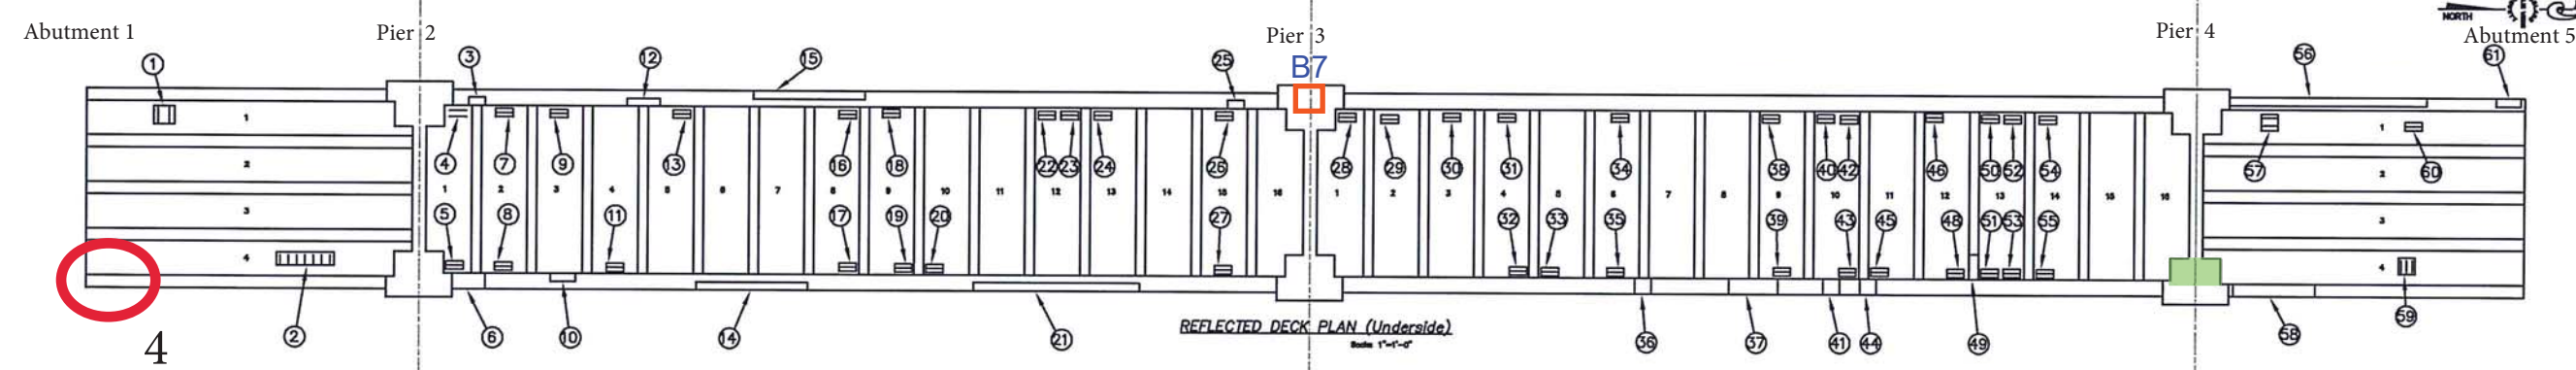
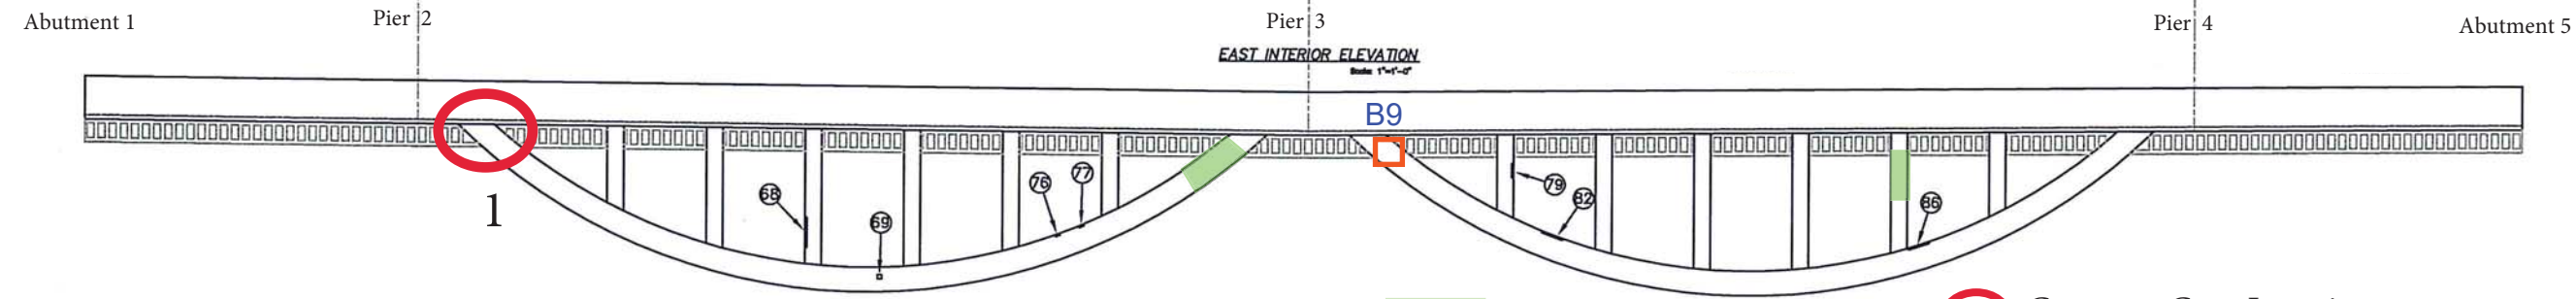
- GPR Scanning Location
- Borescope Location
- Concrete Core Locations:
  1. In the arch near the spring line
  2. In the arch near the spring line
  3. In the deck at the major crack location
  4. In the west girder at Abutment 1

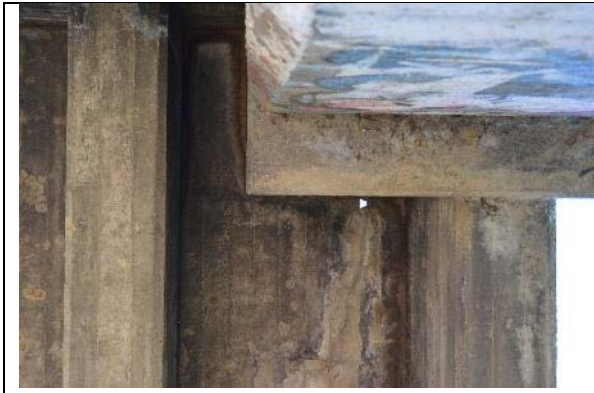
Figure 1 - Defect 100 (DSC\_0219)

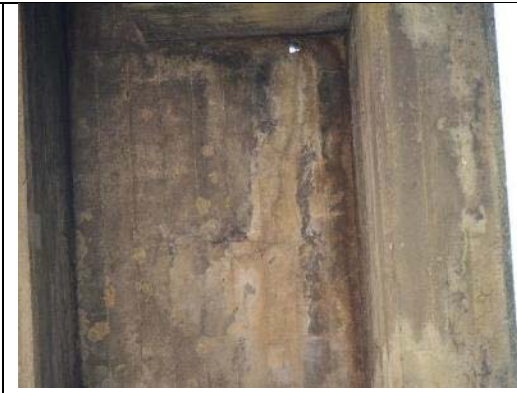
Figure 2 - Defect 101 (DSC\_0204)

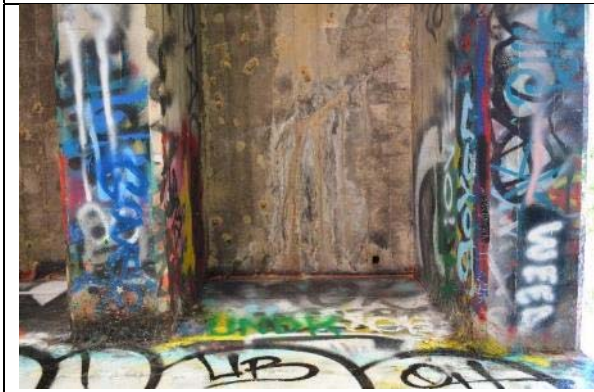
Figure 3 - Defect 102 (DSC\_0206)

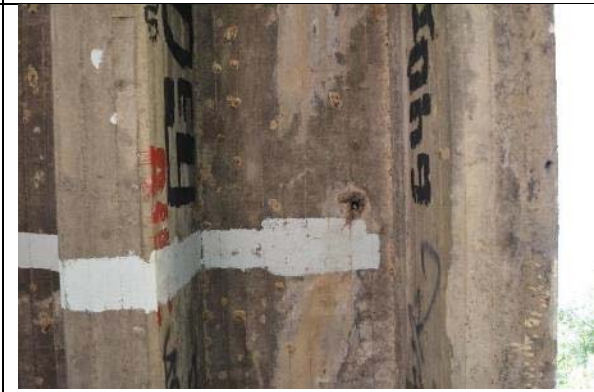
Figure 4 - Defect 103 (DSC\_0209)

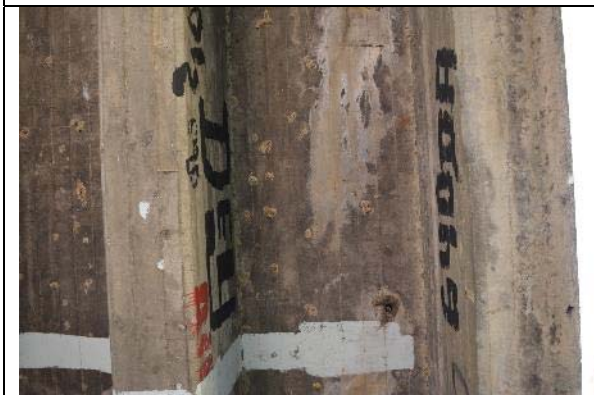
Figure 5 - Defect 104 (DSC\_0210)

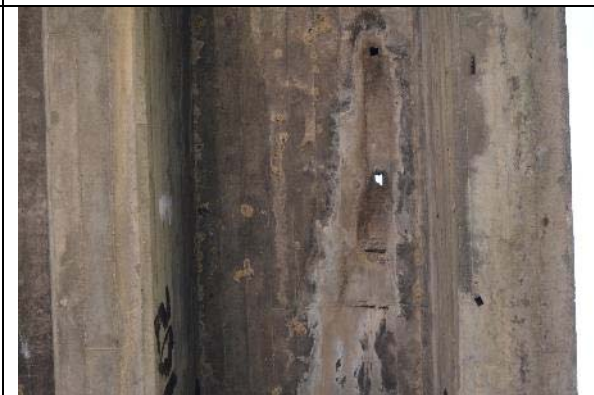
Figure 6 - Defect 105 (DSC\_0212)

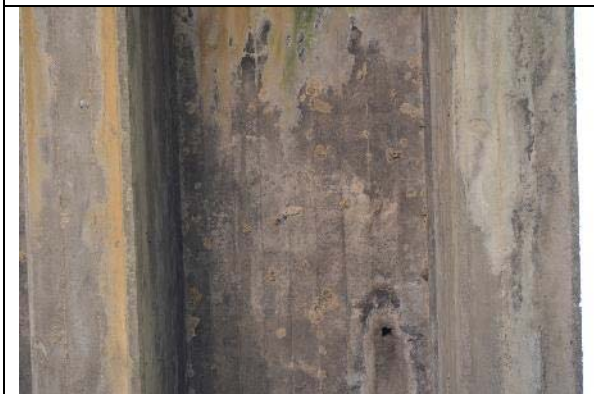
Figure 7 - Defect 106 (DSC\_0214)

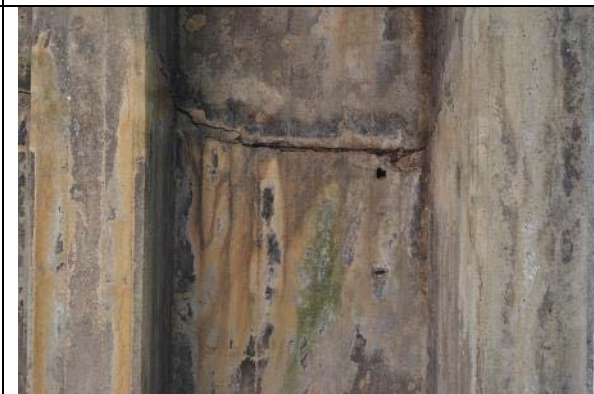
Figure 8 - Defect 107 (DSC\_0216)

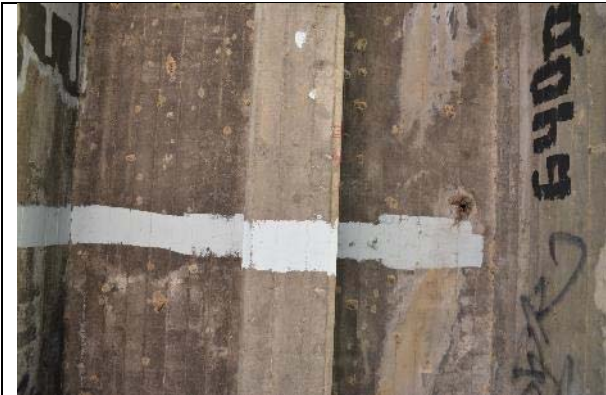
Figure 9 - Defect 108 (DSC\_0224)

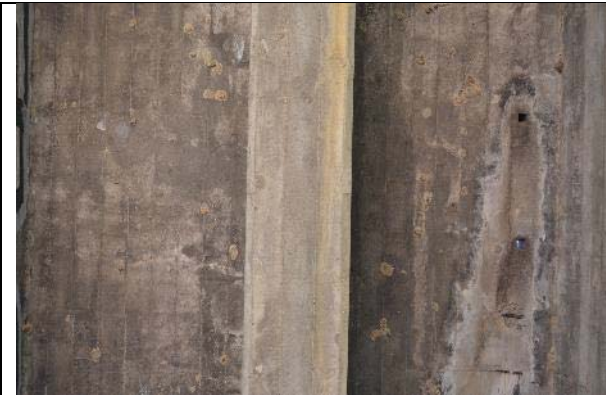
Figure 10 - Defect 109 (DSC\_0229)

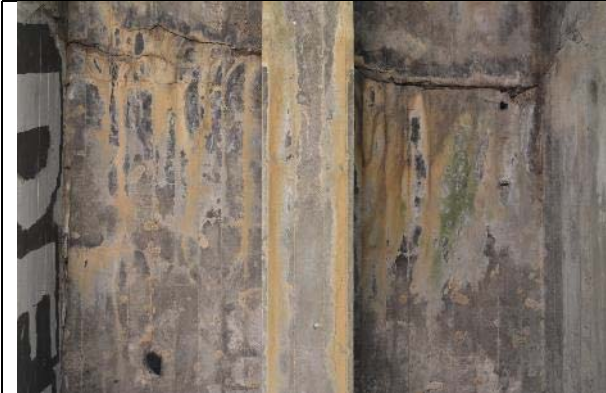
Figure 11 - Defect 110 (DSC\_0232)

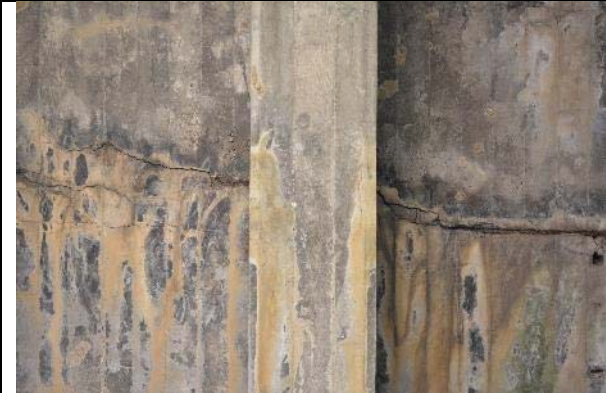
Figure 12 - Defect 111 (DSC\_0233)

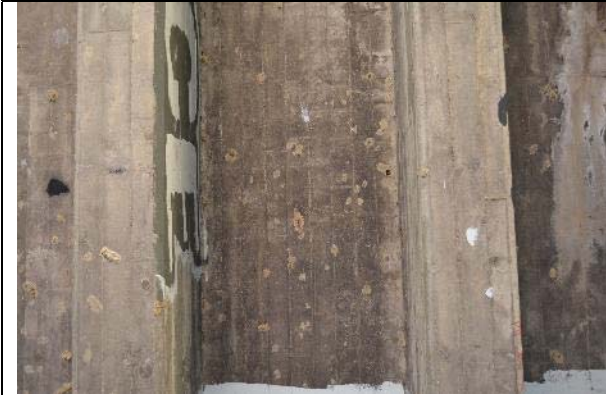
Figure 13 - Defect 112 (DSC\_0242)

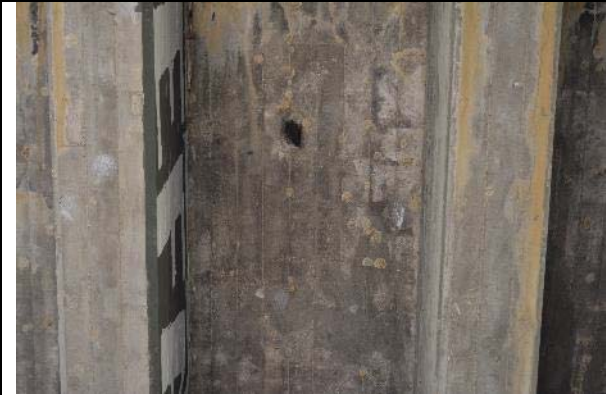
Figure 14 - Defect 113 (DSC\_0248)

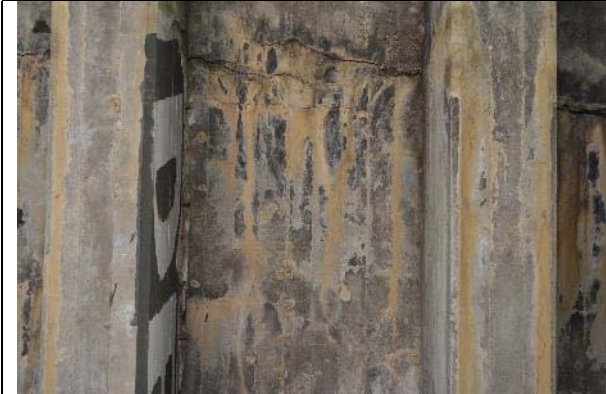
Figure 15 - Defect 114 (DSC\_0250)

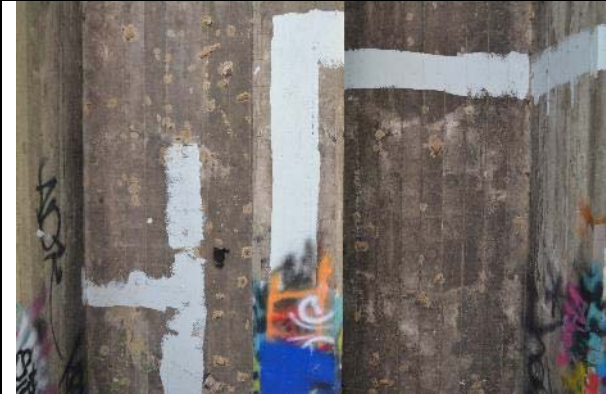
Figure 16 - Defect 115 (DSC\_0259)

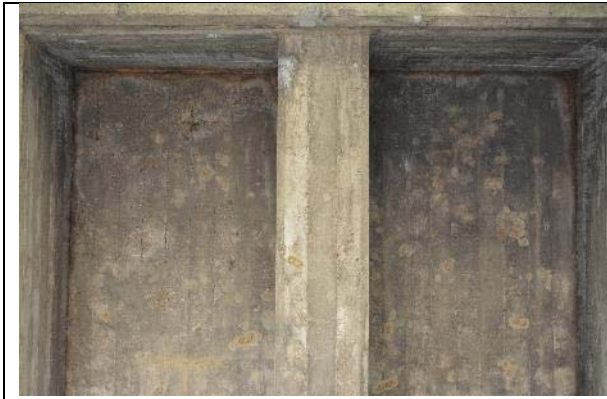
Figure 17 - Defect 116 (DSC\_0274)

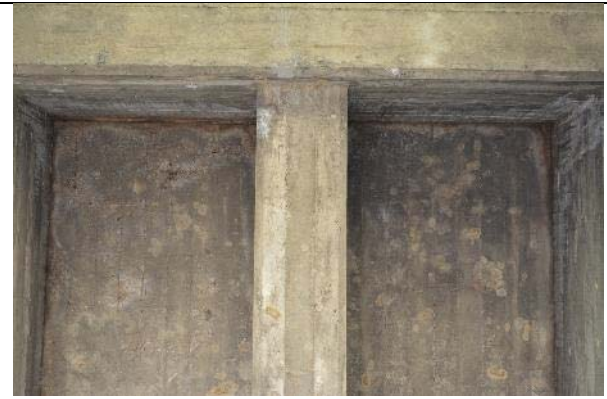
Figure 18 - Defect 117 (DSC\_0275)

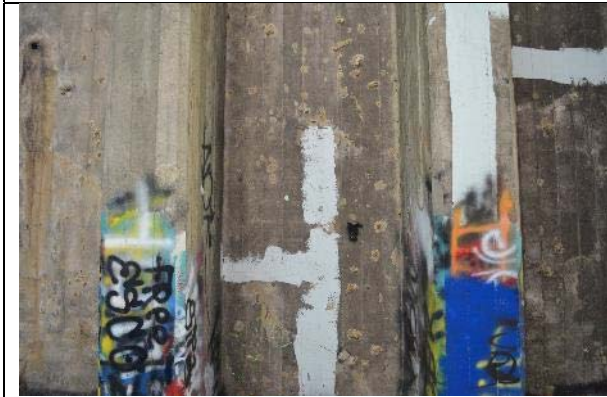
Figure 19 - Defect 118 (DSC\_0277)

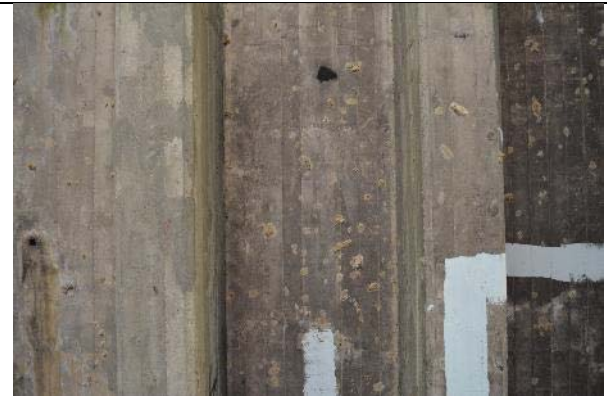
Figure 20 - Defect 119 (DSC\_0279)

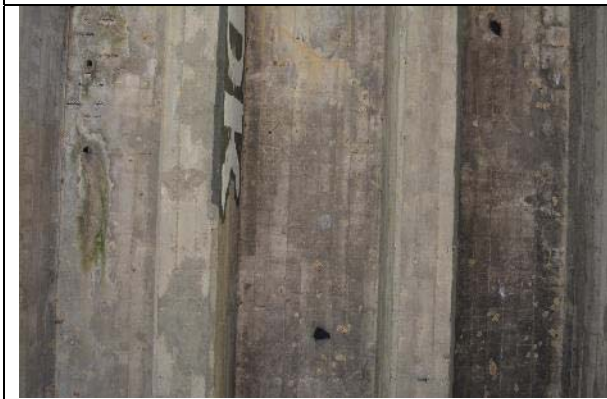
Figure 21 - Defect 120 (DSC\_0281)

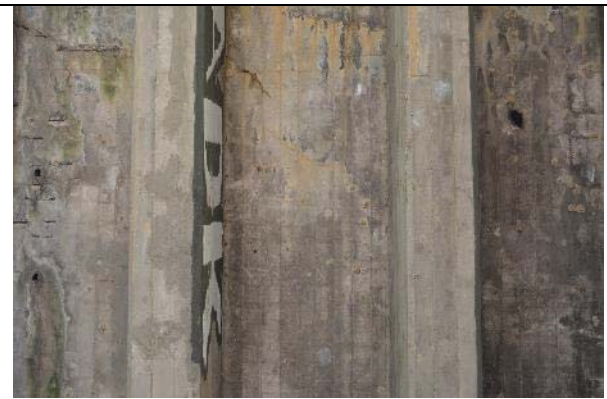
Figure 22 - Defect 121 (DSC\_0282)

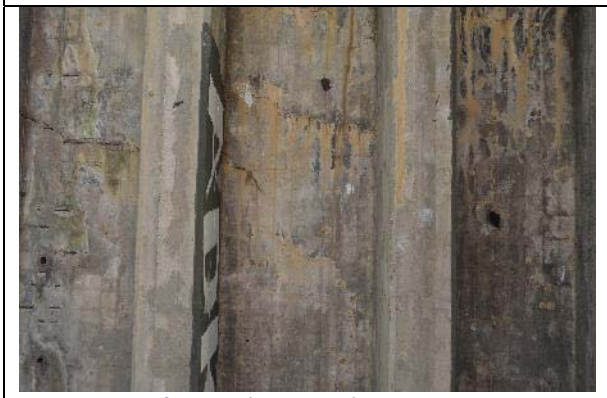
Figure 23 - Defect 122 (DSC\_0283)

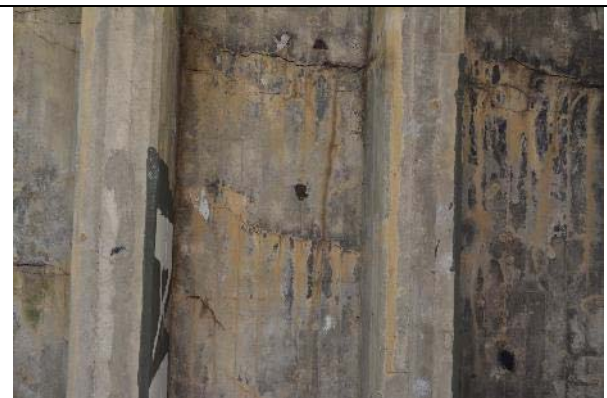
Figure 24 - Defect 123 (DSC\_0284)

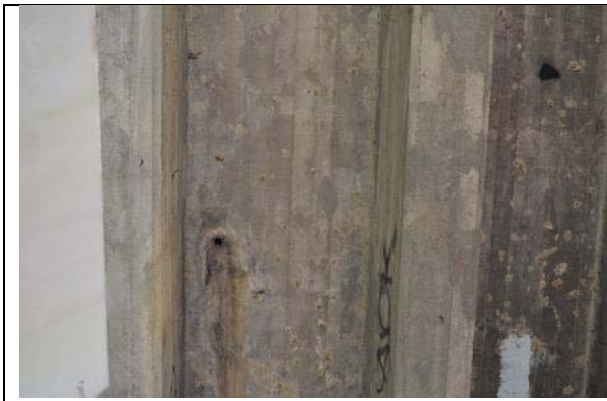
Figure 25 - Defect 124 (DSC\_0307)

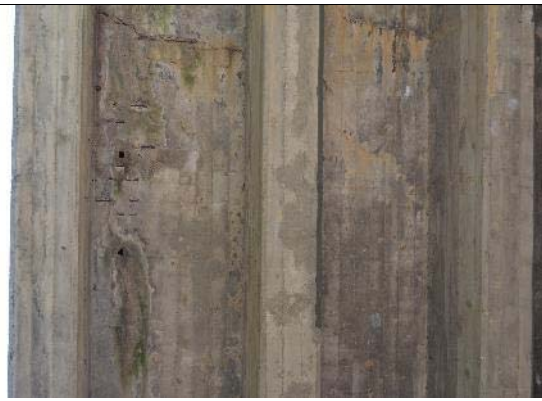
Figure 26 - Defect 125 (DSC\_0311)

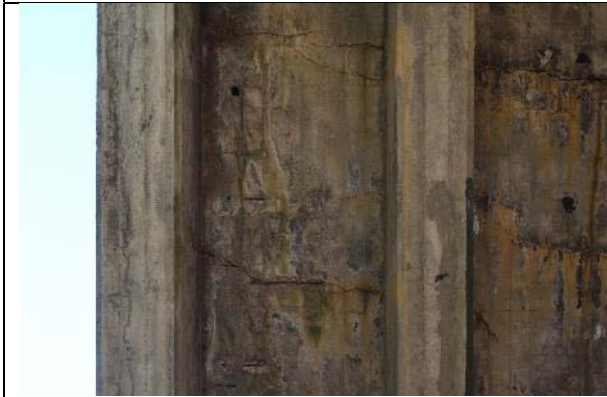
Figure 27 - Defect 126 (DSC\_0313)

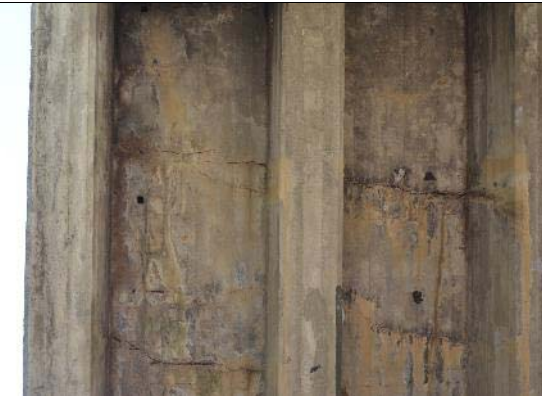
Figure 28 - Defect 127 (DSC\_0315)

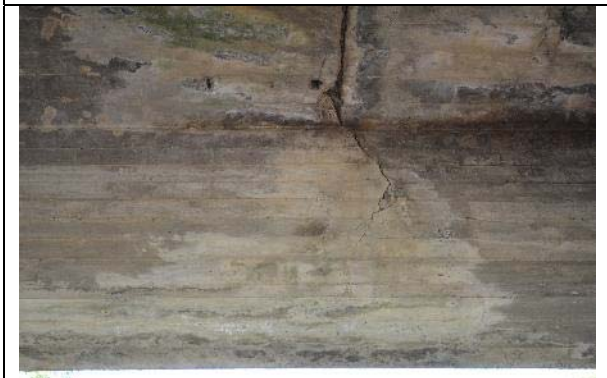
Figure 29 - Defect 128 (DSC\_319)

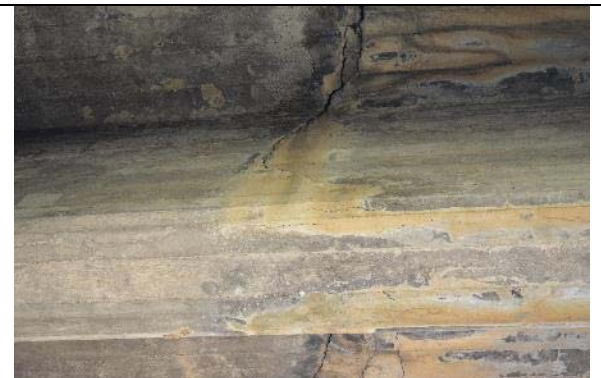
Figure 30 - Defect 129 (DSC\_320)

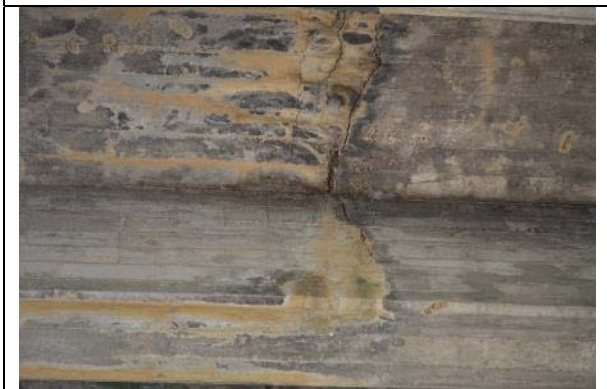
Figure 31 - Defect 130 (DSC\_321)

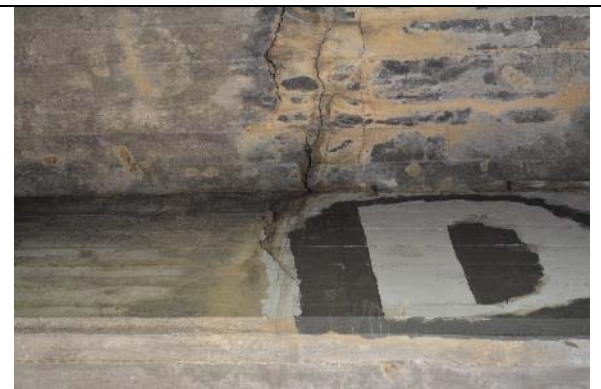
Figure 32 - Defect 131 (DSC\_322)

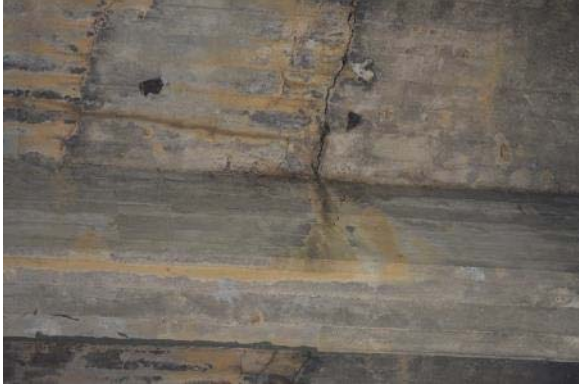
Figure 33 – Defect 132 (DSC\_323)

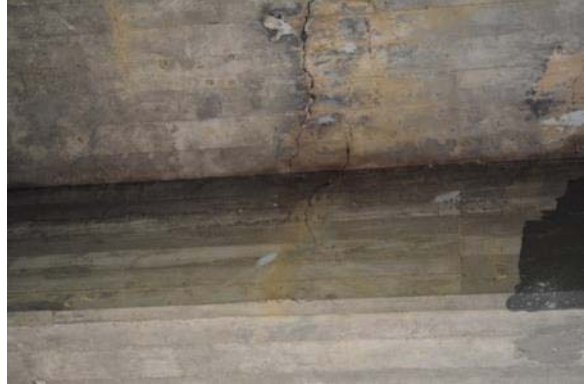
Figure 34 – Defect 133 (DSC\_324)

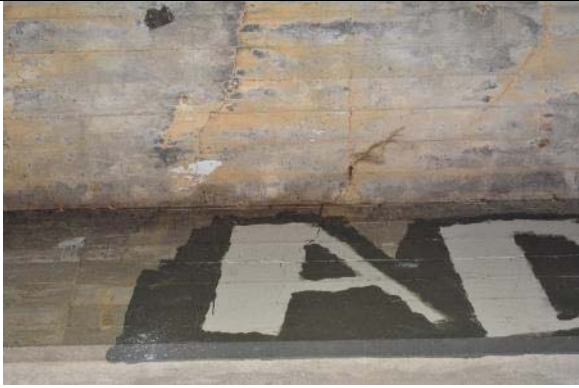
Figure 35 – Defect 134 (DSC\_325)

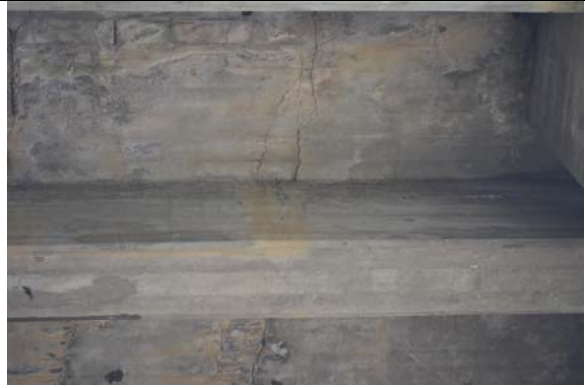
Figure 36 – Defect 135 (DSC\_326)

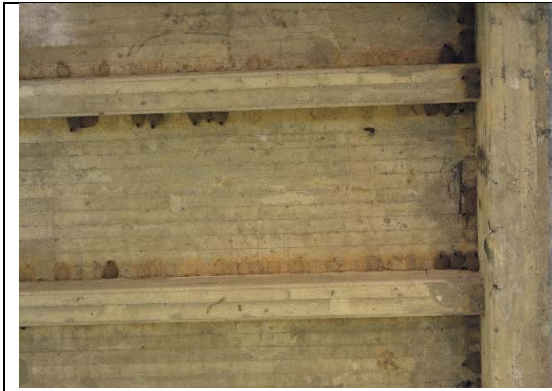
Figure 1 - Defect 201 (DSC\_444)

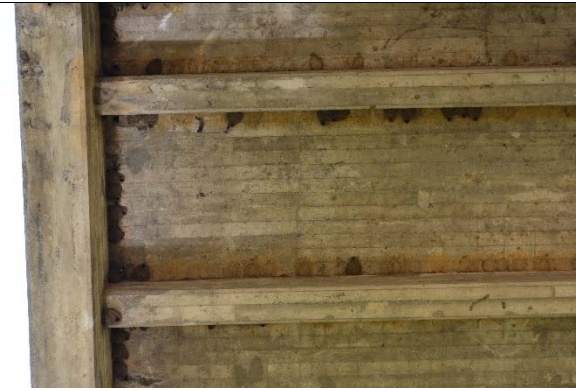
Figure 2 - Defect 202 (DSC\_445)

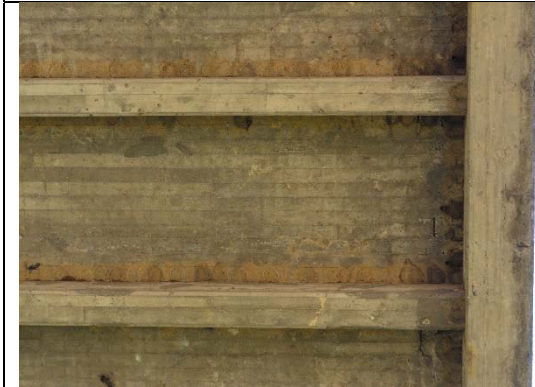
Figure 3 - Defect 203 (DSC\_448)

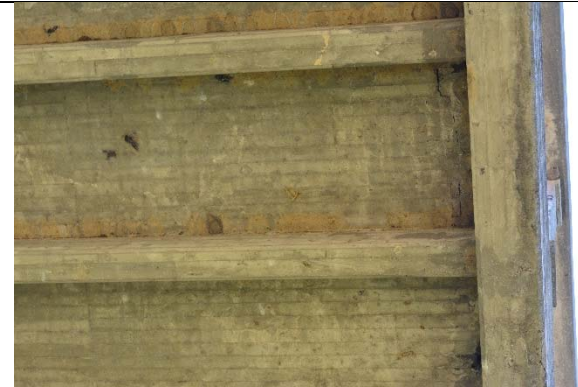
Figure 4 - Defect 204 (DSC\_452)

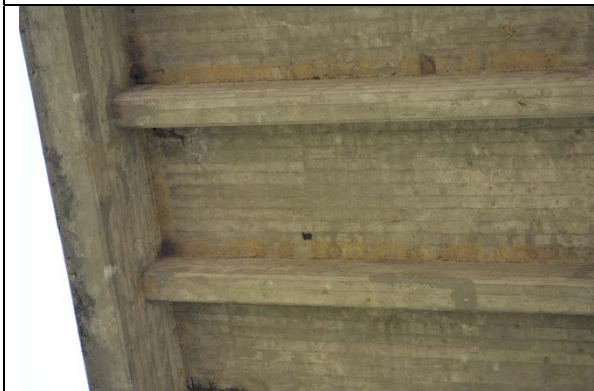
Figure 5 - Defect 205 (DSC\_454)

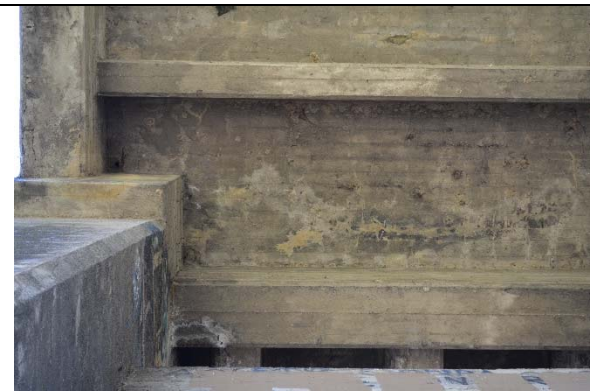
Figure 6 - Defect 206 (DSC\_458)

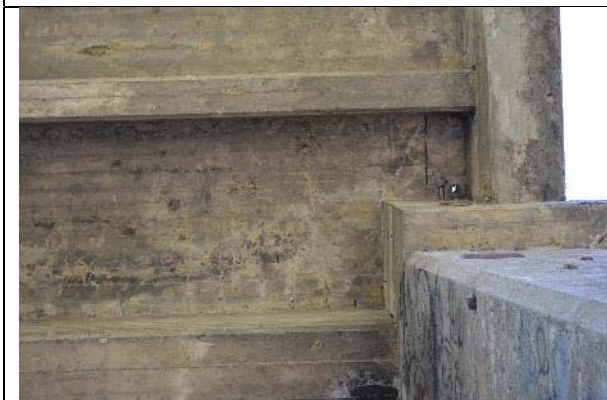
Figure 7 - Defect 207 (DSC\_0459)

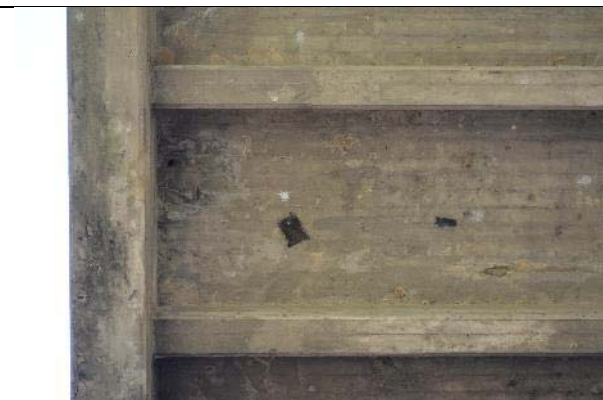
Figure 8 - Defect 208 (DSC\_0460)

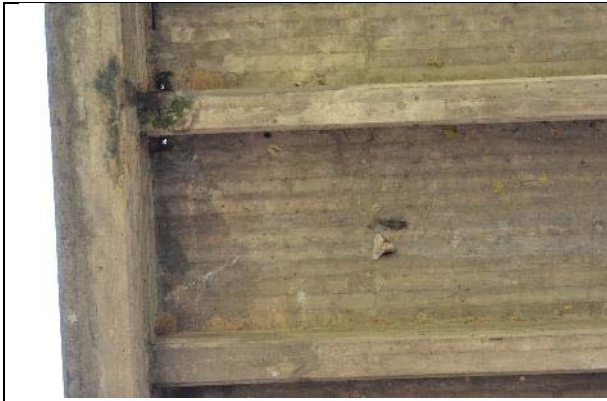
Figure 9 - Defect 209 (DSC\_0462)

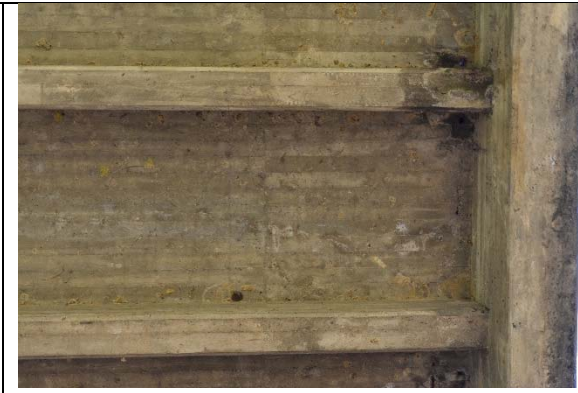
Figure 10 - Defect 210 (DSC\_463)

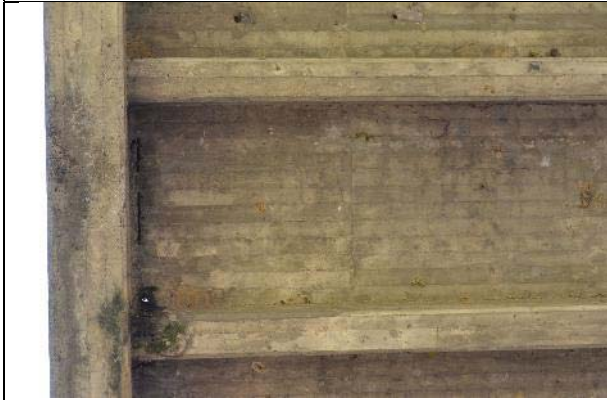
Figure 4 - Defect 211 (DSC\_0464)

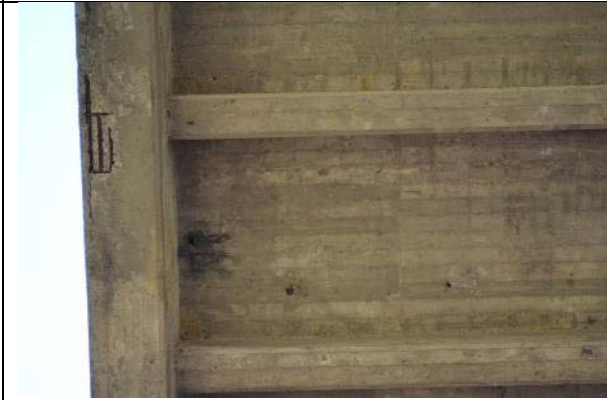
Figure 5 - Defect 212 (DSC\_0466)

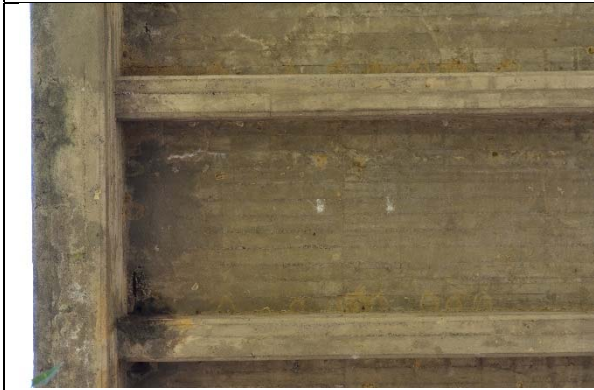
Figure 6 - Defect 213 (DSC\_0470)

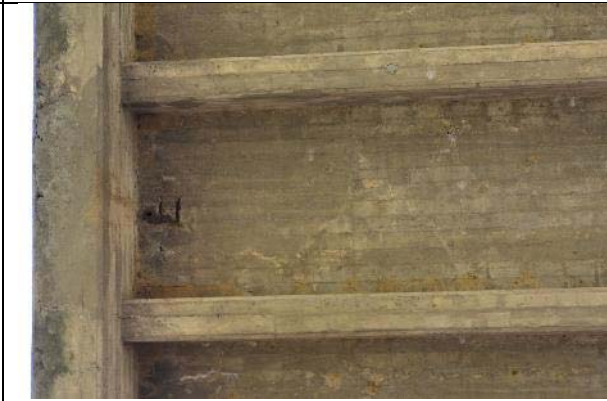
Figure 7 - Defect 214 (DSC\_0472)

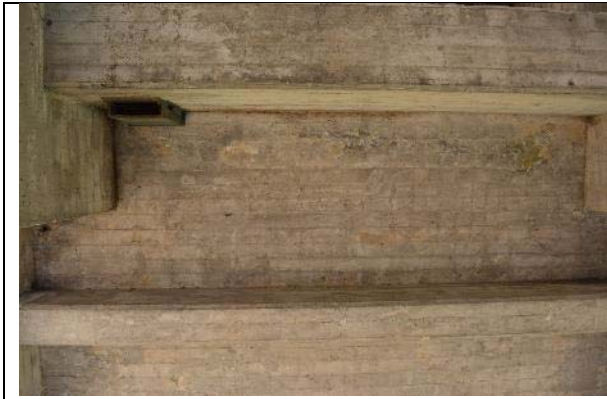
Figure 1 - Defect 179 (DSC\_0403)

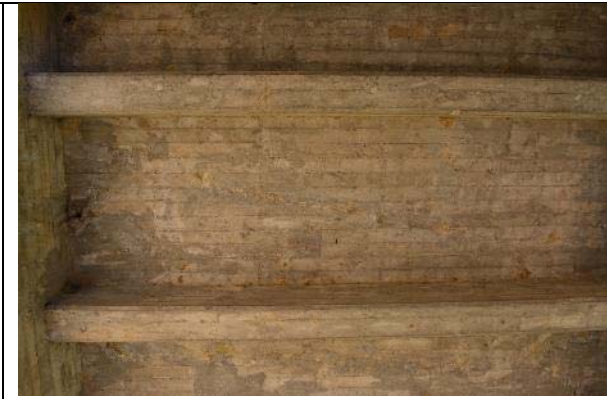
Figure 2 - Defect 180 (DSC\_0406)

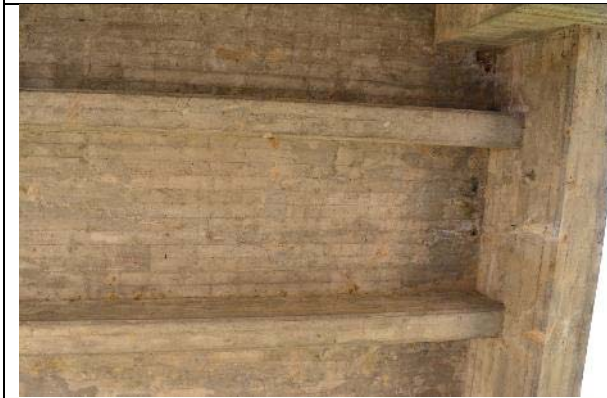
Figure 3 - Defect 181 (DSC\_0407)

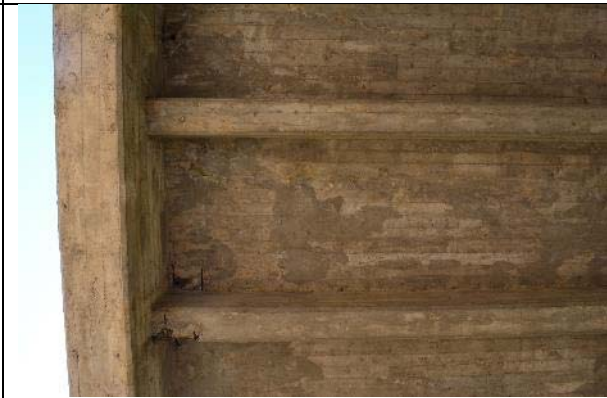
Figure 4 - Defect 182 (DSC\_0408)

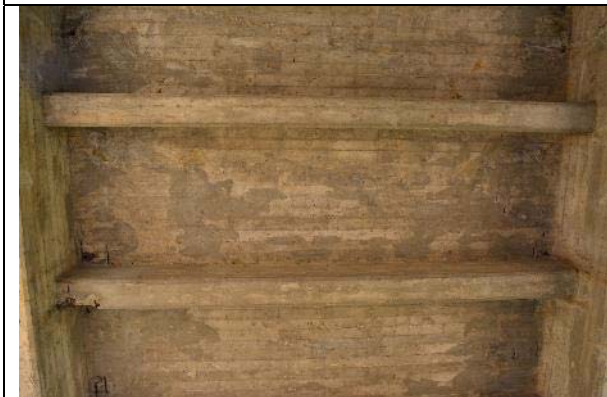
Figure 5 - Defect 183 (DSC\_0409)

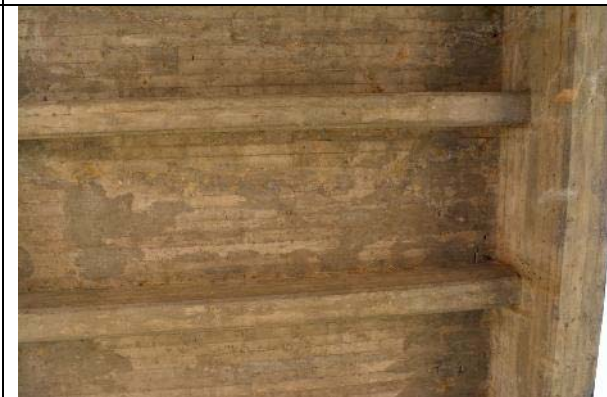
Figure 6 - Defect 184 (DSC\_0410)

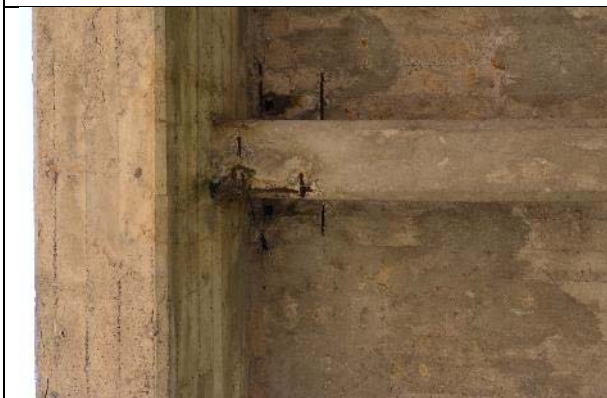
Figure 7 - Defect 185 (DSC\_0411)

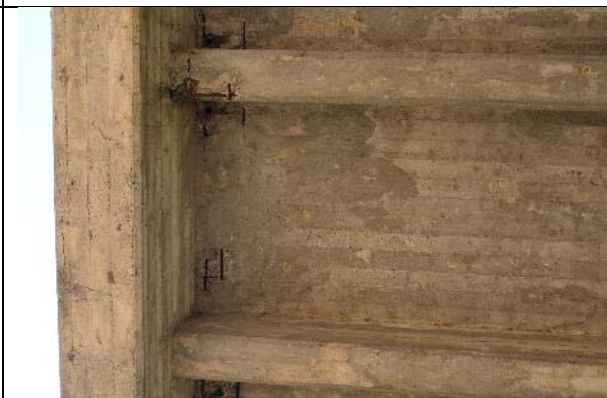
Figure 8 - Defect 186 (DSC\_0412)

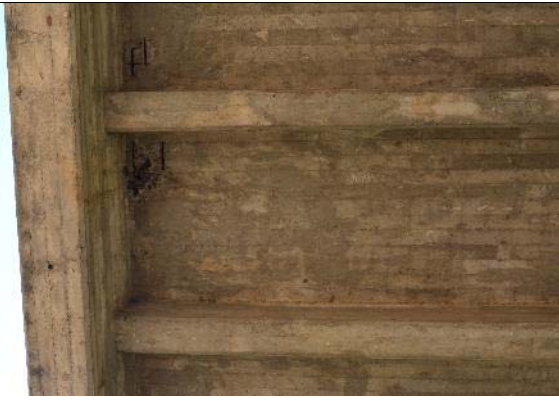
Figure 9 - Defect 187 (DSC\_0415)

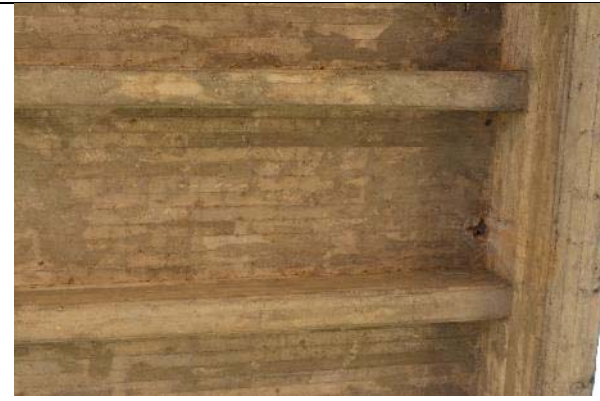
Figure 10 - Defect 188 (DSC\_0417)

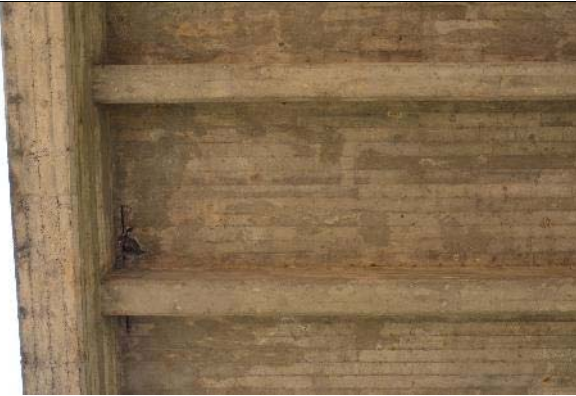
Figure 11 - Defect 189 (DSC\_0418)
