# Project Report

**Putah Creek Bridge Rehabilitation at Stevenson Bridge Road  
Federal Project No. BRLS 5923(059)  
Bridge No. 23C0092**

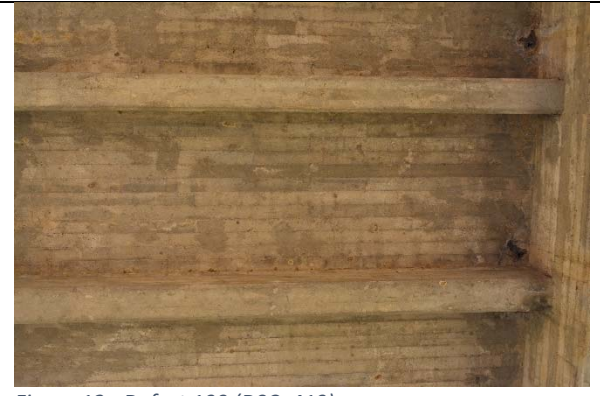
Figure 12 - Defect 190 (DSC\_419)

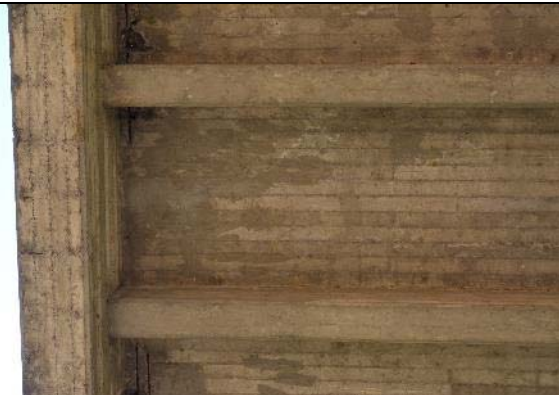
Figure 13 - Defect 191 (DSC\_0420)

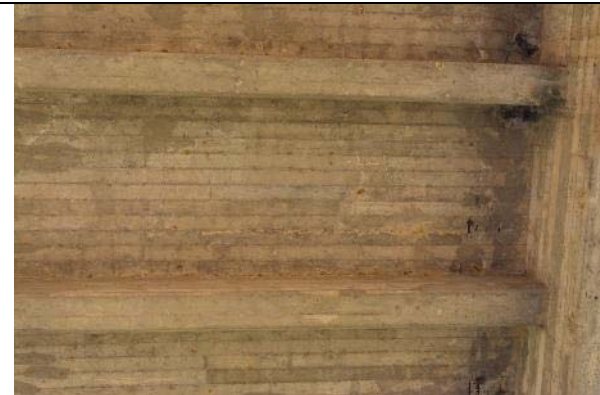
Figure 14 - Defect 192 (DSC\_0421)

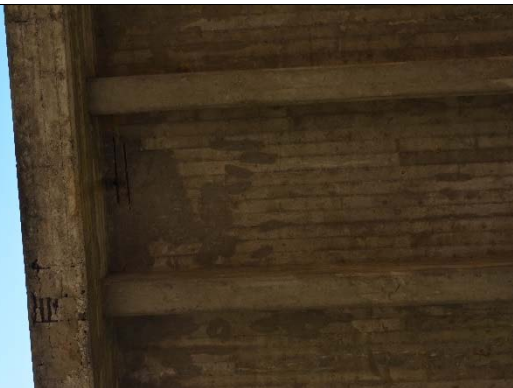
Figure 15 - Defect 193 (DSC\_0422)

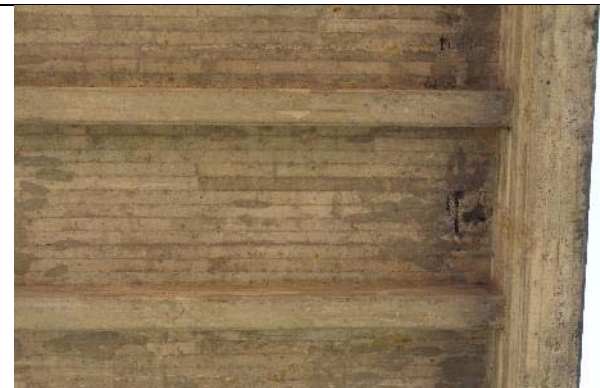
Figure 16 - Defect 193 (DSC\_0423)

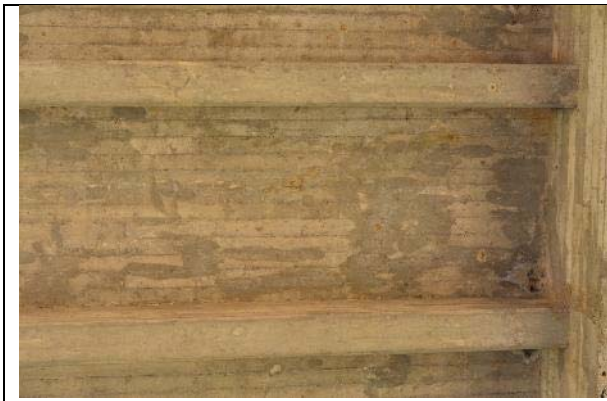
Figure 17 - Defect 194 (DSC\_0425)

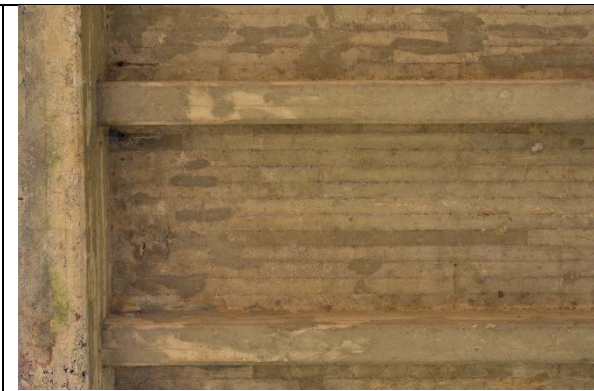
Figure 18 - Defect 195 (DSC\_0426)

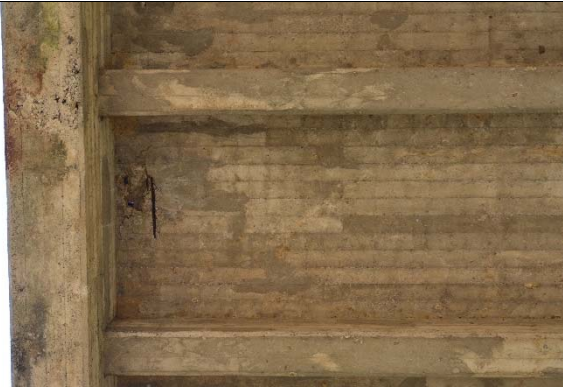
Figure 19 - Unnumbered Defect (DSC\_428) Bay 6

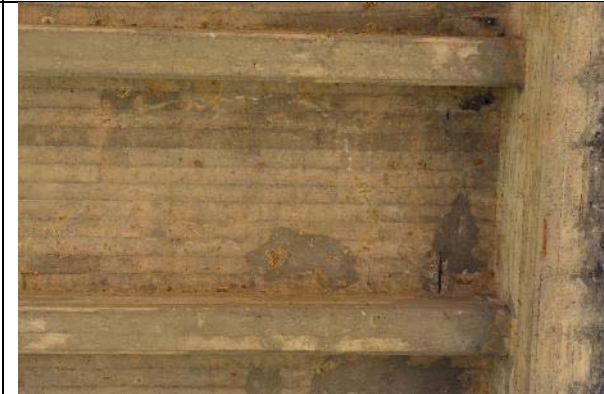
Figure 20 - Defect 196 (DSC\_0433)

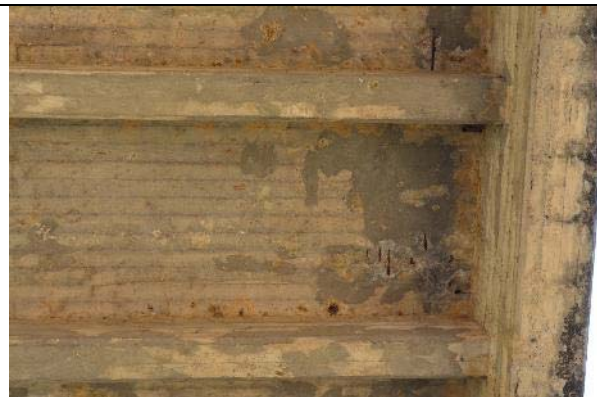
Figure 21 - Defect 197 (DSC\_0435)

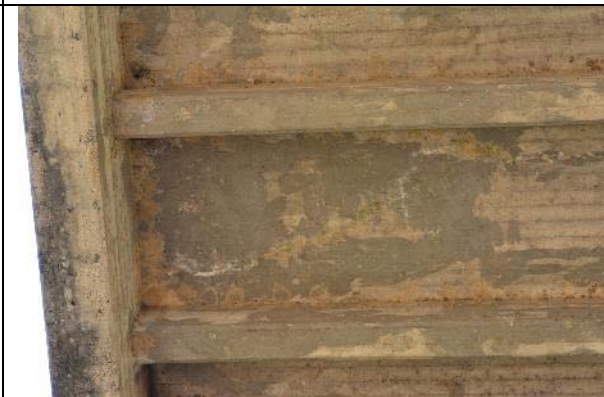
Figure 22 - Defect 198 (DSC\_0436)

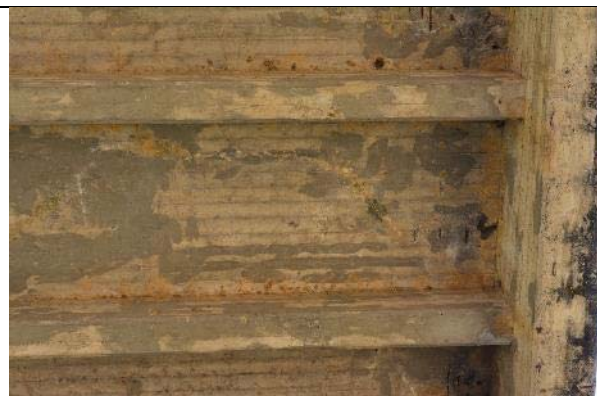
Figure 23 - Defect 199 (DSC\_0437)

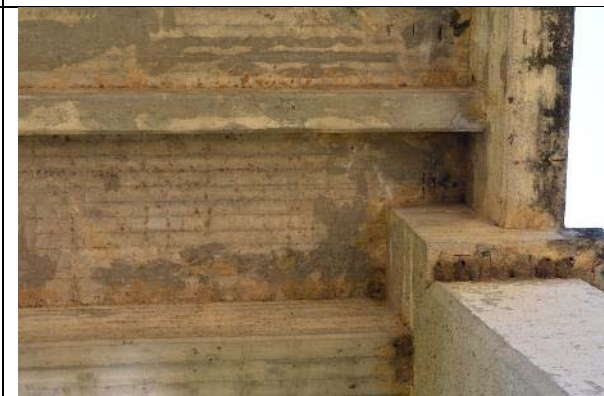
Figure 24 - Defect 200 (DSC\_0439)

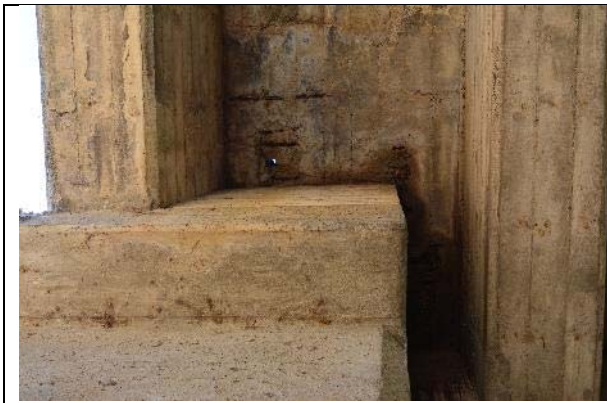
Figure 1 - Defect 136 (DSC\_0330)

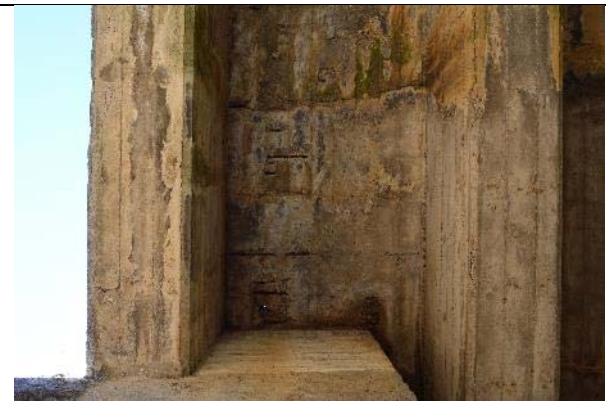
Figure 2 - Defect 137 (DSC\_0331)

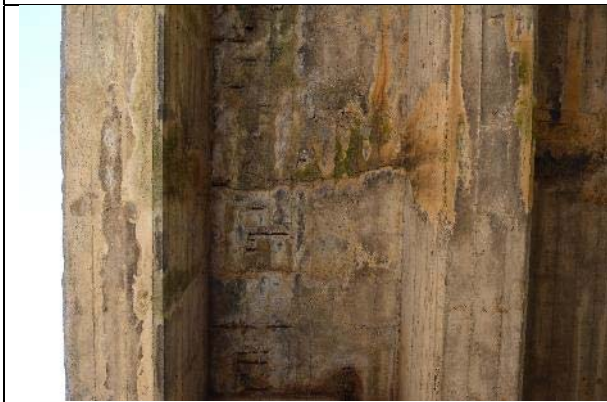
Figure 3 - Defect 138 (DSC\_0332)

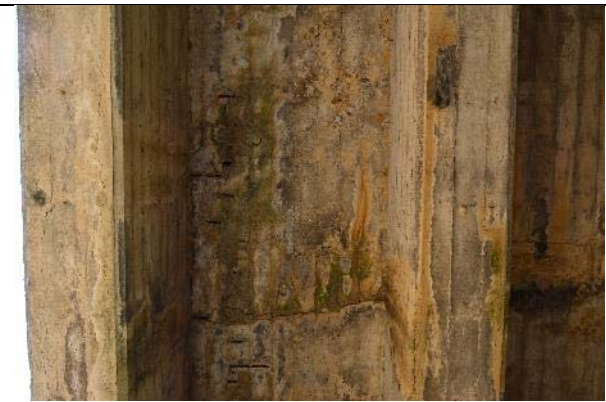
Figure 4 - Defect 139 (DSC\_0333)

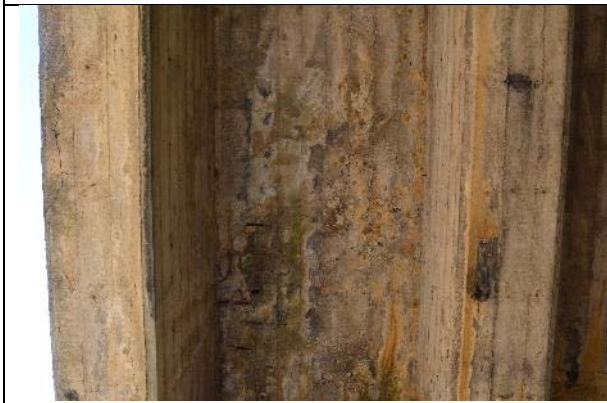
Figure 5 - Defect 140 (DSC\_0334)

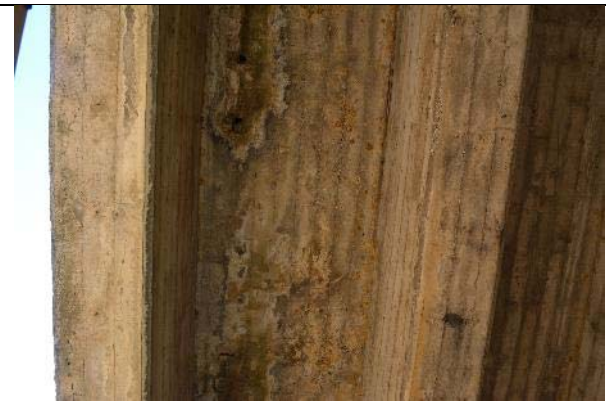
Figure 6 - Defect 141 (DSC\_0336)

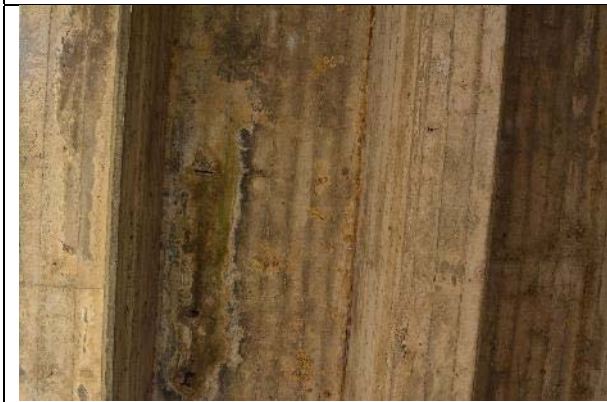
Figure 7 - Defect 142 (DSC\_0339)

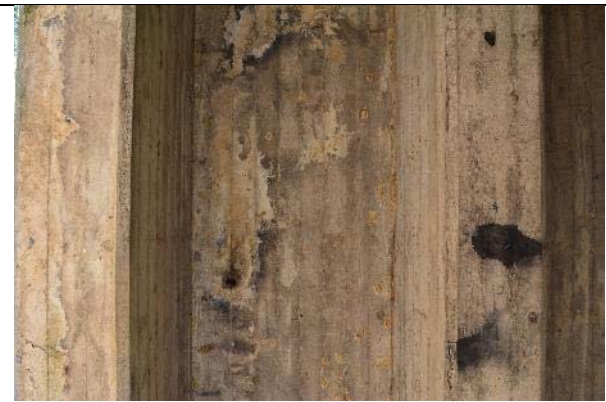
Figure 8 - Defect 143 (DSC\_0343)

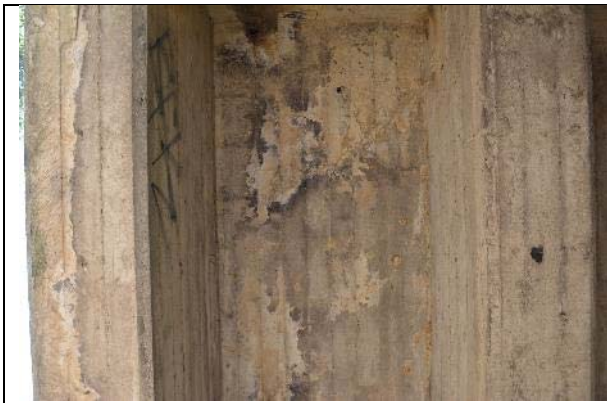
Figure 9 - Defect 144 (DSC\_0344)

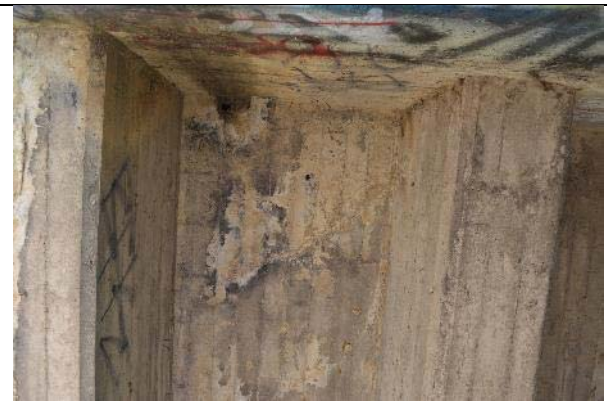
Figure 10 - Defect 145 (DSC\_0345)

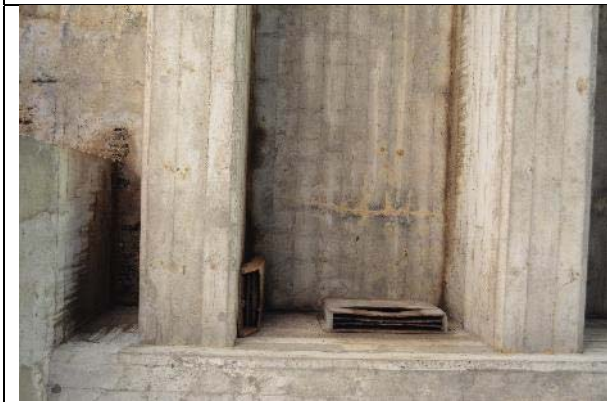
Figure 11 - Defect 146 (DSC\_0346)

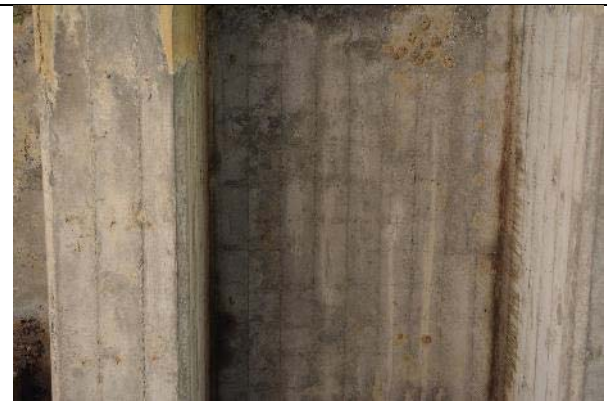
Figure 12 - Defect 147 (DSC\_0348)

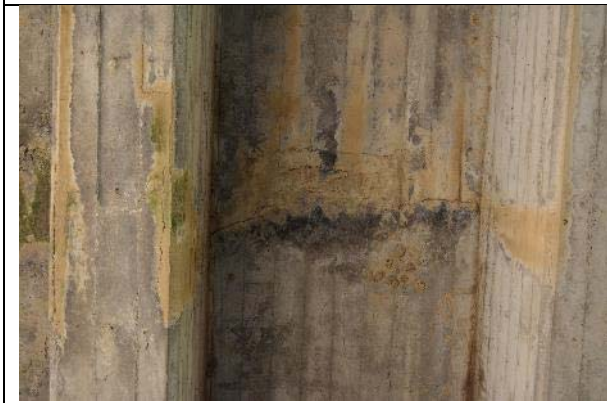
Figure 13 - Defect 148 (DSC\_0349)

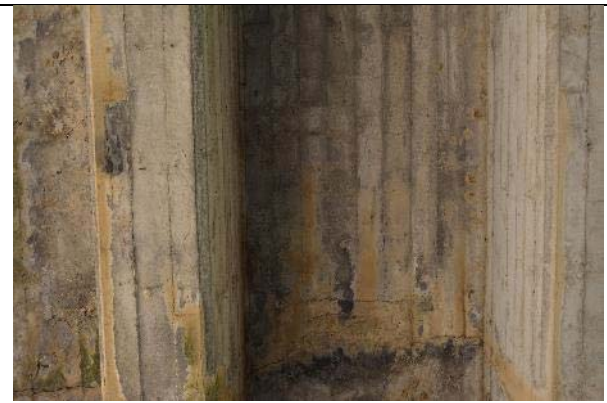
Figure 14 - Defect 149 (DSC\_0350)

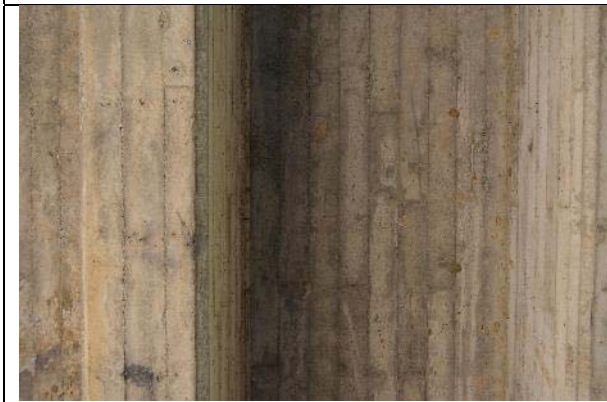
Figure 15 - Defect 150 (DSC\_0352)

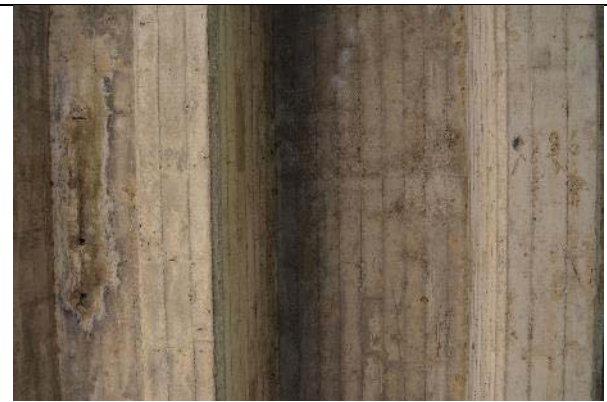
Figure 16 - Defect 151 (DSC\_0353)

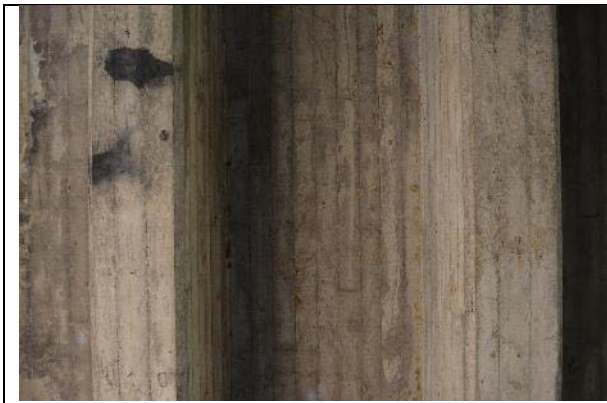
Figure 17 - Defect 152 (DSC\_0355)

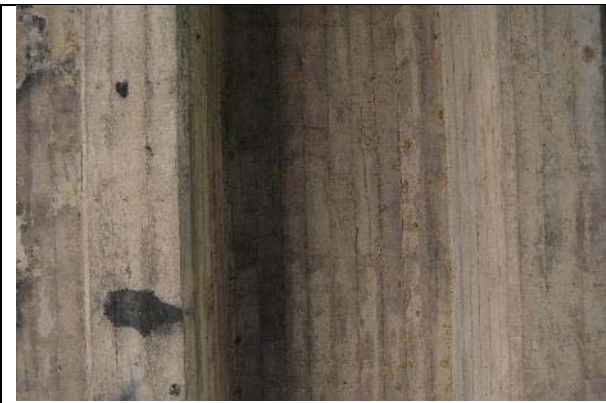
Figure 18 - Defect 153 (DSC\_0356)

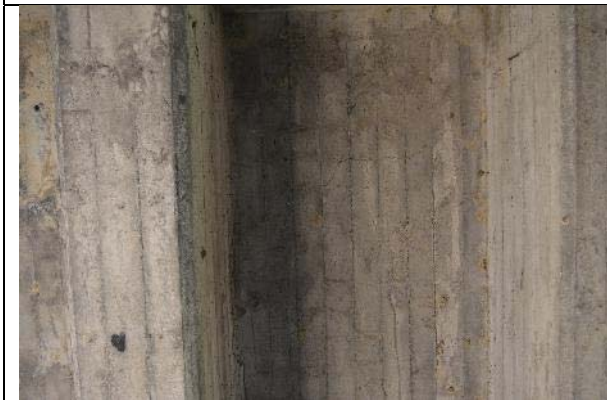
Figure 19 - Defect 154 (DSC\_0357)

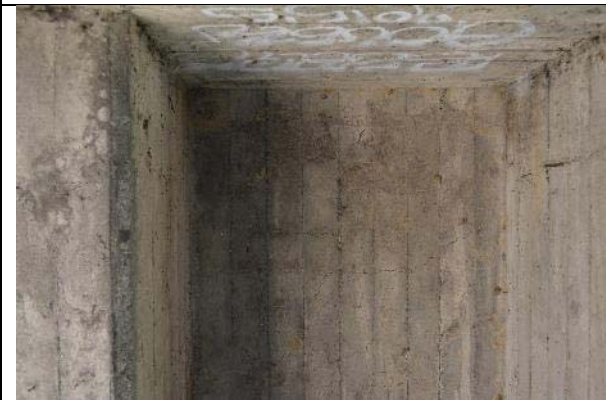
Figure 20 - Defect 155 (DSC\_0358)

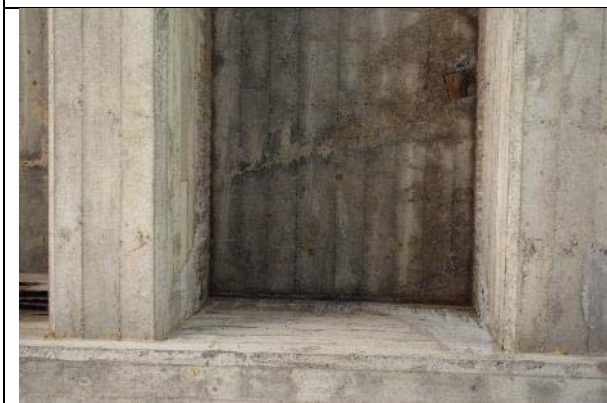
Figure 21 - Defect 156 (DSC\_0359)

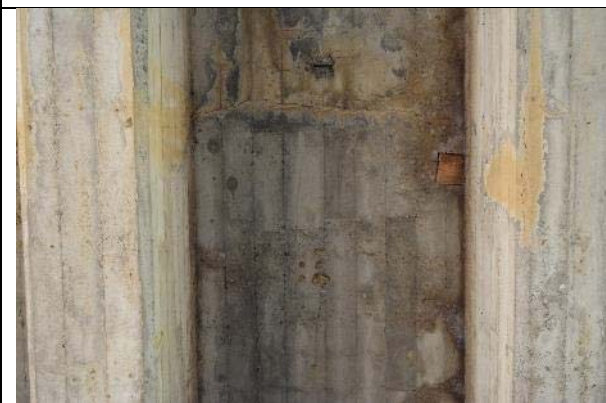
Figure 22 - Defect 157 (DSC\_0361)

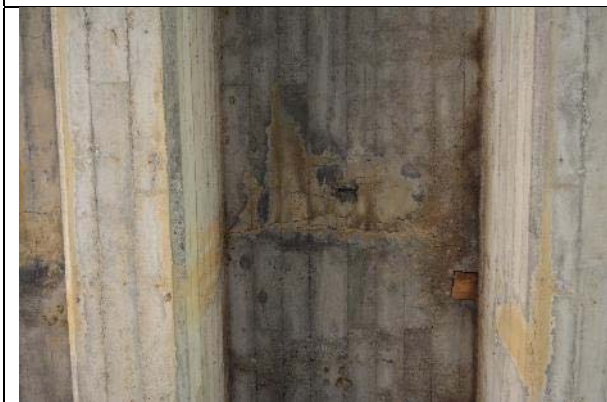
Figure 23 - Defect 158 (DSC\_0362)

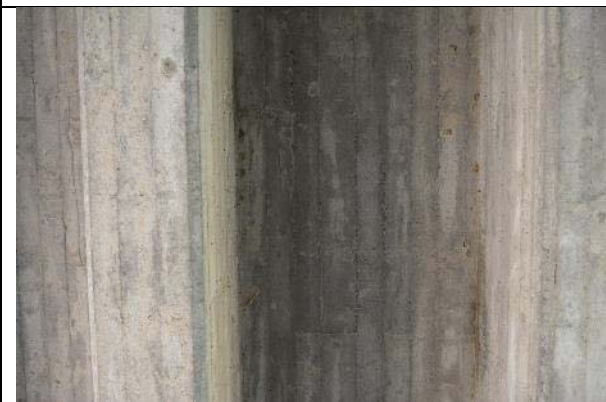
Figure 24 - Defect 159 (DSC\_0370)

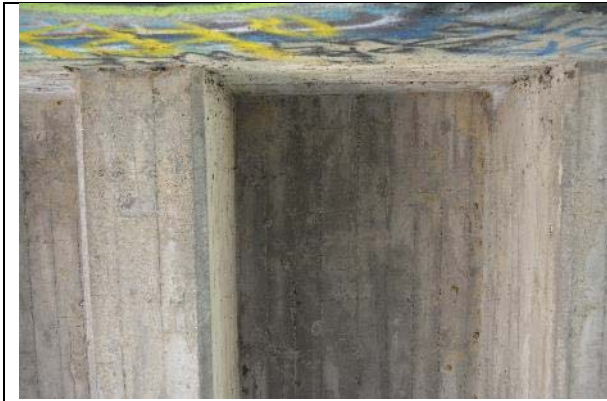
Figure 25 - Defect 160 (DSC\_0372)

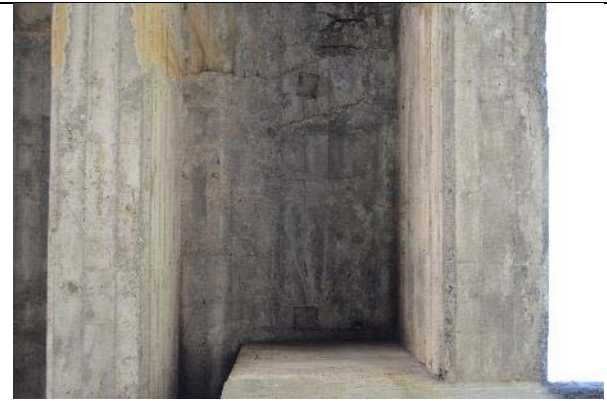
Figure 26 - Defect 161 (DSC\_0374)

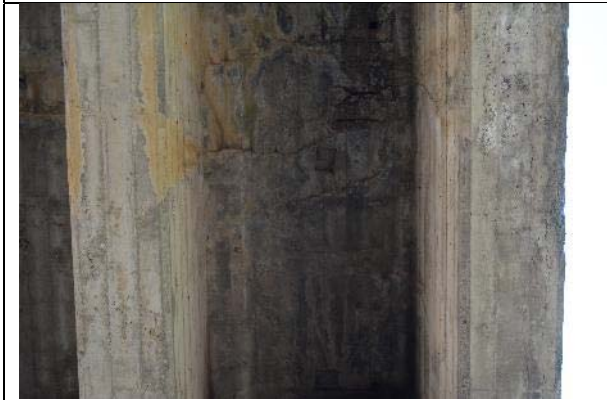
Figure 27 - Defect 162 (DSC\_0375)

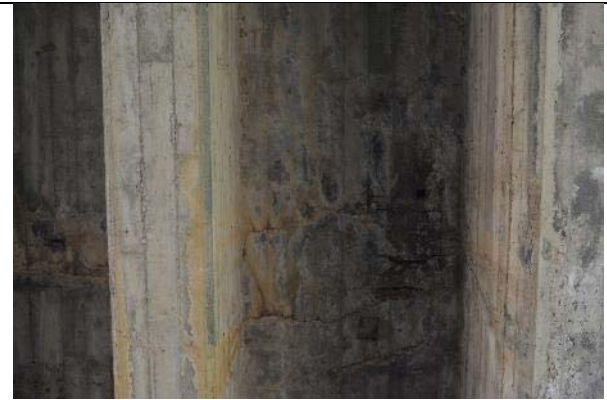
Figure 28 - Defect 163 (DSC\_0377)

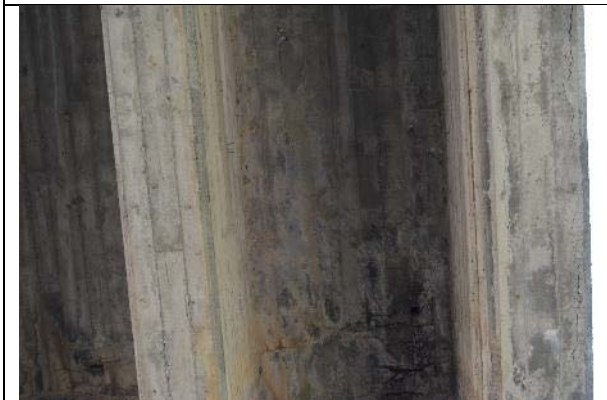
Figure 29 - Defect 164 (DSC\_0378)

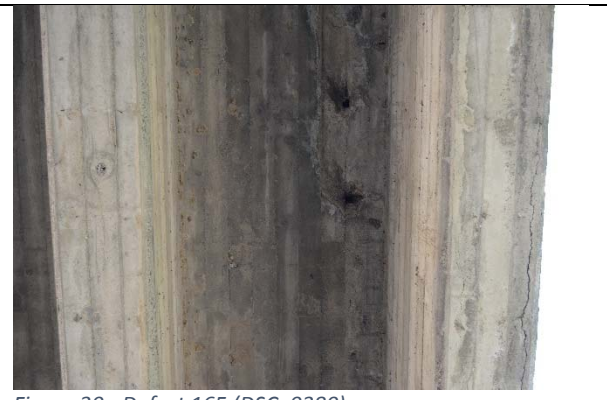
Figure 30 - Defect 165 (DSC\_0380)

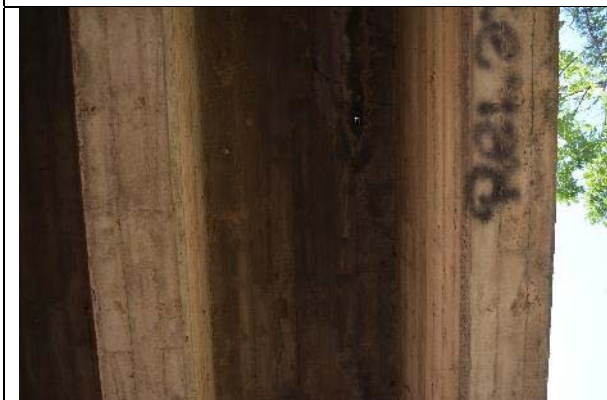
Figure 31 - Defect 166 (DSC\_0383)

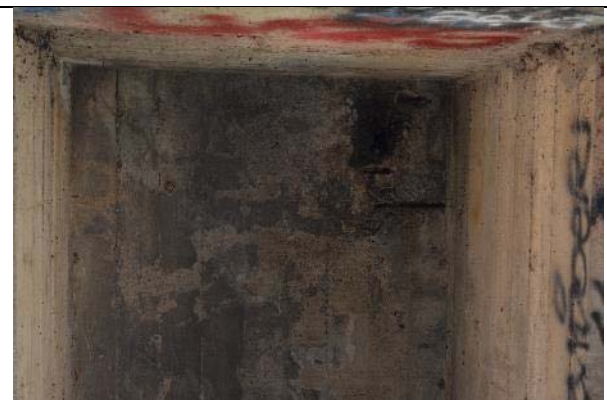
Figure 32 - Defect 167 (DSC\_0386)

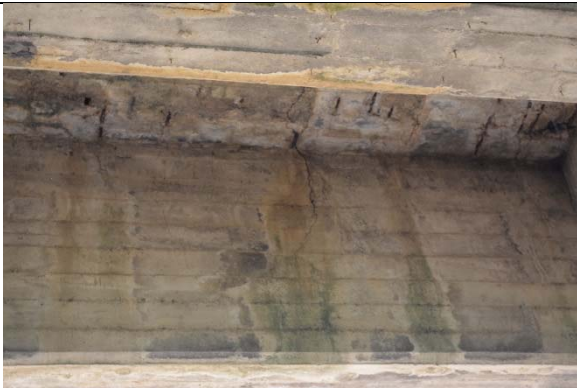
Figure 33 – Defect 168 (DSC\_387)

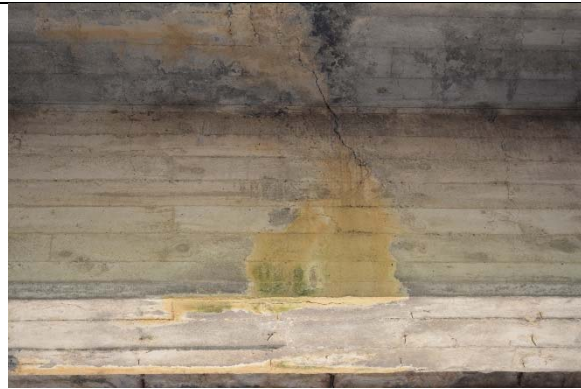
Figure 34 – Defect 169 (DSC\_388)

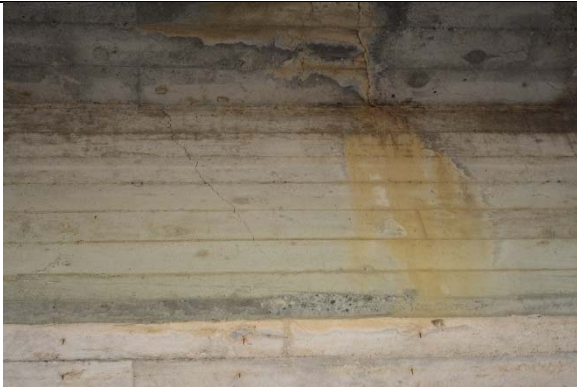
Figure 15 – Defect 170 (DSC\_389)

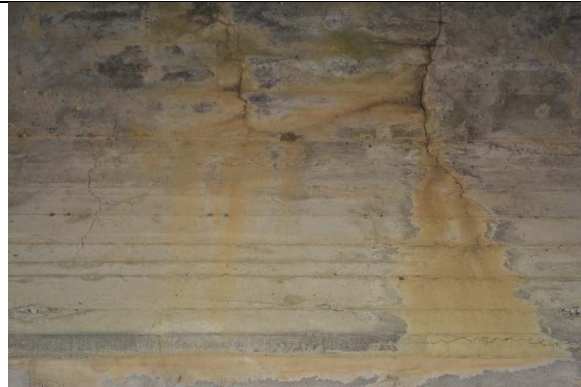
Figure 36 – Defect 171 (DSC\_390)

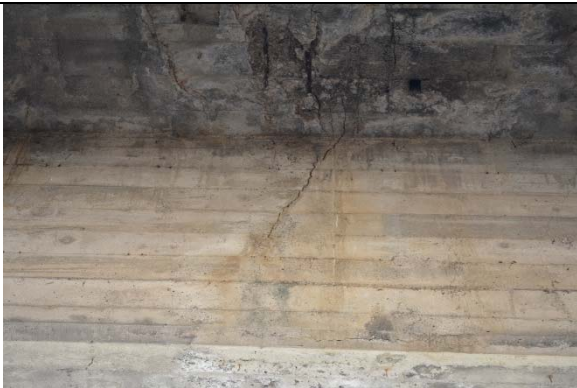
Figure 37 – Defect 172 (DSC\_391)

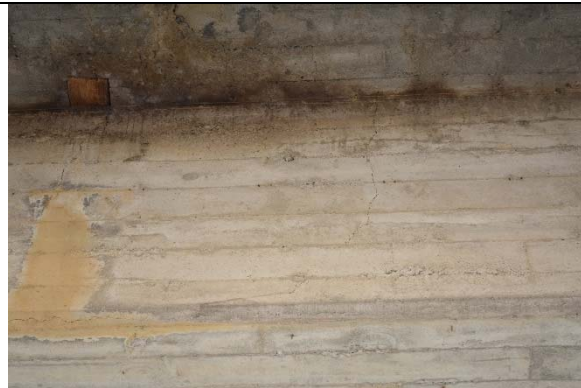
Figure 38 – Defect 173 (DSC\_392)

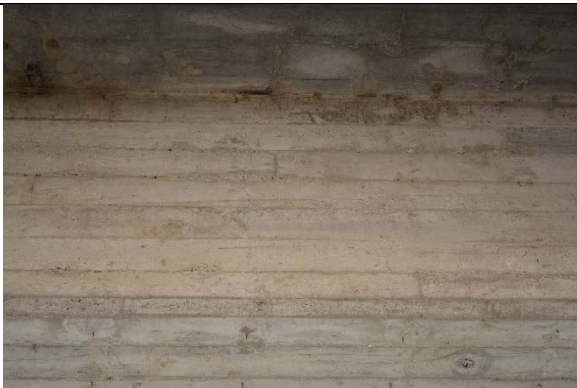
Figure 39 – Defect 174 (DSC\_393)

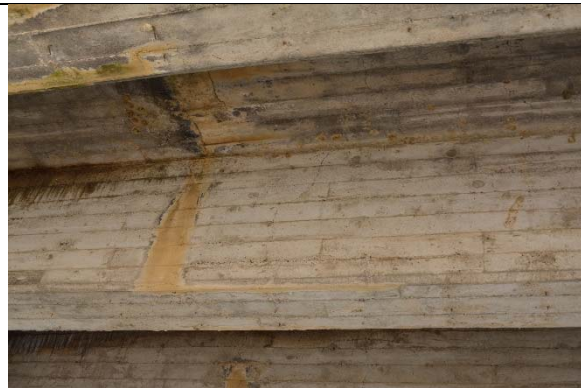
Figure 40 – Defect 175 (DSC\_394)

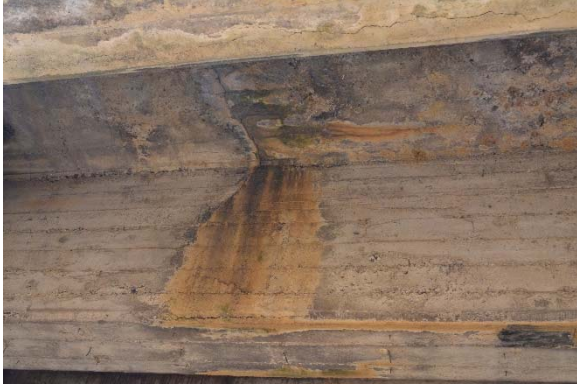
Figure 41 – Defect 176 (DSC\_396)

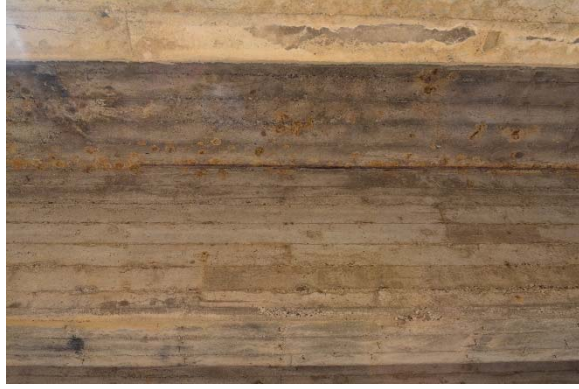
Figure 42 – Defect 177 (DSC\_397)

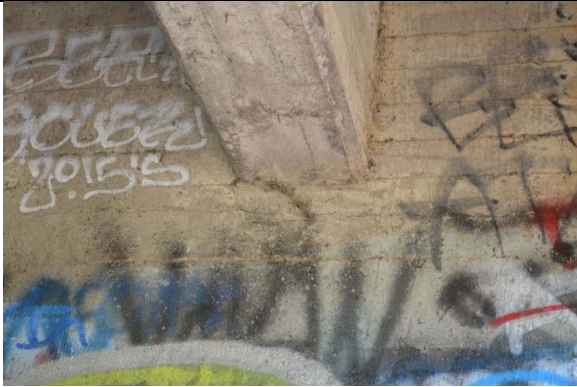
Figure 23 – Defect 178 (DSC\_399)

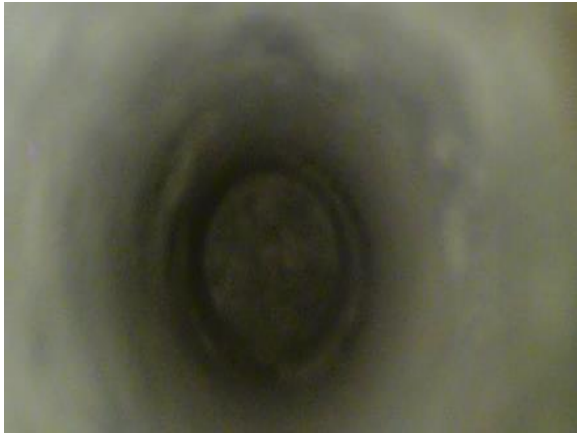
**APPENDIX 3 – Borescope Images**

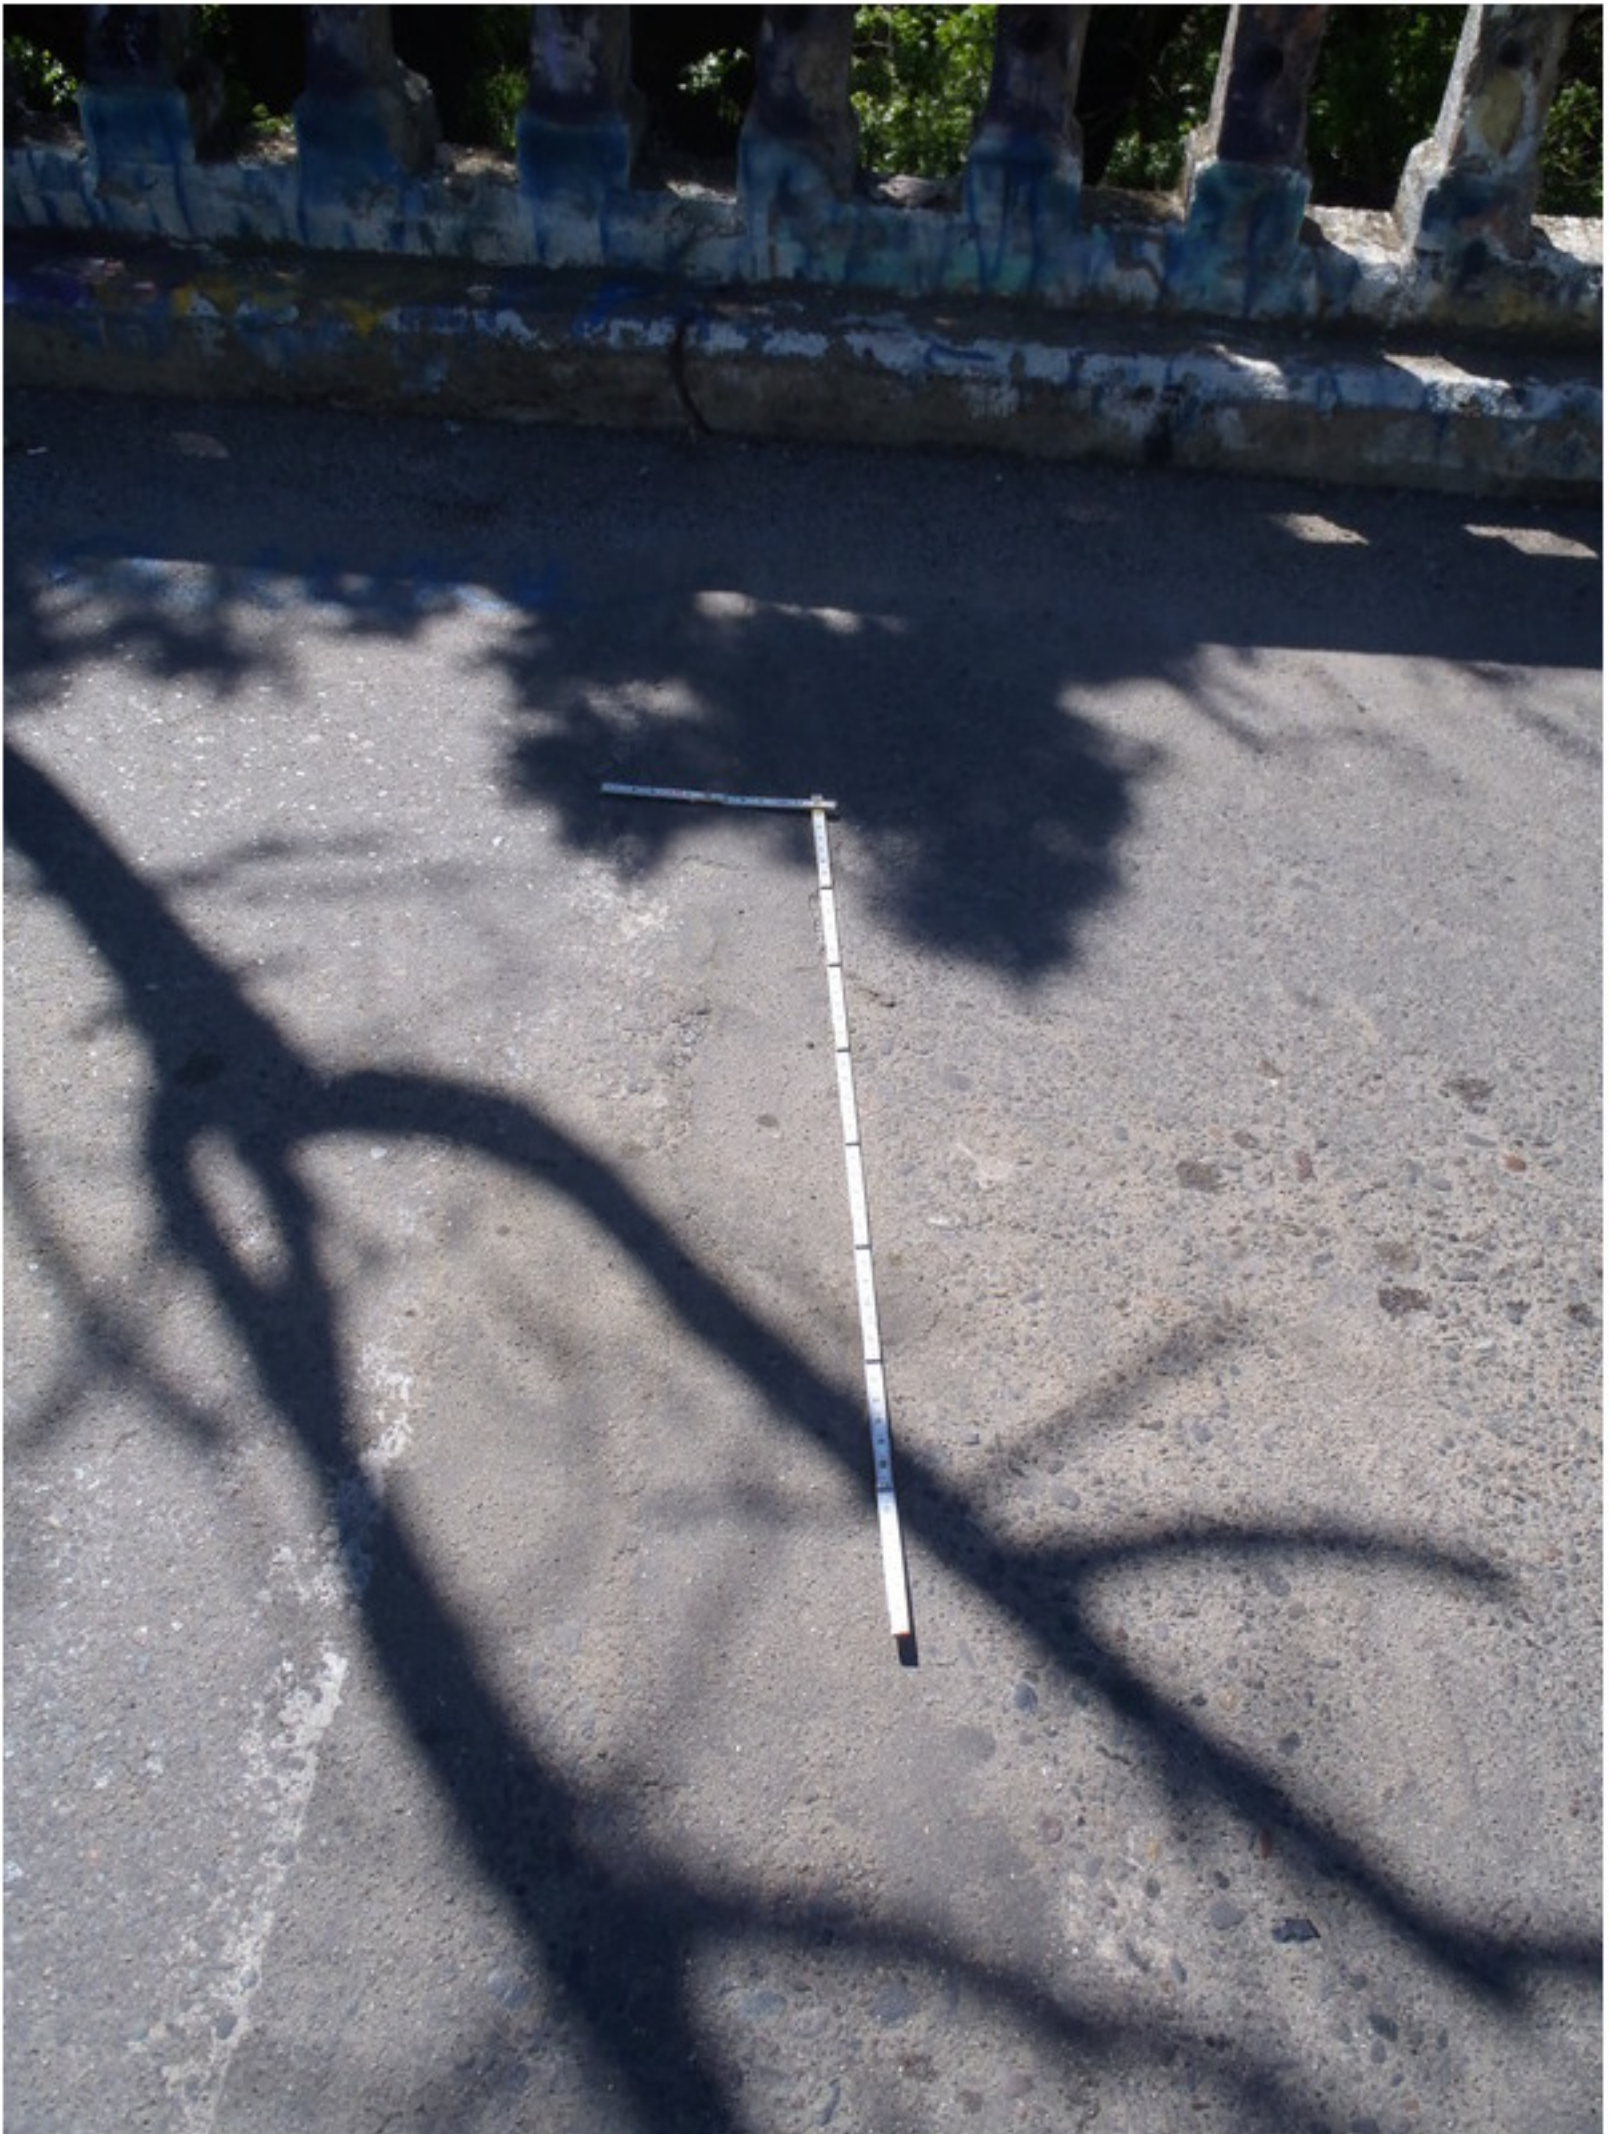
(90) INSPECTION DATE 03/15 (91) FREQUENCY 24 MO  
 (92) CRITICAL FEATURE INSPECTION: (93) CFI DATE  
 A) FRACTURE CRIT DETAIL- NO MO A)  
 B) UNDERWATER INSP- NO MO B)  
 C) OTHER SPECIAL INSP- NO MO C)

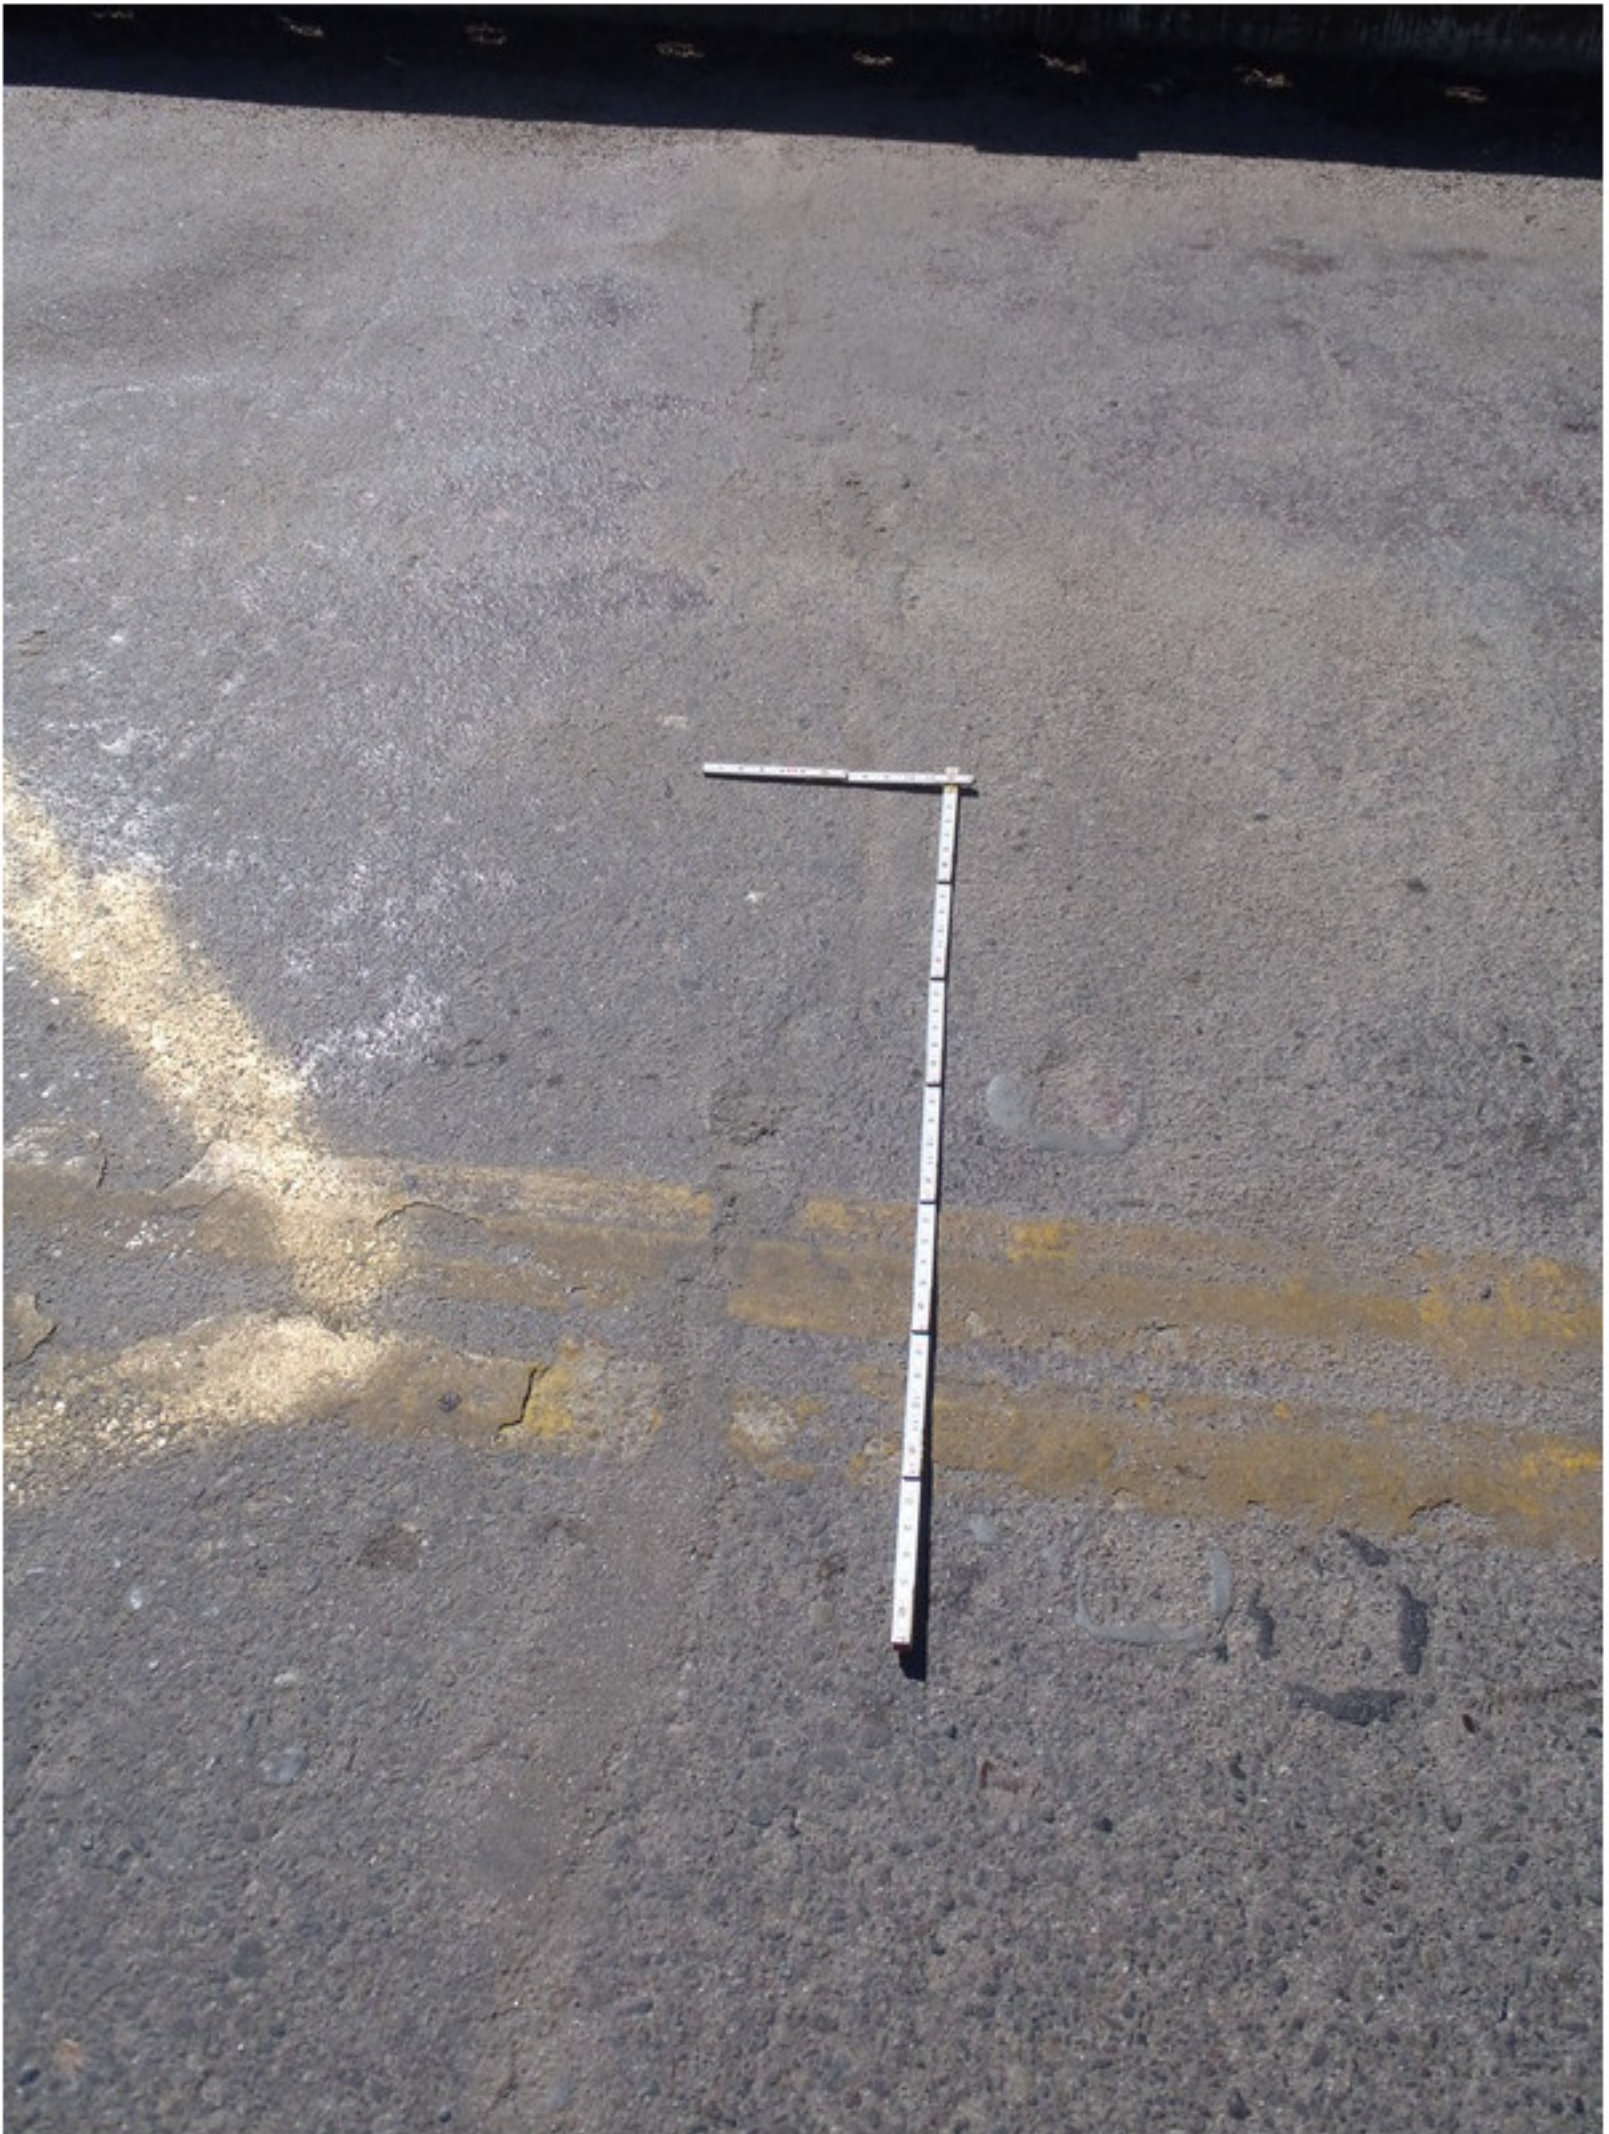
Transverse crack in Span 1 and remainder of deck are treated with methacrylate.
