# Project Report

**Putah Creek Bridge Rehabilitation at Stevenson Bridge Road  
Federal Project No. BRLS 5923(059)  
Bridge No. 23C0092**

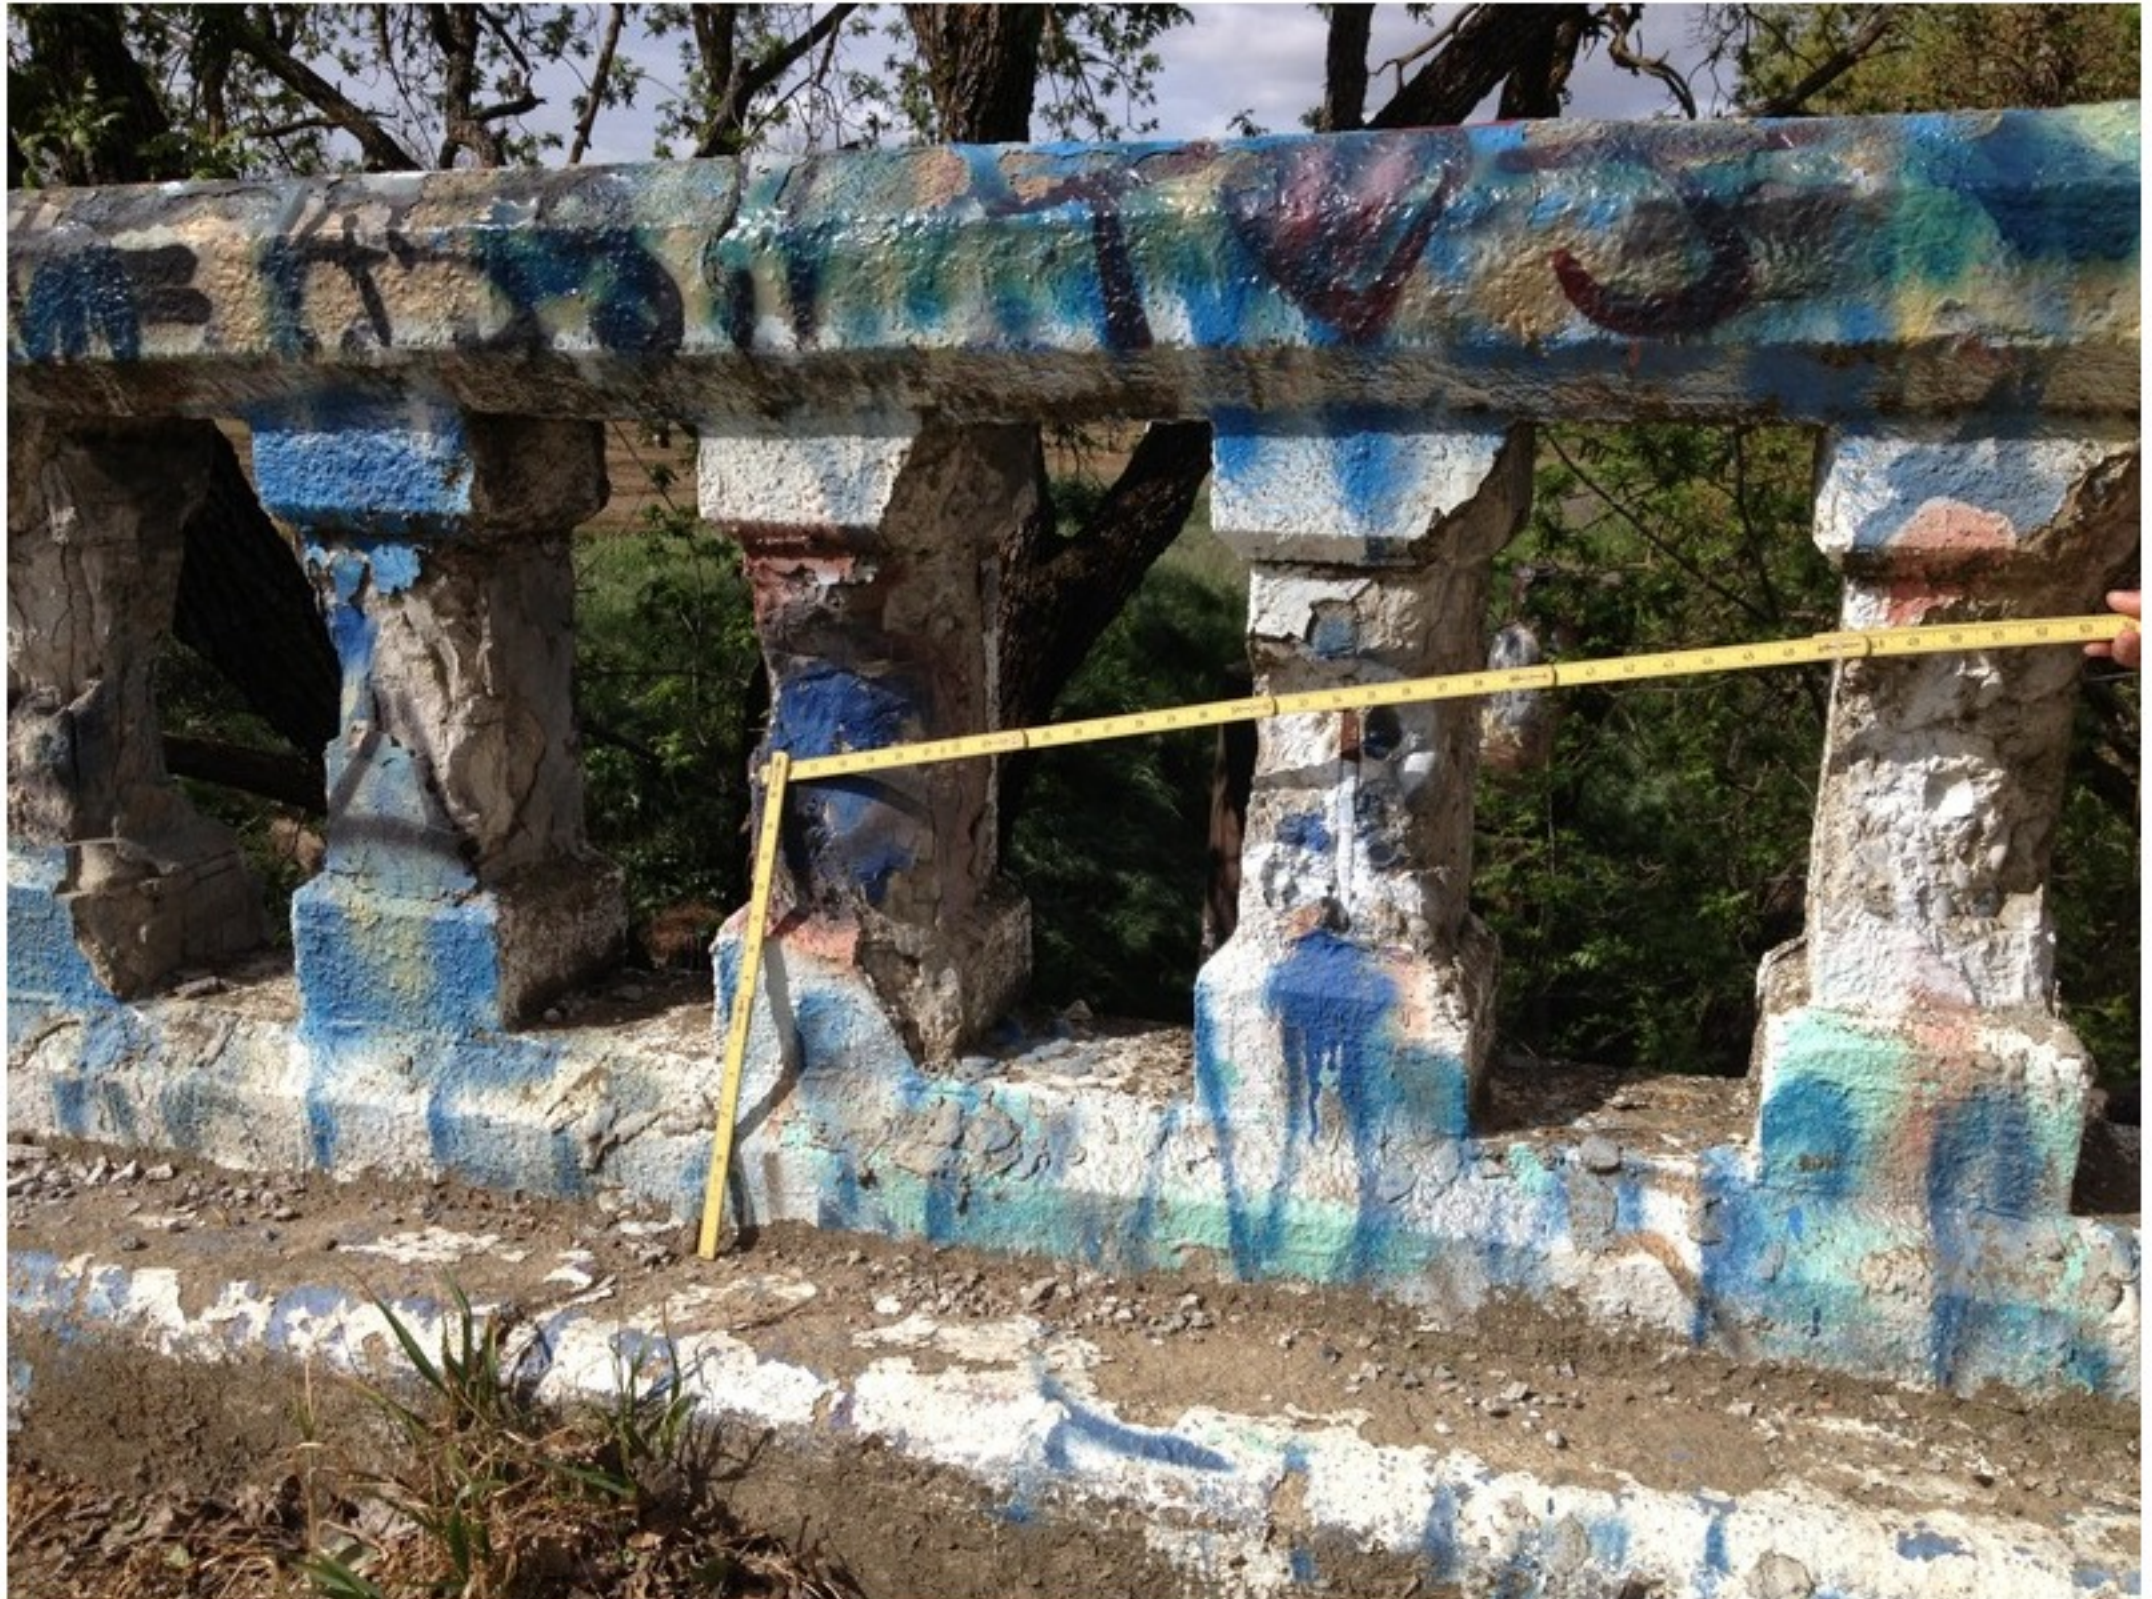
Photo No. 1  
Damage to the left rail in Span 1

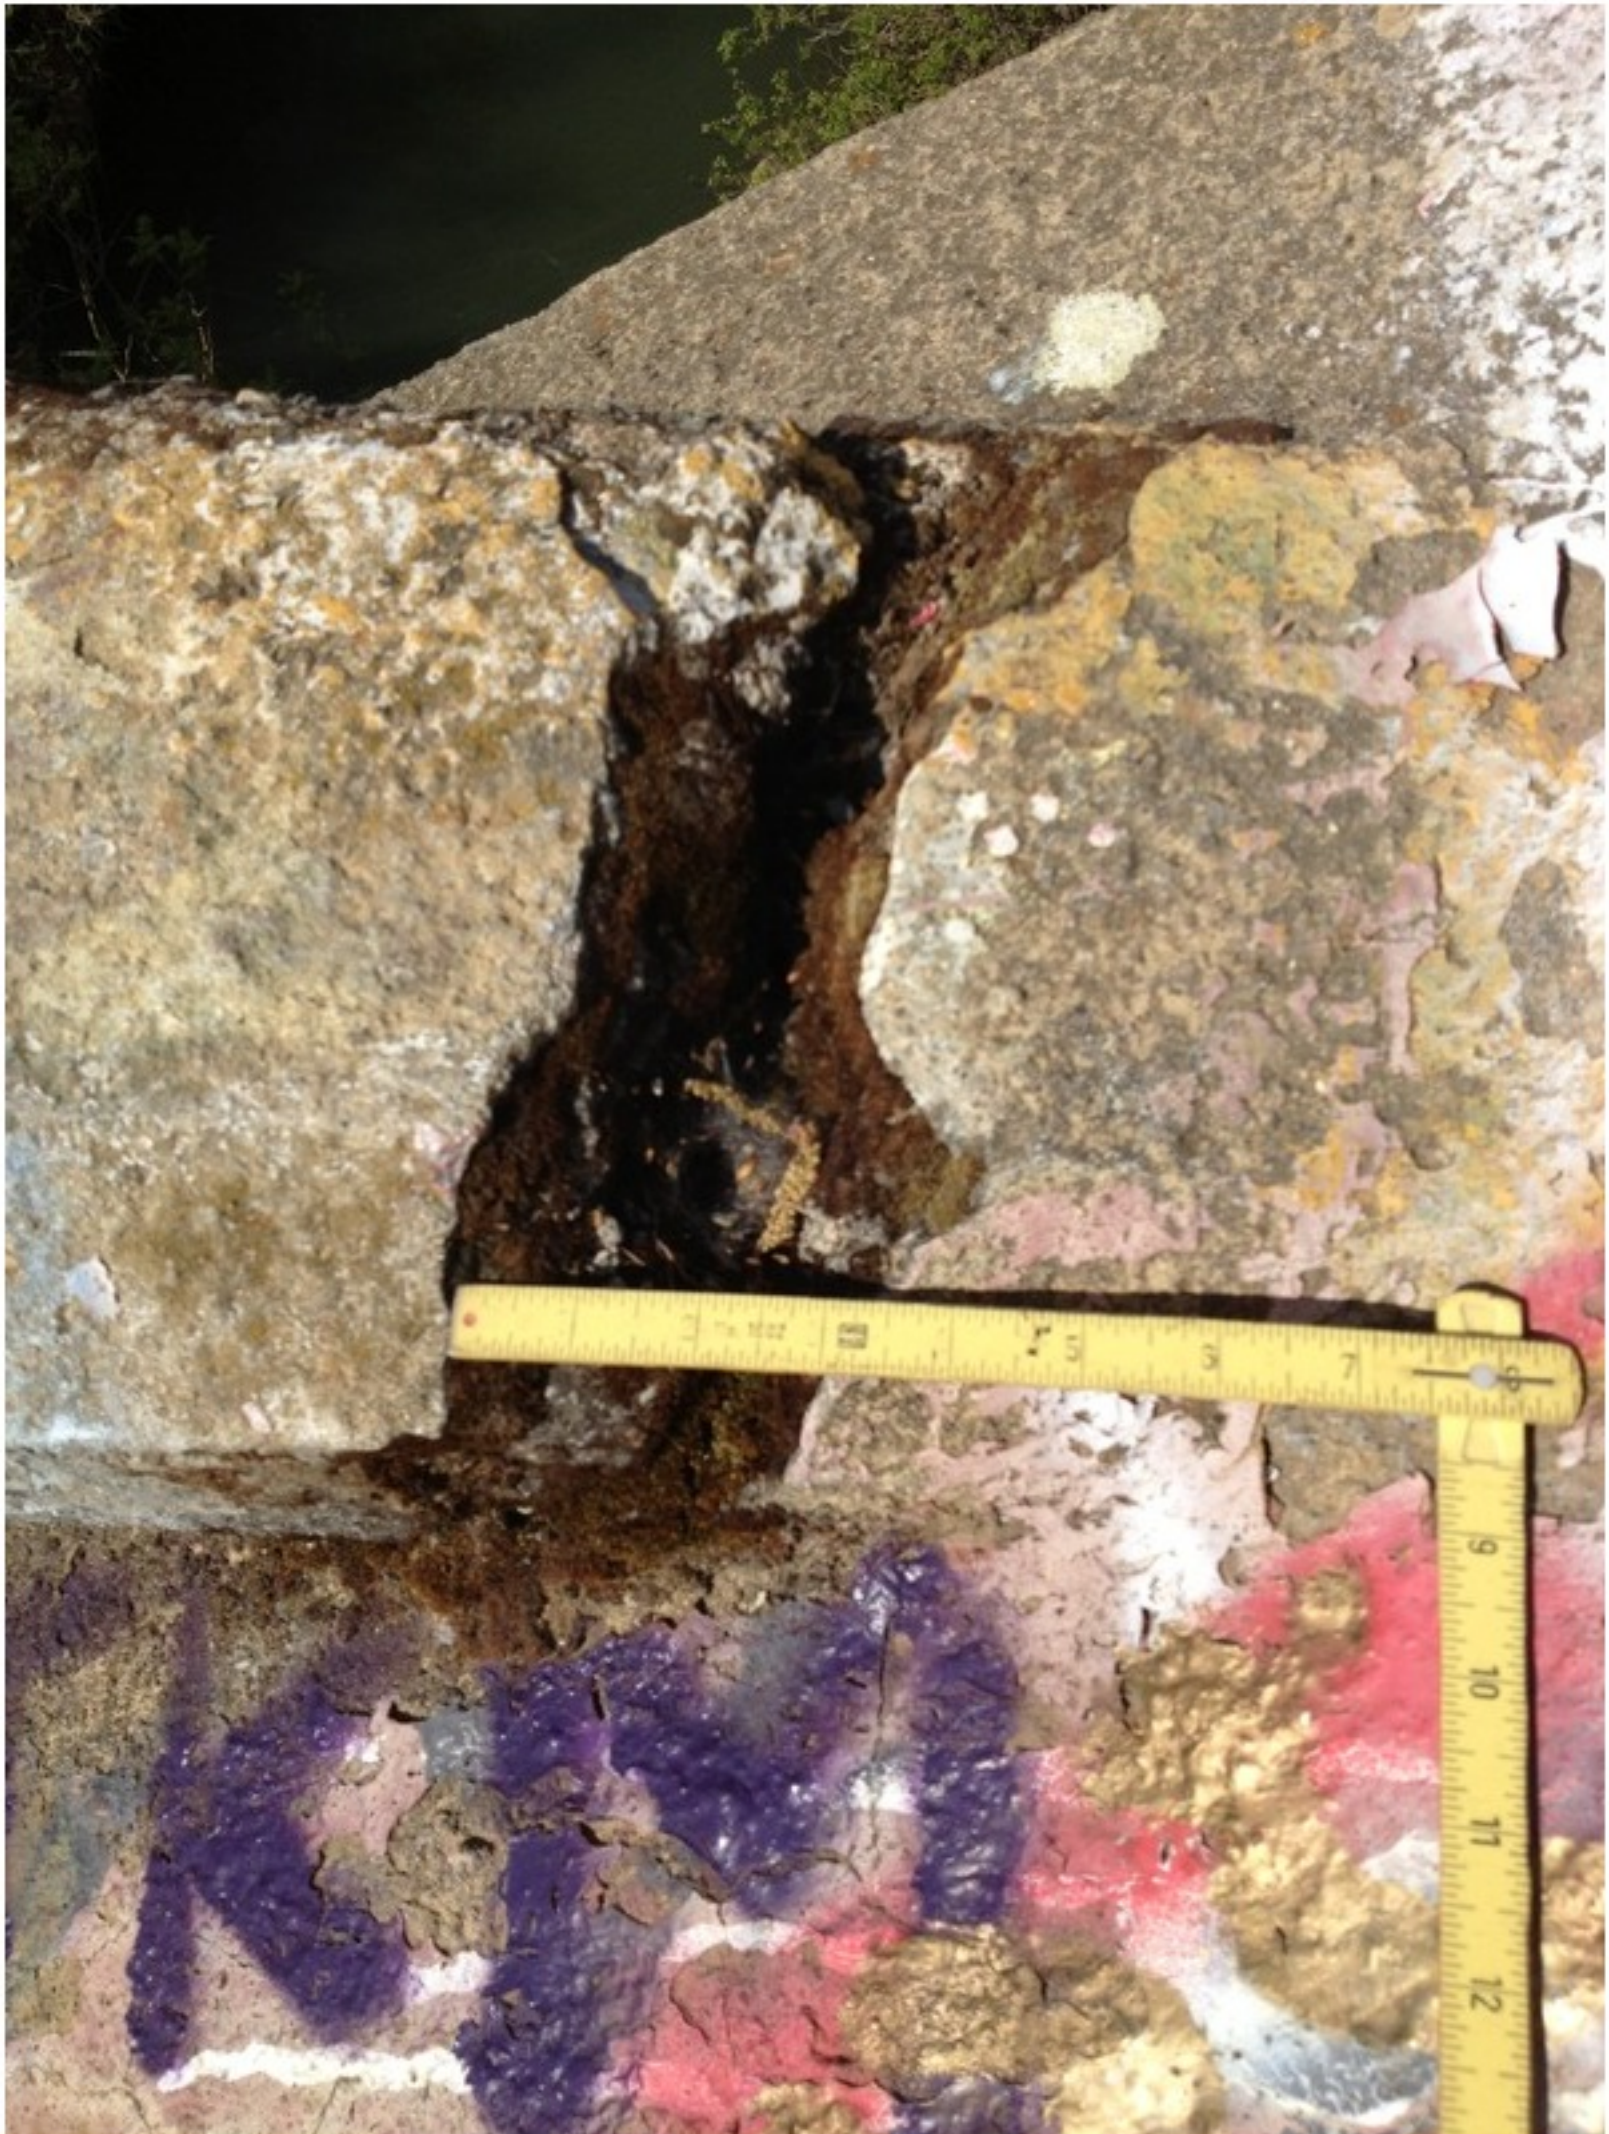
Photo No. 2  
Crack on the left rail at the connection with the northern arch over Bent 3

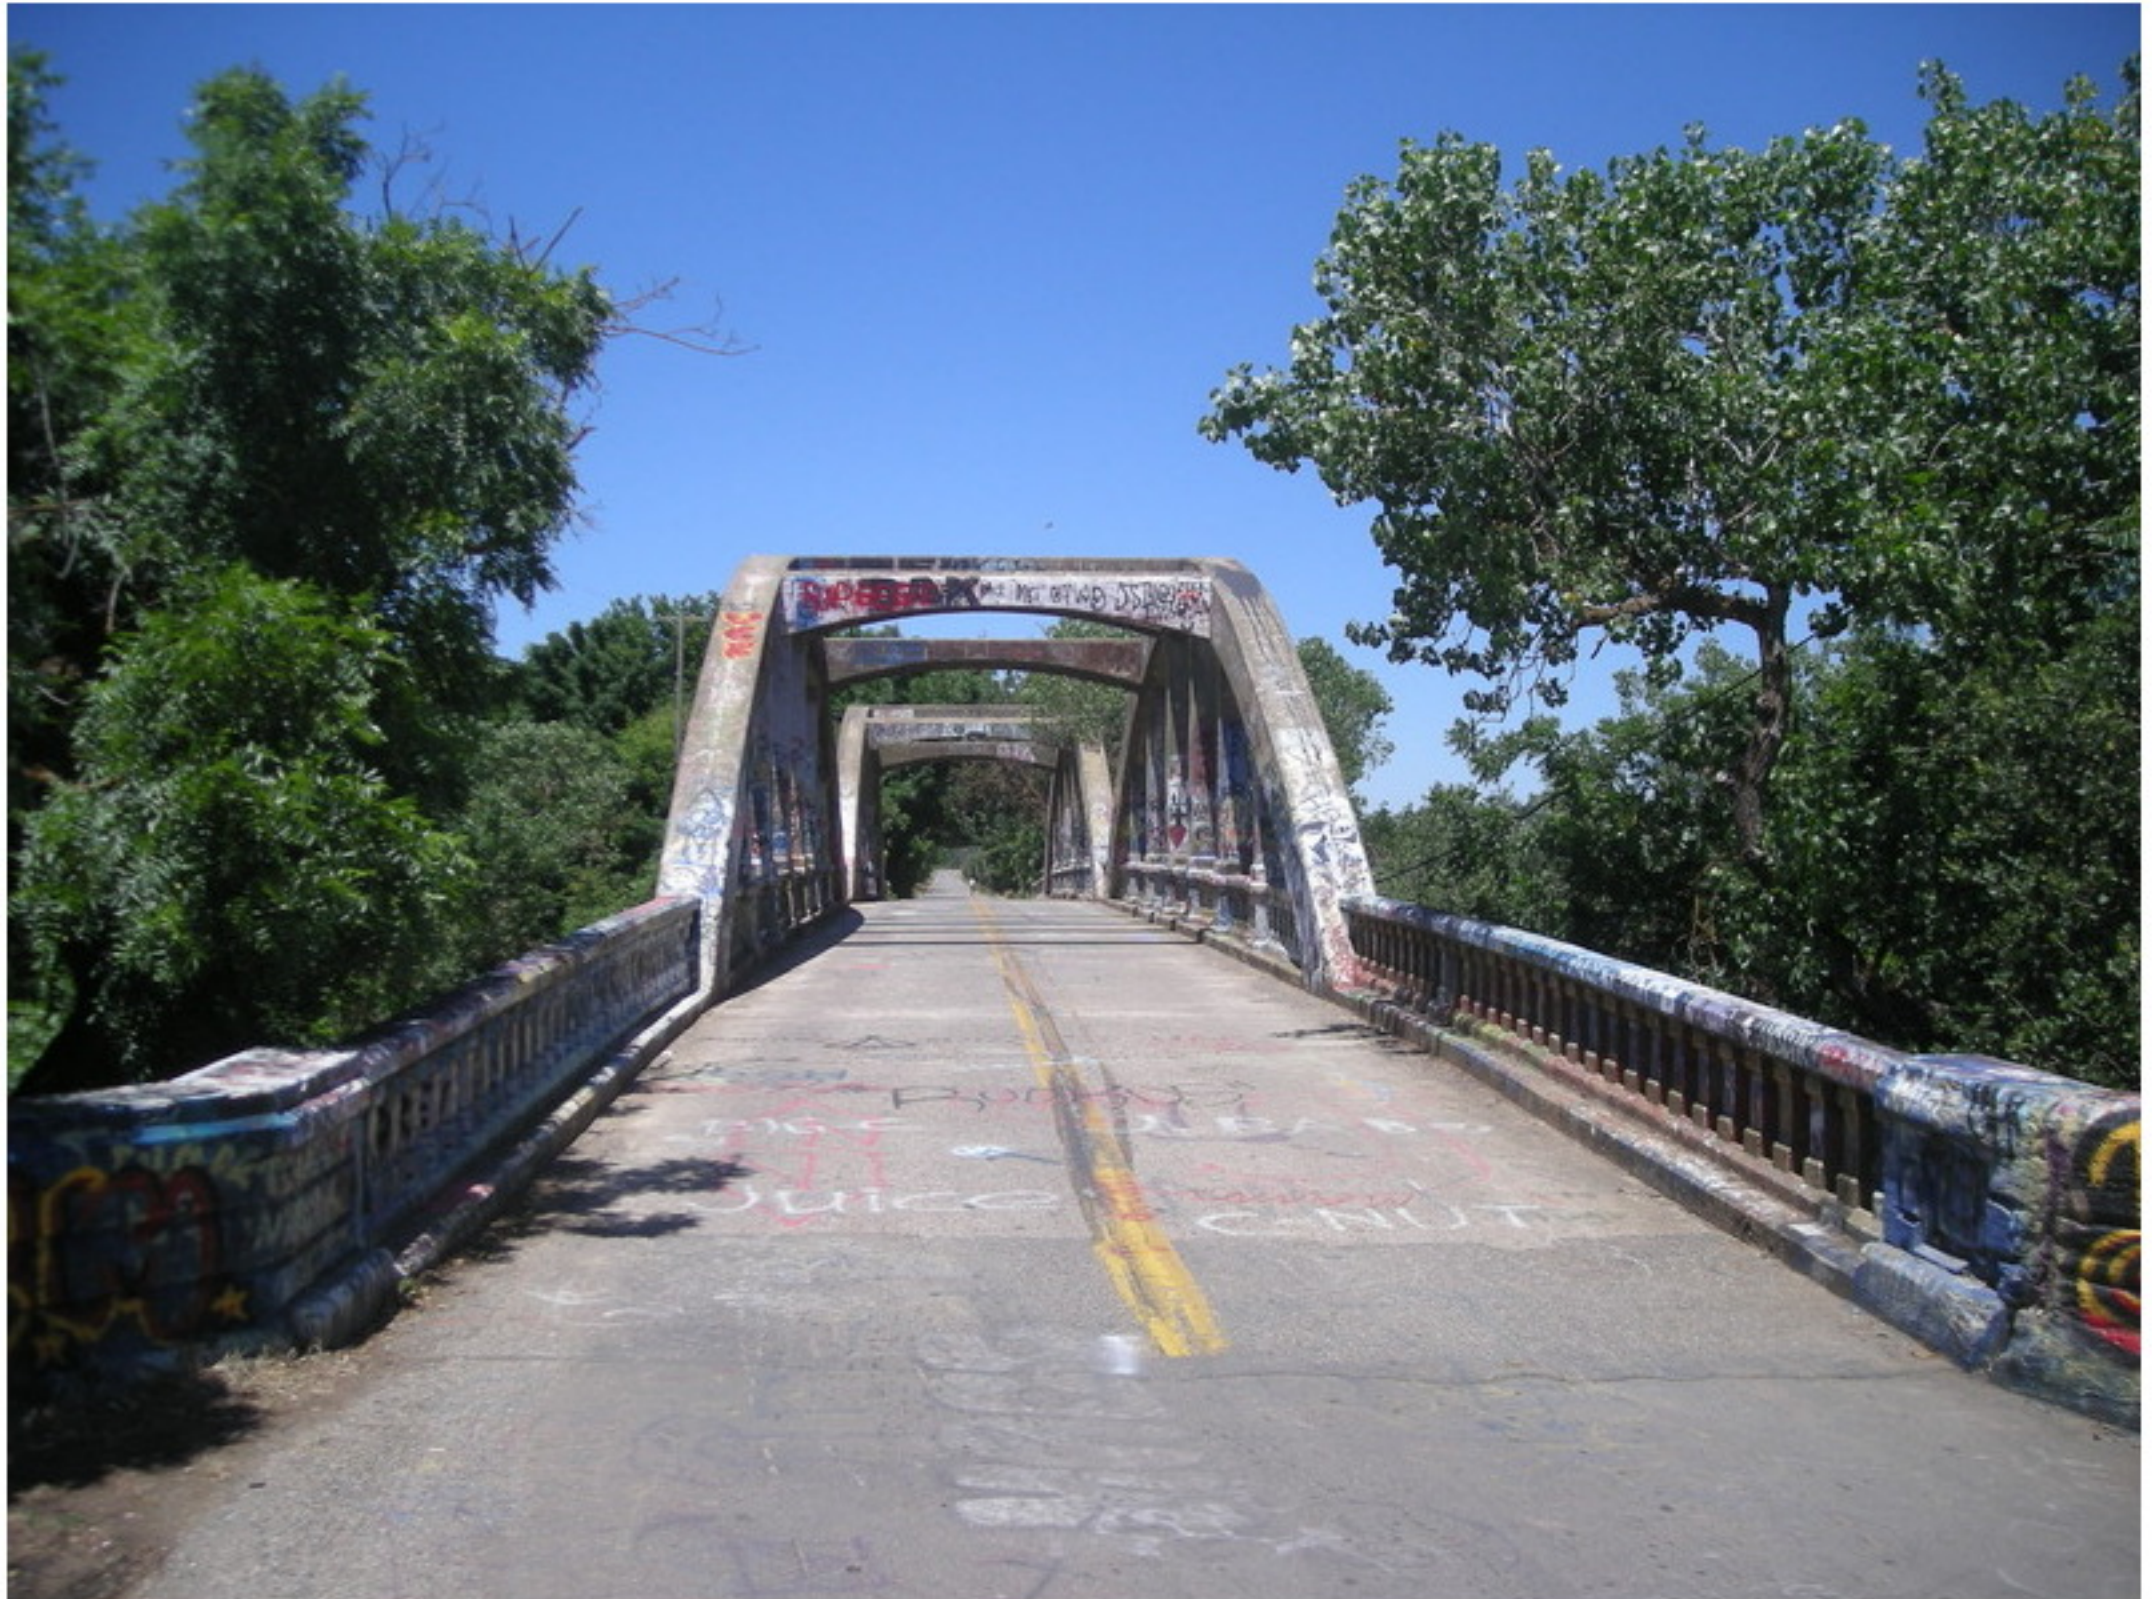
Photo No. 1  
Roadway view looking North

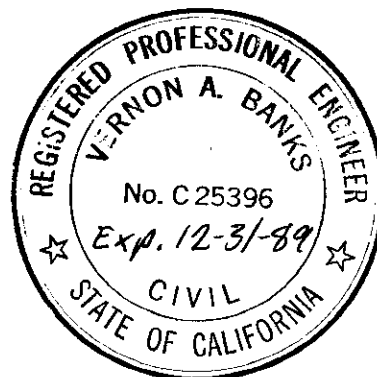
Bridge No. 23C-92  
Location 10-Sol/Yol-FAS/W851  
Dist - Co - Rte - PM - City  
Date of Investigation April 6, 1982
