U.S. Chemical Safety and Hazard Investigation Board

Seven Key Lessons to Prevent Worker Deaths During Hot Work In and Around Tanks

Effective Hazard Assessment and Use of Combustible Gas Monitoring Will Save Lives

No. 2009-01-SB

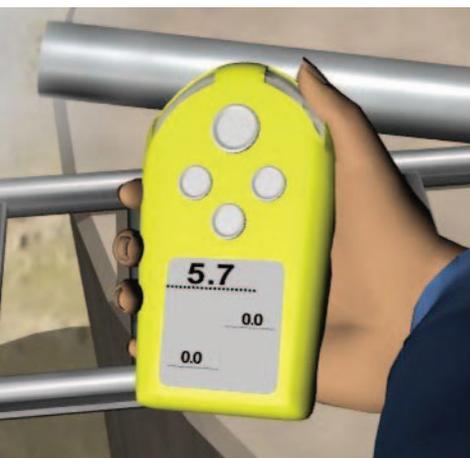
Example of a combustible gas detector used to test for the presence of flammable gas or vapor.

Flammable gas and vapor concentrations are generally determined using a portable combustible gas detector, also called an LEL.³ meter. Combustible gas detectors are relatively inexpensive and widely available. Training in LEL instrument use is a key component to effective gas testing and is a critical aspect of an effective hot work safety program.

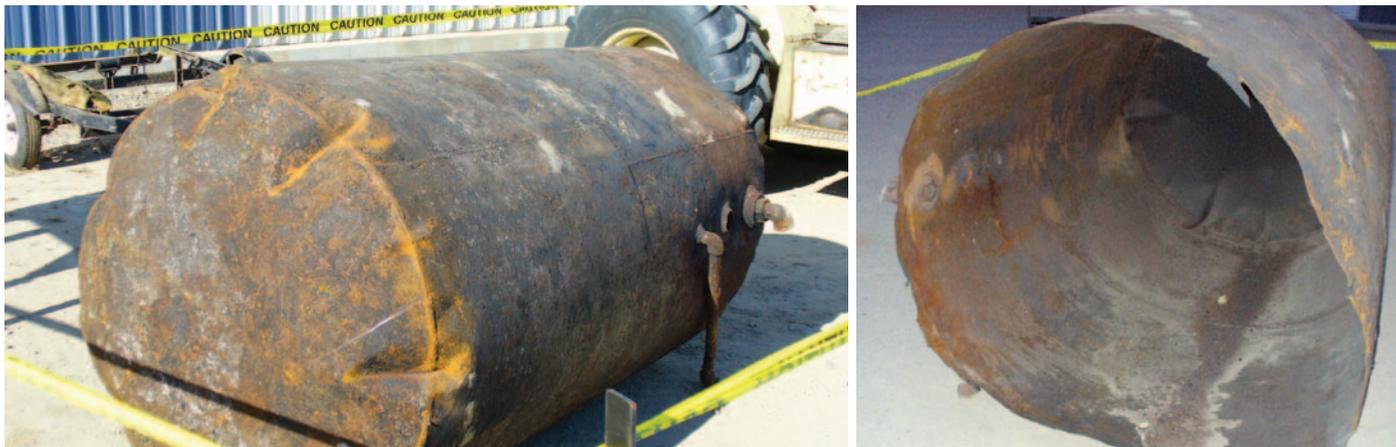
Exterior and interior views of the fuel tank involved in the hot work accident at A.V. Thomas Produce.

Two employees at A.V. Thomas Produce were using an oxygen-acetylene torch to loosen a fitting on an old fuel tank, which the company hoped to refurbish for field storage of diesel fuel. The workers, however, were unaware that the tank contained residual hydrocarbon liquid and vapor from an unknown prior use. The tank was not cleaned or purged before work began. Shortly after applying heat to the tank, an explosion occurred, blowing the end of the vessel off. Both employees were airlifted to a regional burn center, where they were treated for burns covering 30 to 50% of their bodies.

The facility had no formal hot work program, and no permit was issued for the hot work being performed. No combustible gas testing was performed prior to commencement of the hot work; the company did not have a policy that required it. In addition, many workers were mono-lingual Spanish speakers and had not been trained on safe hot work procedures or on the proper use of gas detectors in their native language.

Analyze the Hazards, Monitor the Atmosphere,
Test the Area, Use Written Permits, Train Thoroughly

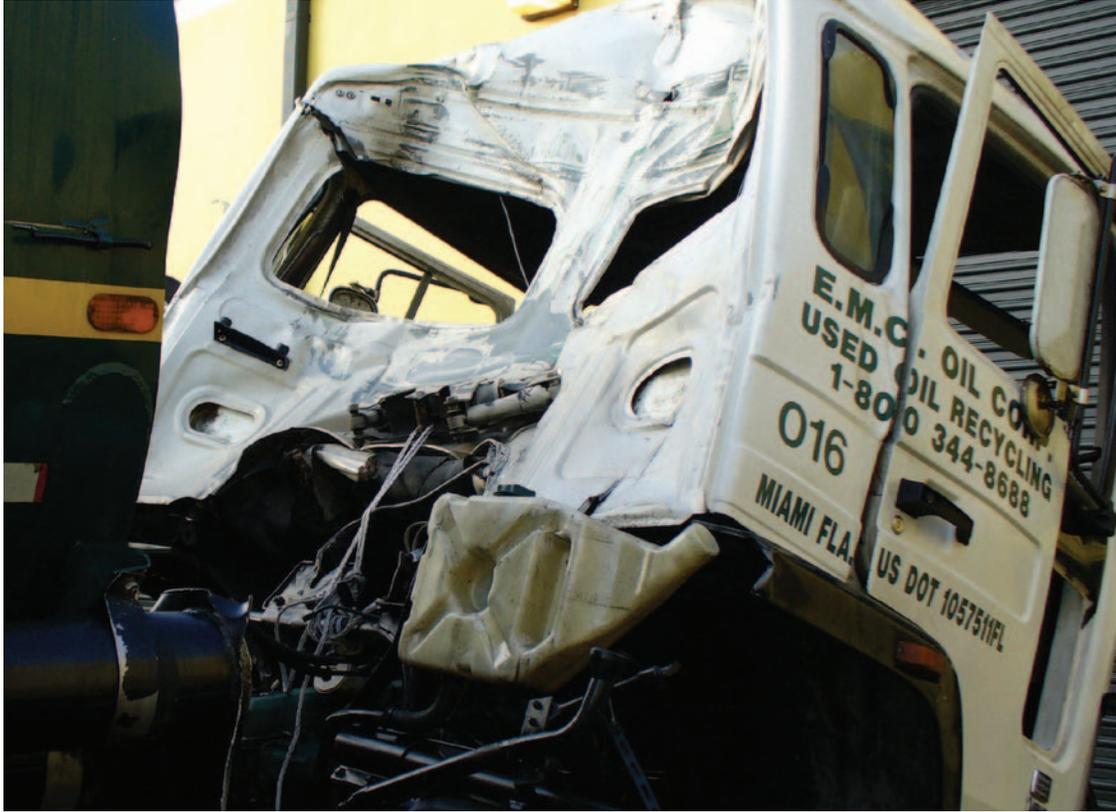
Damage to an oil tanker sustained from the December 2, 2008, explosion at EMC Used Oil Corporation.

An explosion killed a contract welder who was repairing a two-compartment oil tanker and injured another worker at the EMC Used Oil facility. The welder was in the process of welding transfer piping onto the tanker when residual hydrocarbon vapor from the 2,500-gallon rear compartment ignited, causing a powerful explosion.

The surviving worker stated that the contractors did not perform combustible gas monitoring and relied upon the host company to assure that tanks were safe for hot work. However, EMC indicated that it relied on contractors to monitor for gas; although the company owned a multiple gas detector, it was used only for confined space entry. EMC did not have a formal hot work permitting or authorization system.

Use Alternatives, Analyze the Hazards, Monitor the Atmosphere, Test the Area, Use Written Permits, Supervise Contractors

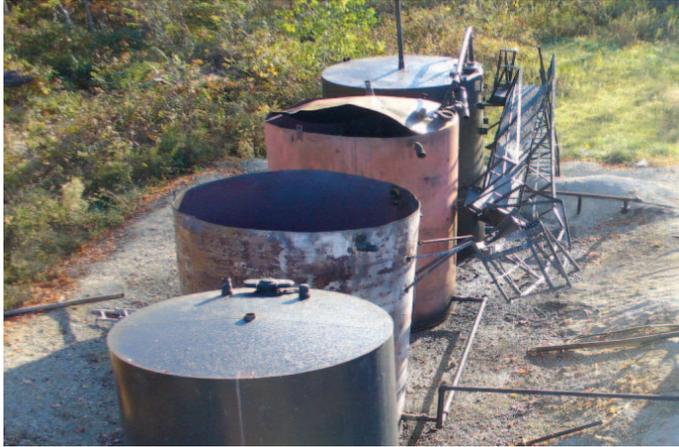
Oil storage tanks involved in fire and explosion at MAR Oil.

An explosion killed two contract workers while they were welding above a series of three interconnected crude oil storage tanks at a MAR Oil site. The explosion occurred when the workers attempted to weld a bracket on top of one of the tanks, near an atmospheric vent. Because the tanks were interconnected, oil flowing into an adjacent tank likely displaced flammable vapor into the tank being welded. The vapor escaped through the vent and was ignited by welding sparks.

The CSB investigators found that combustible gas monitoring was not performed prior to or during the welding. There is conflicting evidence as to whether or not the welding job was authorized by the host company. MAR Oil lacked a formal hot work program that required the hot work be identified in a written permit and be authorized by a person responsible for hot work management. The company had no formal program to select or oversee contractors, and the two contractors lacked documented training on safe hot work practices.

Use Alternatives, Analyze the Hazards, Monitor the Atmosphere, Test the Area, Use Written Permits, Train Thoroughly, Supervise Contractors

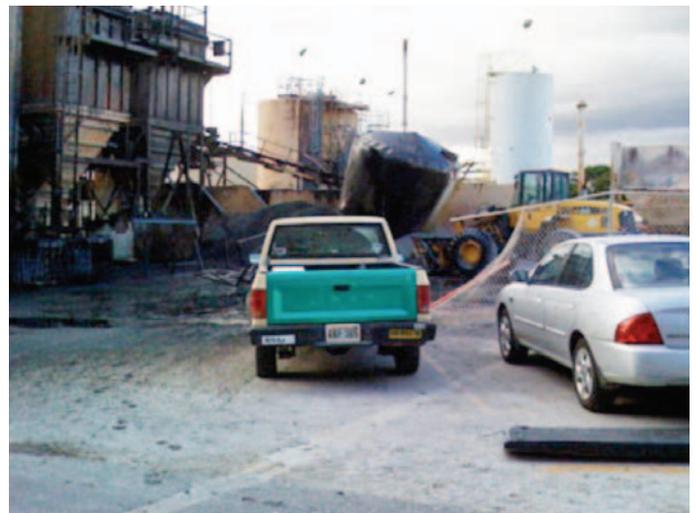
A contract welder was killed while welding on a catwalk located over a 9,300-gallon waste oil storage tank at the Philip Services Corporation (PSC). Following an investigation, the Honolulu Fire Department (HFD) concluded that, during the welding, sparks dropped in and around the vent area of the tank. The contents of the tank ignited, resulting in an explosion and fire. The force of the explosion hurled the contract welder about 120 feet, fatally injuring him. Three others were injured, and the tank was thrown about 30 feet.

According to the HFD investigation, a PSC official asserted that the contractors were not authorized to weld within the dike area surrounding the tank, a hot work permit had not been issued for the welding, and combustible gas monitoring was not conducted. Conversely, the contracting company's personnel asserted that they believed that the work was authorized and that PSC had conducted combustible gas monitoring prior to the welding activity.

View of Philip Services Corporation following a October 7, 2008, waste oil storage tank explosion.

Use Alternatives, Analyze the Hazards, Monitor the Atmosphere, Test the Area, Use Written Permits, Supervise Contractors

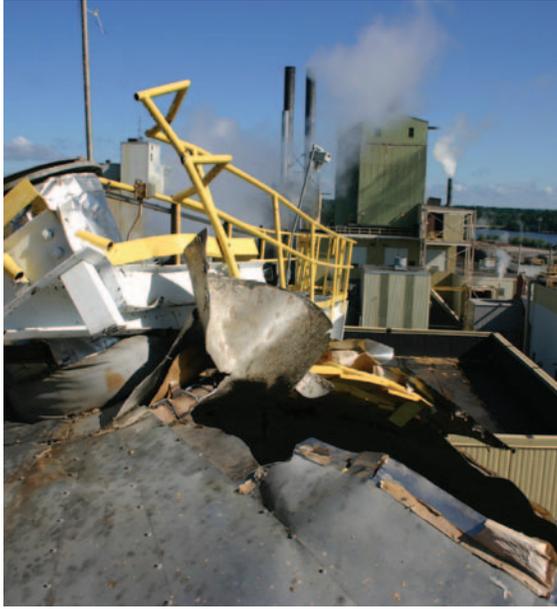
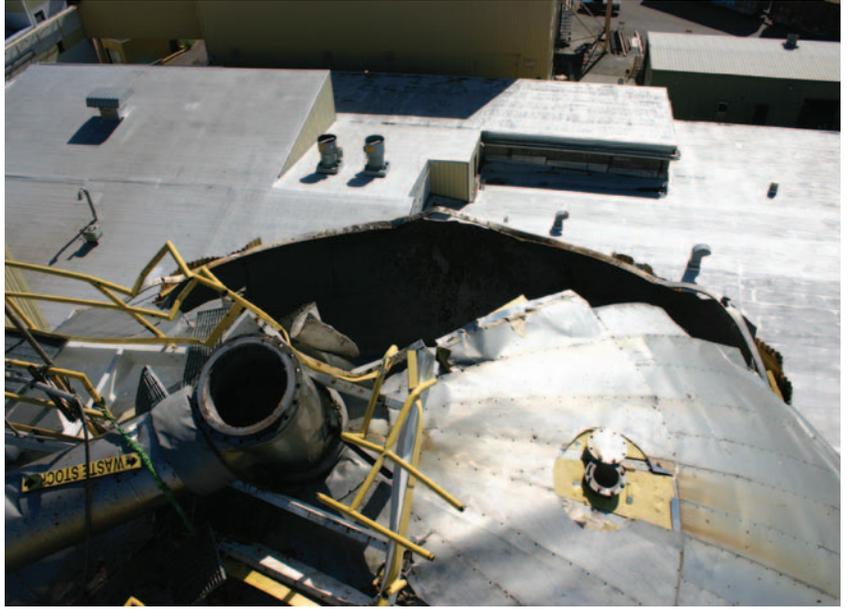
Views of the storage tank involved in the 2008 explosion at Packaging Corporation of America.

Three workers were killed in an explosion at the Packaging Corporation of America (PCA) fiberboard manufacturing facility while they were welding on a temporary metal clamp to stabilize a damaged flange connection. The flange was located on top of an 80-foot tall storage tank that contained recycled water and fiber waste.

Facility personnel were unaware of the potential presence of flammable gas from the decomposition of the organic material in the tank, and combustible gas monitoring was not typically required or performed prior to starting work. At the time of the accident, three workers were on a catwalk above the tank; one began welding the flange into place when sparks from the welding ignited flammable vapors inside the tank. The resulting explosion ripped open the tank lid, knocking two of the workers to the ground 80 feet below. All three workers died of traumatic injuries. A fourth worker, who had been observing the work from a distance, survived with minor injuries.

The CSB analysis of the tank contents determined that anaerobic bacteria had multiplied inside the tank and water recycle system over time, feeding on organic waste material. The bacteria likely produced hydrogen, a highly flammable gas, which ignited during the welding work. The CSB found that at the time of the incident, PCA supervisors and workers were unaware of the risks of flammable gas production from anaerobic bacteria growth. PCA did not perform a hazard analysis or recognize fiber waste tanks as potentially hazardous. Combustible gas monitoring was not required for the work.

Analyze the Hazards, Monitor the Atmosphere,
Test the Area

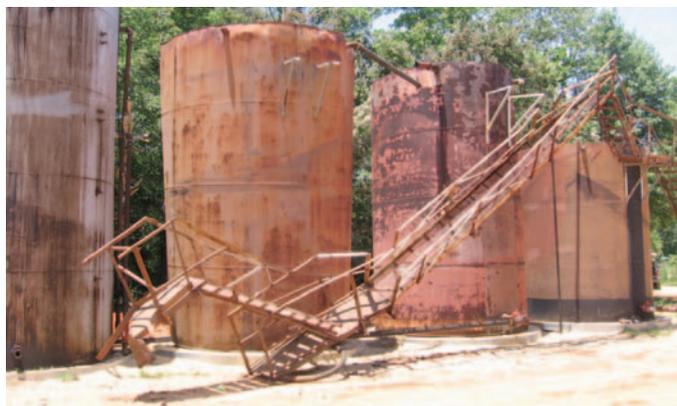
On June 5, 2006, contract workers were installing a new pipe between two oil tanks at a rural oilfield when sparks from a welding torch ignited flammable hydrocarbon vapor venting from one of the tanks. That tank and another nearby tank exploded, killing three workers who were standing above the tanks and seriously injuring a fourth. As in the MAR Oil accident, all of the tanks were interconnected by piping and one of the tanks contained crude oil, the source of the vapor that fueled the explosions.

The workers had not performed combustible gas monitoring prior to or during the hot work, instead relying on the unsafe and unreliable practice of using a lit torch to check one of the tanks for flammable vapor. Workers did not empty or isolate the tank that contained crude oil prior to initiating hot work activities.

Neither the contract company nor Partridge-Raleigh required written hot work permits. The contractor company did not provide hot work safety training to employees. Furthermore, Partridge-Raleigh did not have safety requirements for its oilfield contractors.

Tanks involved in the 2006 accident that killed three workers at the Partridge-Raleigh Oilfield.

Use Alternatives, Analyze the Hazards, Monitor the Atmosphere, Test the Area, Use Written Permits, Train Thoroughly, Supervise Contractors

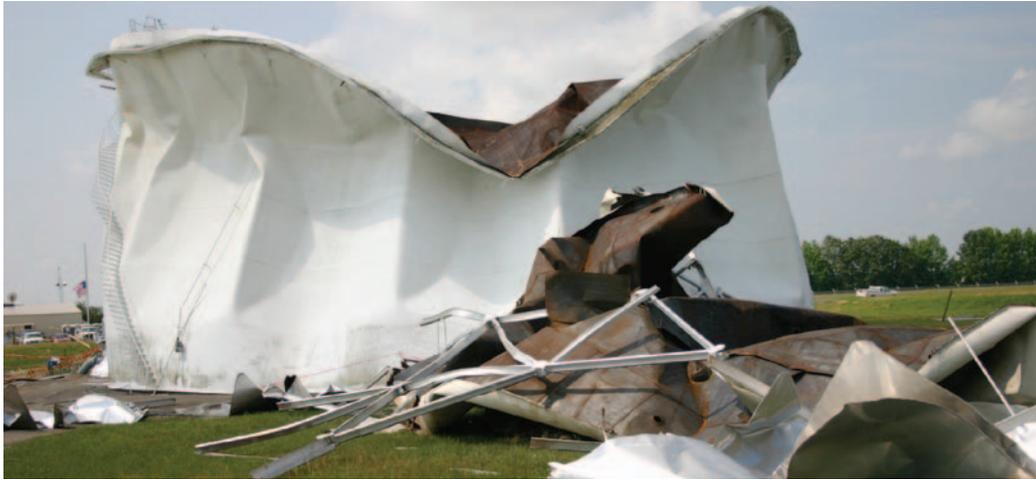
The gasoline storage tank at the TEPPCO McRae Terminal following the 2009 hot work accident that killed three workers.

Three contractors were using a cutting torch on top of the internal floating roof of a 67,000-barrel capacity gasoline storage tank at the TEPPCO Partners McRae Terminal when an internal explosion blew both the top of the floating roof and the secondary dome-shaped lid off the tank. All three were killed. The contractors were preparing to install a gauge pole. The gauge floats within the pole and measures the quantity of product within the tank. Part of the installation process involved cutting an opening into the floating roof for the pole to be inserted. The torch-cutting activity most likely ignited flammable vapor within the tank.

work permit to torch-cut the roof. The hot work permit indicated that gas testing occurred at 7:00 am, the start of the work shift. However, no documentation exists indicating that gas testing was conducted after the workers returned from lunch or when they started the hot work activities just prior to the explosion at approximately 2:30 pm. Work atmospheres can change rapidly; gas monitoring needs to be conducted immediately prior to and during hot work activities to ensure that workers are constantly aware of the potential development of an explosive atmosphere.

Analyze the Hazards, Monitor the Atmosphere,
Test the Area, Supervise Contractors

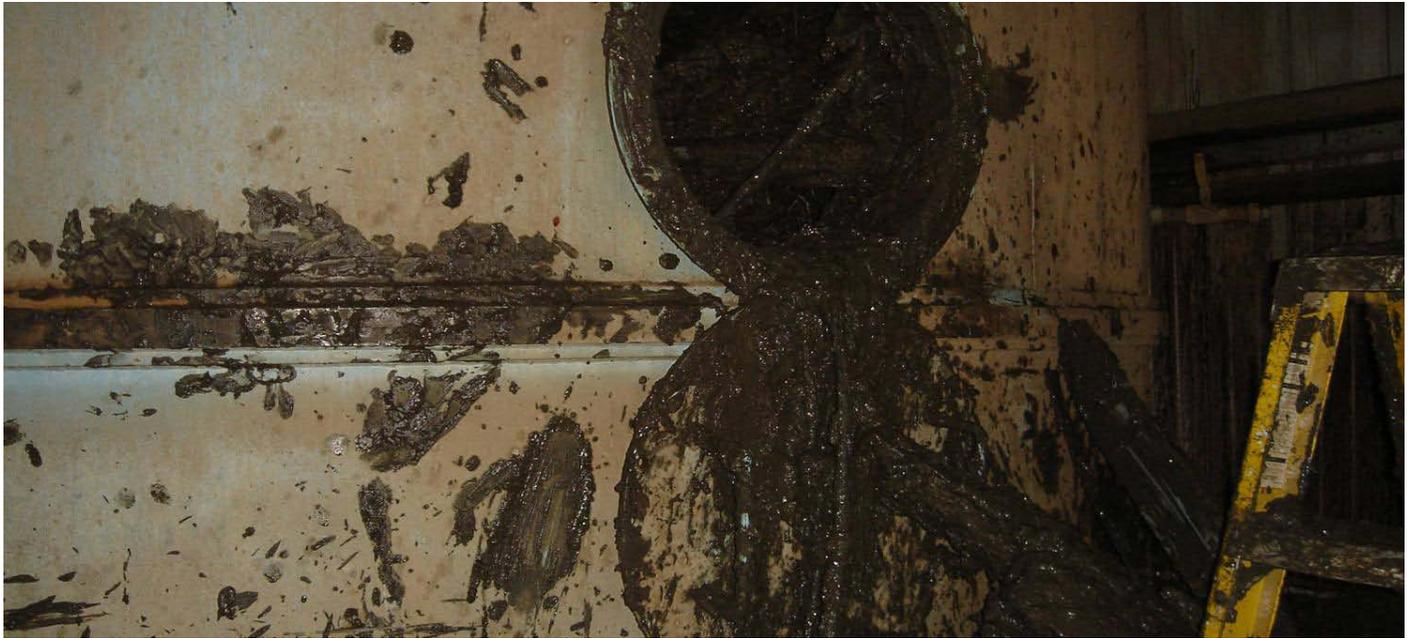
Potato-washing tank involved in the February 2009 accident at ConAgra Foods.

A welding contractor was killed while repairing a 1 ¼ by ½ inch crack on the bottom of a water clarifier tank at a ConAgra Foods facility. The 23-foot-tall tank was used to separate dirt and debris from wastewater in a potato-washing process area. The tank was open at the top and had a metal skirt around its cone-shaped base. While the welder was working inside the tank, an explosion occurred; the internal tank structures collapsed, resulting in his death.

The CSB determined that approximately 14 inches of debris-laden water had leaked through the crack in the tank and accumulated in the hidden space under the tank skirting. Examination of a sample of the liquid indicated that bacterial decomposition of the organic matter likely produced flammable gas, which was then ignited by the welding activity.

In this case, ConAgra personnel had tested for combustible gas inside the tank prior to the hot work, but only from the entrance of the tank and no flammable gas was detected. Monitoring for combustible gases was not conducted in the immediate area of the crack just prior to the initiation of the welding or in the adjacent space where flammable gas was present. Personnel were inadequately trained on the use of the specific combustible gas detector that was used and no hot work permit had been issued prior to commencing the welding.

Analyze the Hazards, Monitor the Atmosphere,
Test the Area, Use Written Permits, Train Thoroughly

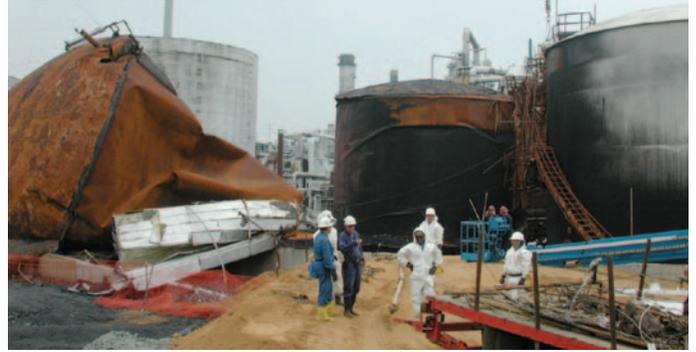
A massive explosion destroyed a large storage tank containing a mixture of sulfuric acid and flammable hydrocarbons at the Motiva Enterprises Delaware City Refinery. One contract worker was killed, eight others were injured, and sulfuric acid from collapsed and damaged tanks polluted the Delaware River. The explosion occurred during welding operations to repair a catwalk above the sulfuric acid tank, when flammable hydrocarbon vapor was ignited by welding sparks. This resulted in a powerful explosion inside the tank, which had holes in its roof and shell and a deficient inerting system.

On the day of the accident, combustible gas testing was performed only at the start of the hot work, but monitoring was not conducted for the duration of the hot work activities. Throughout the five hours between the last gas test and the explosion, the ambient temperature warmed by 14 degrees. This warming increased the evaporation of hydrocarbons inside the tank, and the resulting flammable vapor leaked out the tank's holes into the work area.

Motiva had a hot work program that included written permits, but the program was inadequate. Hot work was allowed near tanks that contained flammables including

A view of the flammable storage tank involved in the accident at the Motiva Refinery.

those that had known holes due to corrosion. Continuous atmospheric monitoring and the control of welding sparks were not required.

Use Alternatives, Analyze the Hazards, Monitor the Atmosphere, Test the Area, Supervise Contractors
