MIDDLE GREEN VALLEY
SOLANO COUNTY, CALIFORNIA

PRELIMINARY GEOTECHNICAL EXPLORATION

PREPARED BY
ENGEO Incorporated

March 20, 2019

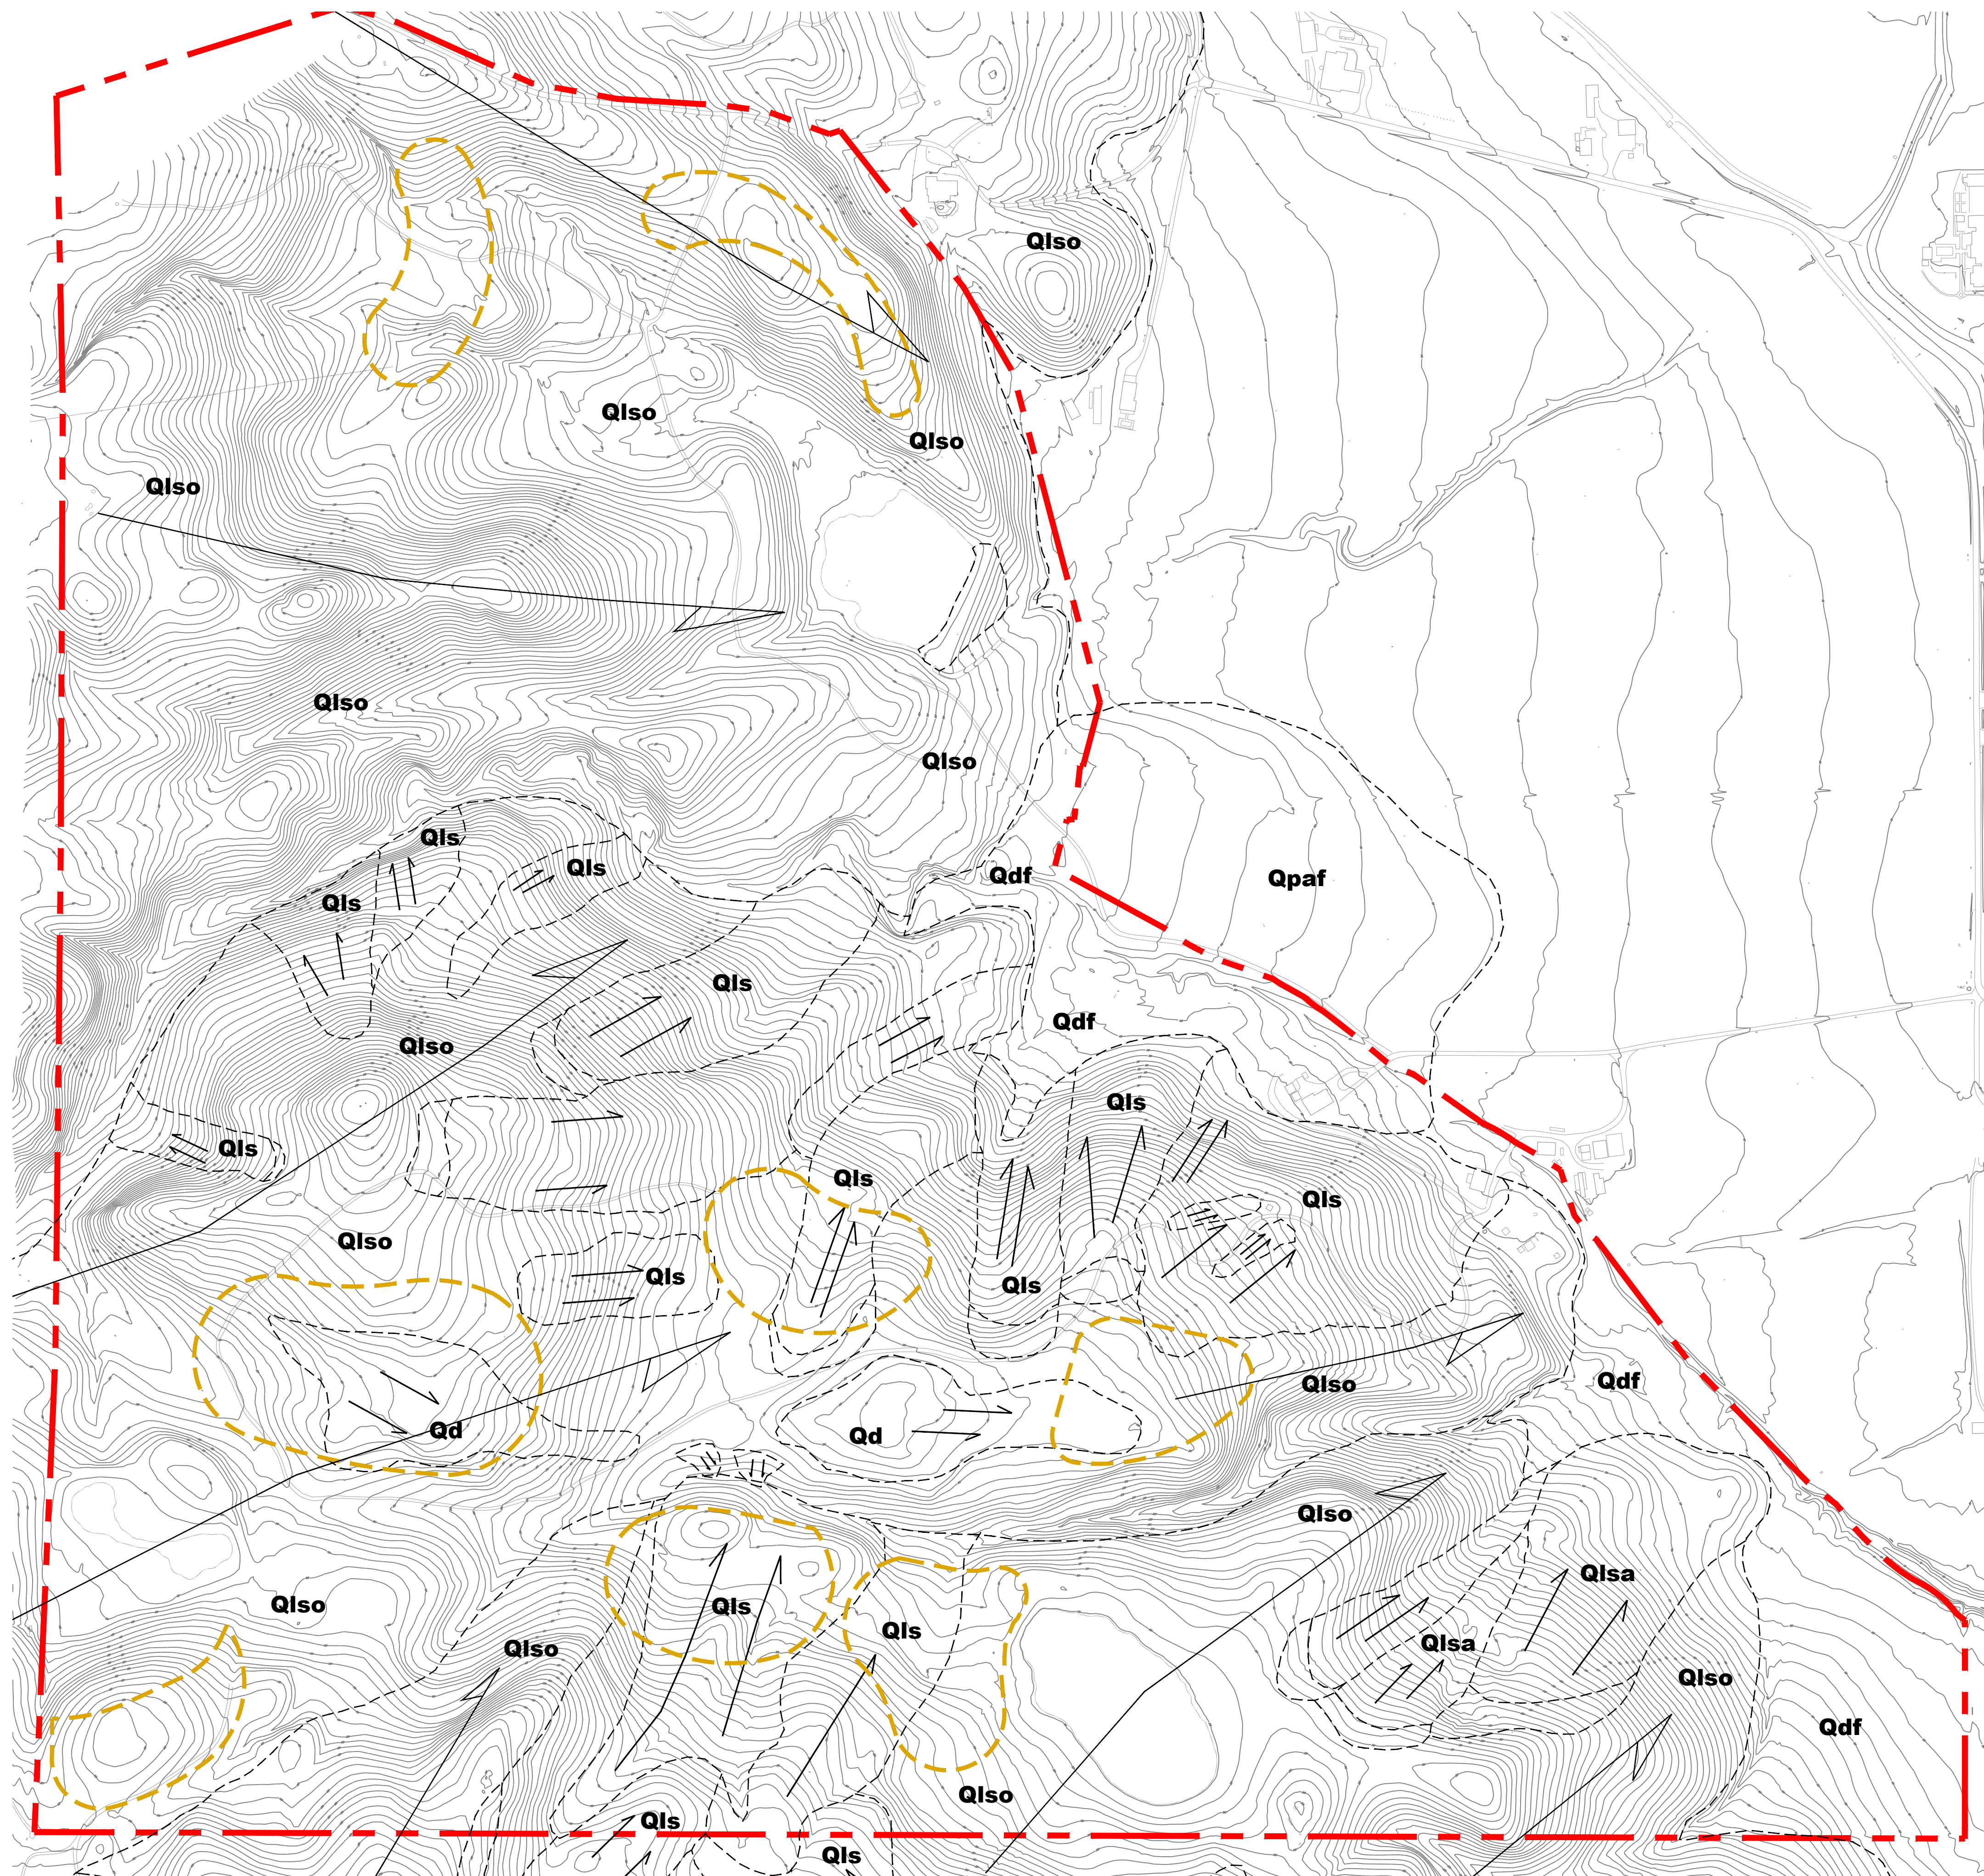
- EXPLANATION**
ALL LOCATIONS ARE APPROXIMATE
- - - - - SITE BOUNDARY
 - - - - - RURAL MEADOW RESIDENTIAL DESIGNATIONS (MIDDLE GREEN VALLEY, 2019)
 - - - - - GEOLOGIC CONTACT
 - Qlsa** () ACTIVE EARTHFLOW SHOWING FLOW DIRECTION AND HEADSCARP
 - Qls** () EARTHFLOW SHOWING FLOW DIRECTION AND HEADSCARP
 - Qlso** () DEEP-SEATED BEDROCK LANDSLIDE (DORMANT)
 - Qpaf** PLEISTOCENE ALLUVIAL FAN DEPOSITS
 - Qdf** DEBRIS FAN DEPOSIT
 - Qd** QUATERNARY COBBLE DEBRIS FLOWS

- Older, deep-seated bedrock landslides covering most of the east facing slopes west of Green Valley identified on Figure 5 as Qlso. These landslides display evidence of past, large-scale displacement such as prominent, high headscarps, large scale hummocky topography containing many large displaced bedrock blocks and very large topographic troughs below headscarps that are interpreted to be graben areas formed by detachment of bedrock block from the adjacent ridgelines. Similar deep-seated landslides mantle most of the east facing ridge slope west of the Green Valley Fault from Benicia to the north end of Green Valley (Manson, 1989, Allen et. al, 2009). In the MGV Specific Plan area, the deep-seated landslides appear to be dormant and do not display geomorphic evidence of very recent large-scale movement. They are deeply incised by streams, low-lying areas are filled with colluvium, and the toes of the landslides are covered by younger debris fan deposits. Based on these observations it is likely that the deep-seated landslides are of Pleistocene age. However, the bedrock materials within the Qlso deposits are marginally stable and are mantled with numerous smaller landslides that locally show evidence of more recent activity.
